Bar Locks and Early Church Security in the British Isles

John F. Potter

Access Archaeology

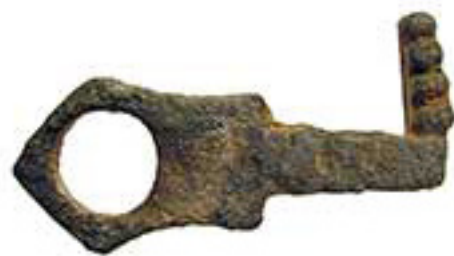
Figure 1.4. A bronze key with a clawed blade probably of Viking origin dated to about AD 300.

key, used to manually release different locking systems. They were probably of Viking (Celtic) age and were found in the Värnamo area of Sweden. They were in all probability used in much the same manner as described by Homer. Figure 1.4 illustrates a bronze key identified as of Viking source with a clawed blade (*Historia om nycklar 3 liten*) which is believed to have been used about AD 300; while Figure 1.5, which is a similar clawed key, has been described as of Anglo-Viking origin and dated to about AD 900 (author J. F. Smith). Dr Raine Borg holds a large personal collection of keys, and he has produced a drawing of one of his keys from southern Sweden which is thought to date from the early 1100s. It is believed to have been operated as a metallic (iron) mechanism within a block of wood and, as the key is more than 150mm long, it is possible to presume that locking could be achieved from either side (of a door) by means of a keyhole. In many locking mechanisms little of the action can be readily viewed and the workings may be encased. The pull-ring lock from Sweden (shown in Figure 1.6) required two hands to operate, one for pulling the ring whilst the other turned the key. It is dated to 1312-13 and is photographed here by Raine Borg.

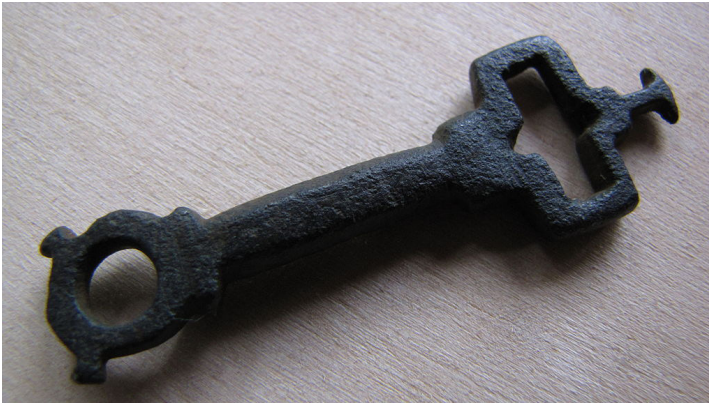
Figure 1.5. A further clawed key thought to be of Anglo-Viking origin and dated to about AD 900.

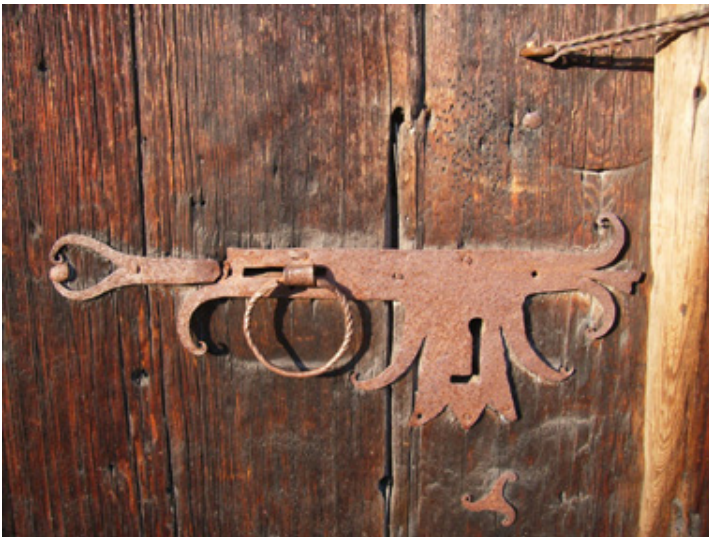
Figure 1.6. A pull-ring lock Swedish key (dated to 1312-1313) photographed by Dr R. Borg. The mechanism requires two hands operate - one to draw the bolt, the other to turn the key.

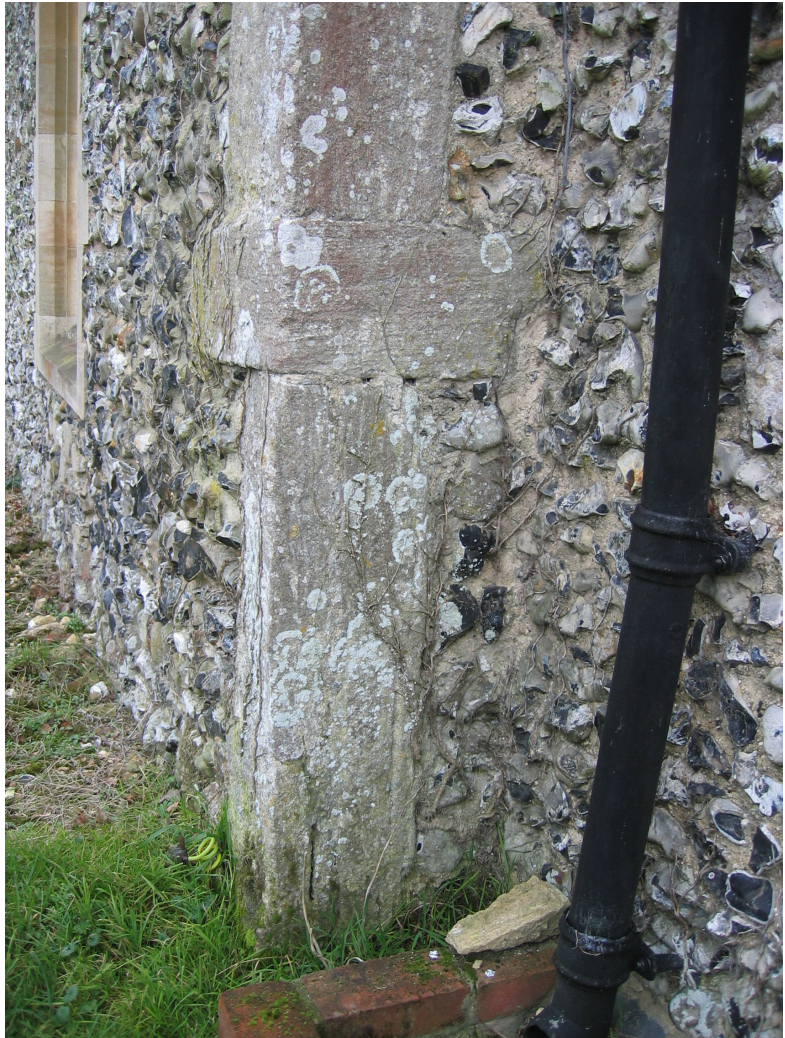
Figure 1.10. Detail of the lowest three stones (in the long and short Anglo-Saxon style) in the south-west nave quoin at Stretthall church (TL 484 398) in Essex (after Potter, 2009c). From the lowest stone upwards, the bedding orientations are BVFR, BH, BVFL. The rock type used is Barnack Stone, imported into the region.
