The Swash Channel Wreck

An Archaeological
Investigation
of a 17th-Century
Armed Dutch
Merchantman

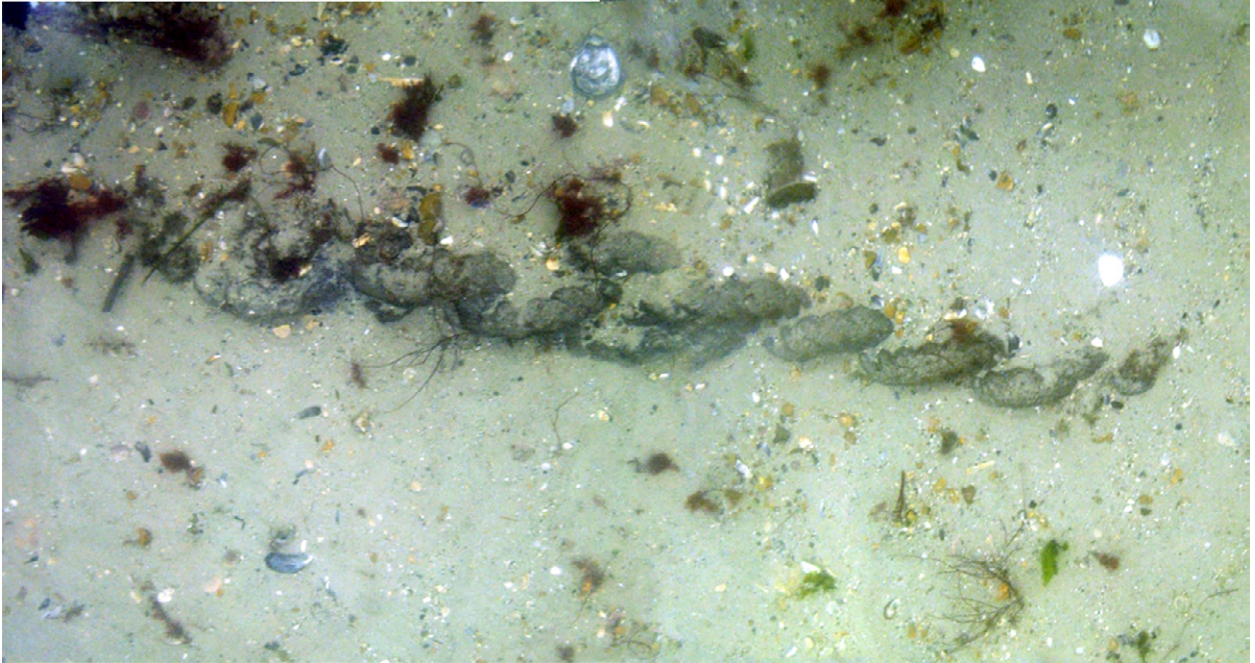
Figure 1.3. Cable potentially relating to the salvage

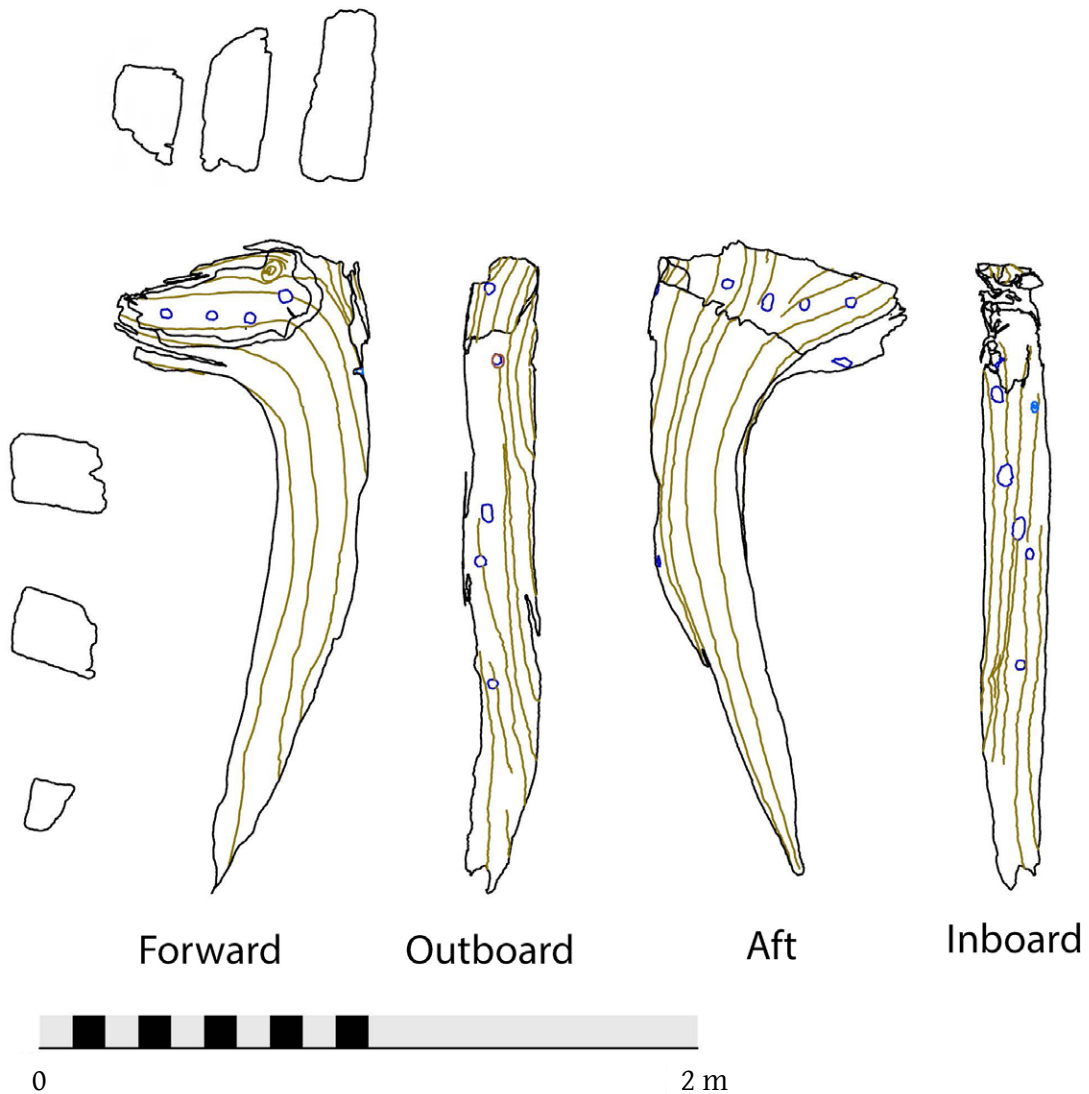
Figure 4.4. SCW1310 disarticulated knee

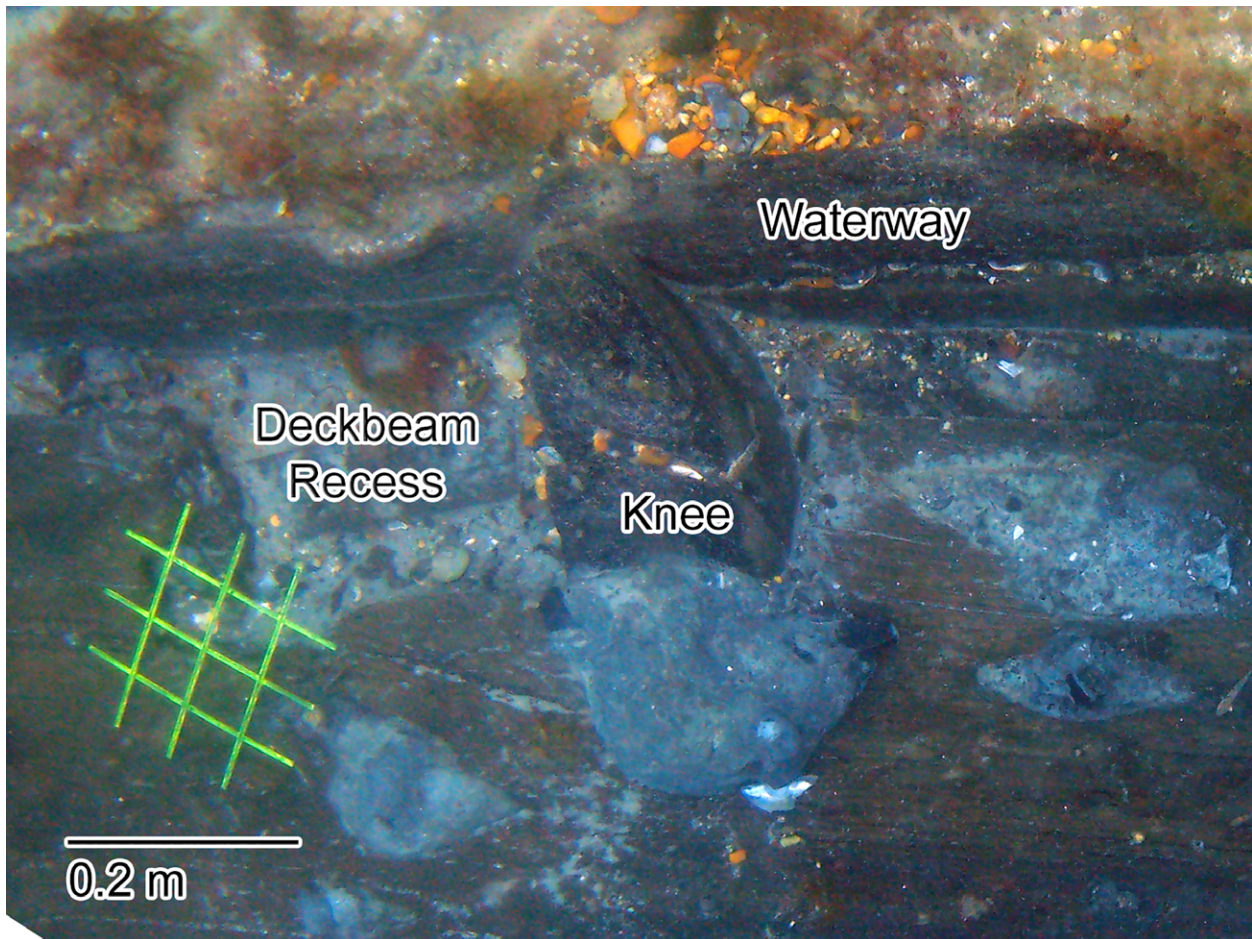
Figure 4.6. Small knee in the stern supporting the quarterdeck

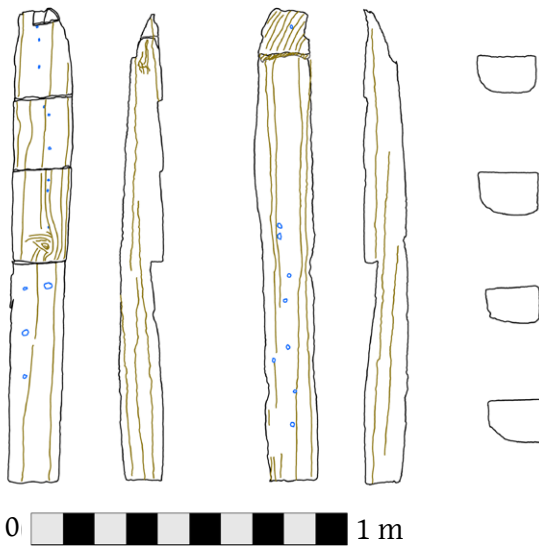
Figure 4.25 Stanchion frame SCW1227 showing the hook for the last strake and the joggles for the weatherboarding and rails

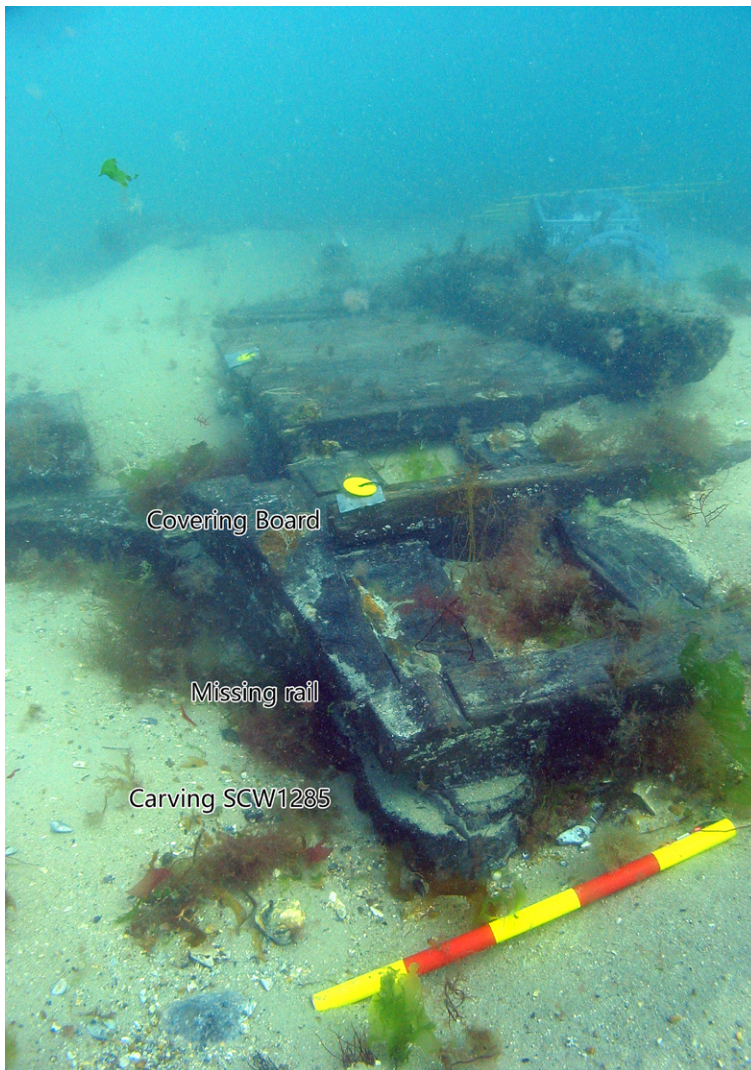
Figure 4.42. Missing rail shown in the 2004 photographs from Wessex Archaeology

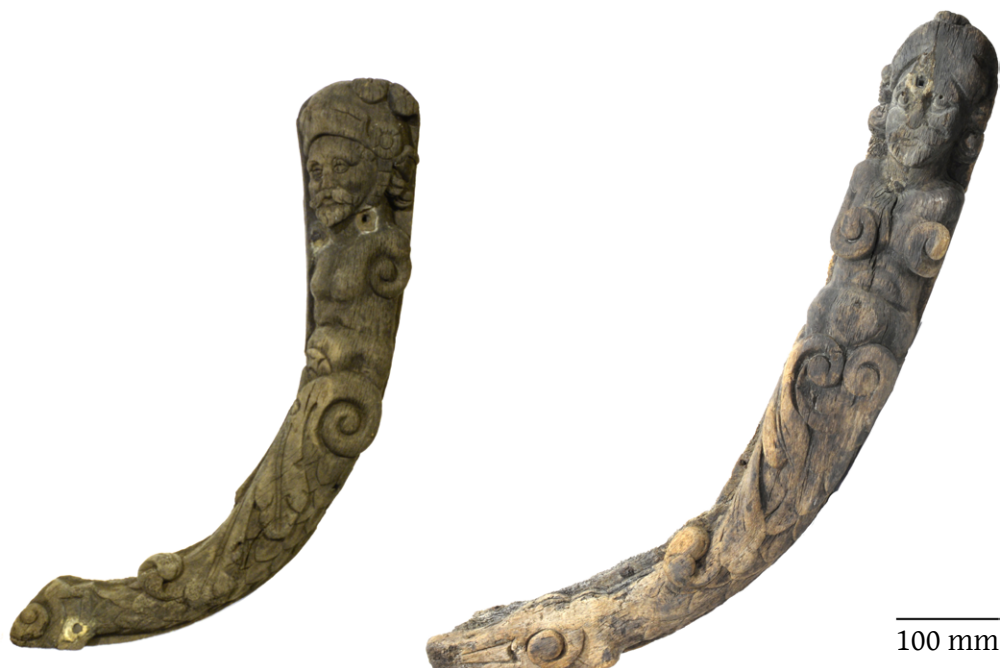
Figure 4.44. Tritons SCW18 (left) and SCW1285 (right)

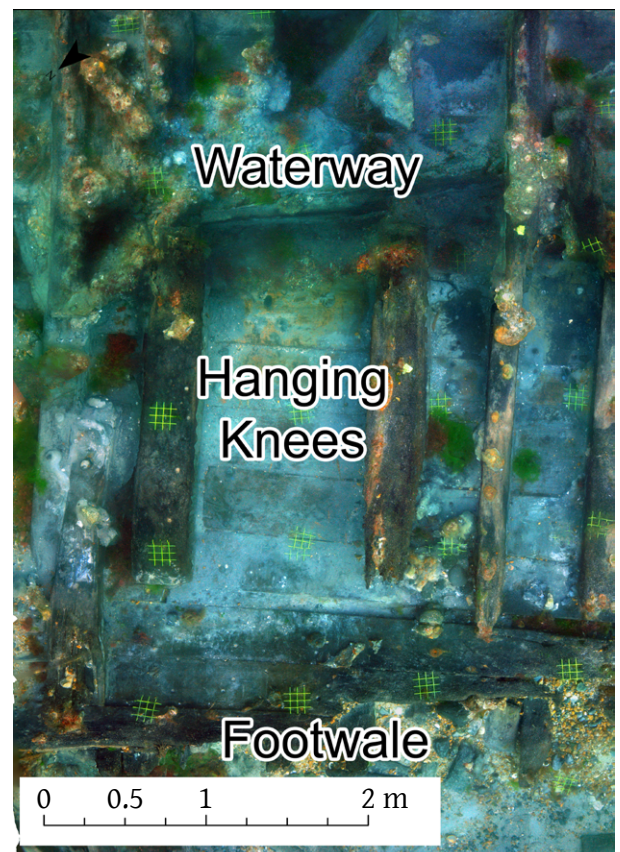
Figure 4.56. The hold at midships

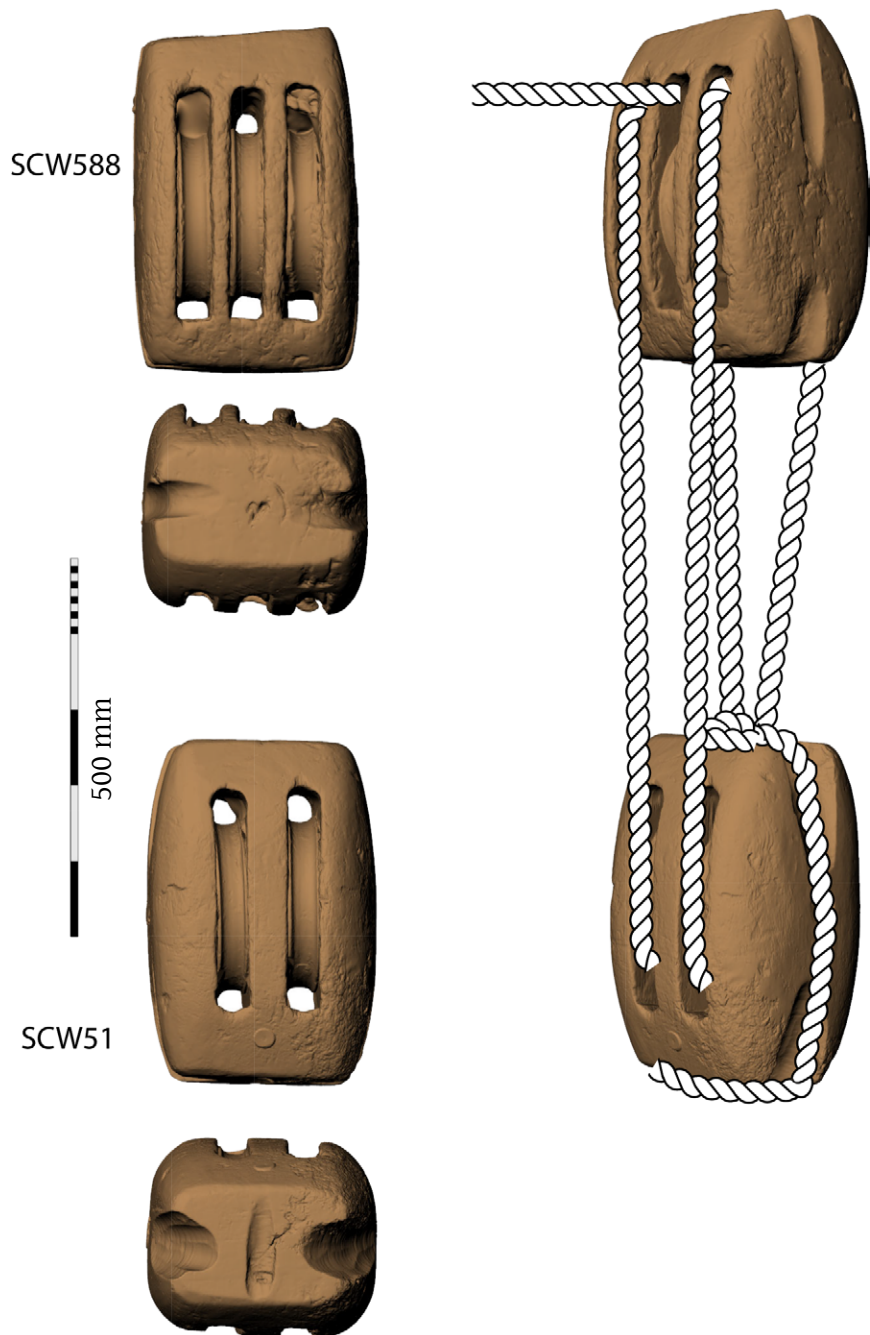
Figure 5.5. SCW51 and 588 in an example of a gyn tackle

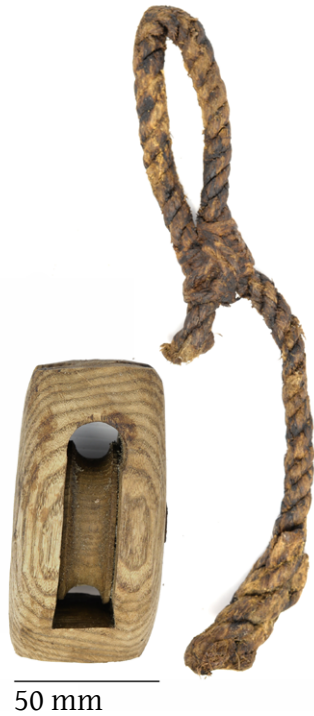
Figure 5.10. SCW435 next to its strop

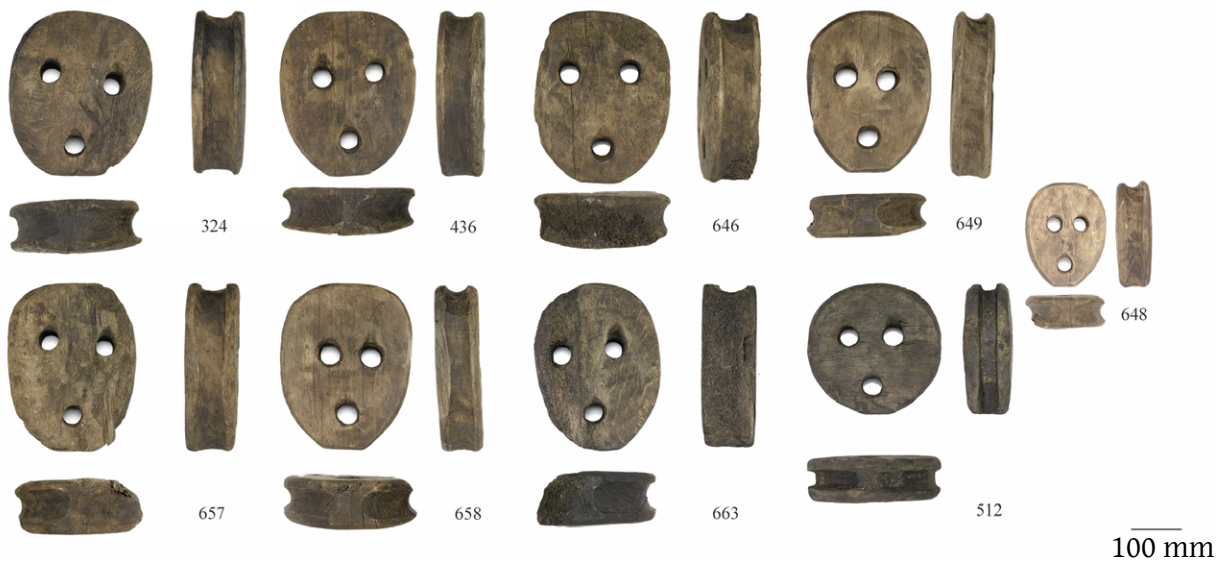
Figure 5.16. Deadeyes recovered from the wreck

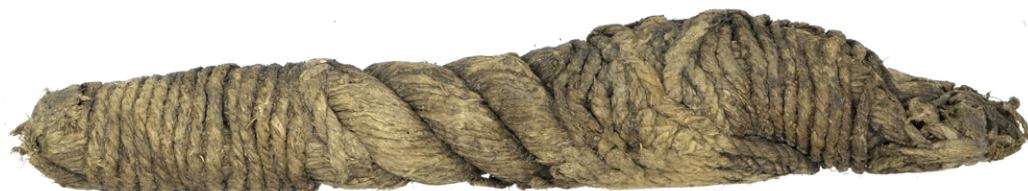
SCW221 is a Z-laid hawser approximately 52mm diameter (6½" circumference). The mouse is in very poor condition but would have been c 12" in circumference when complete. The poor condition of the mouse allowed its composition to be ascertained: a possible layer of serving using a 4–5mm stuff, followed by a few layers of some heavier small stuff that on investigation was found to be a three-strand sennit or

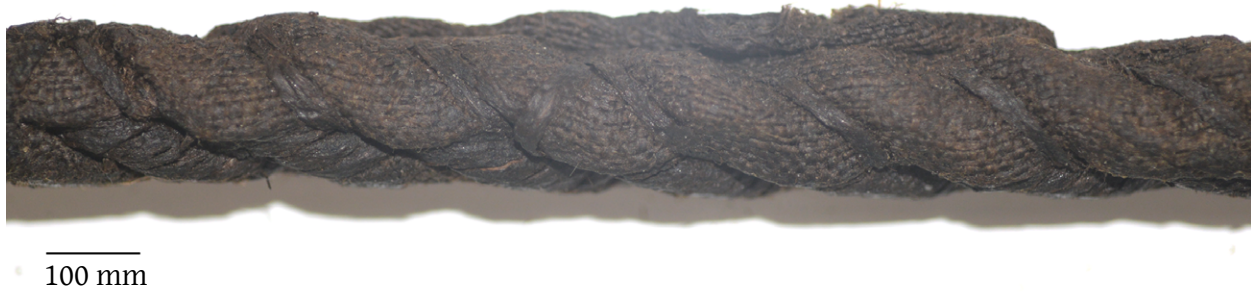
Figure 5.19. Sail cloth stitched to the boltrope

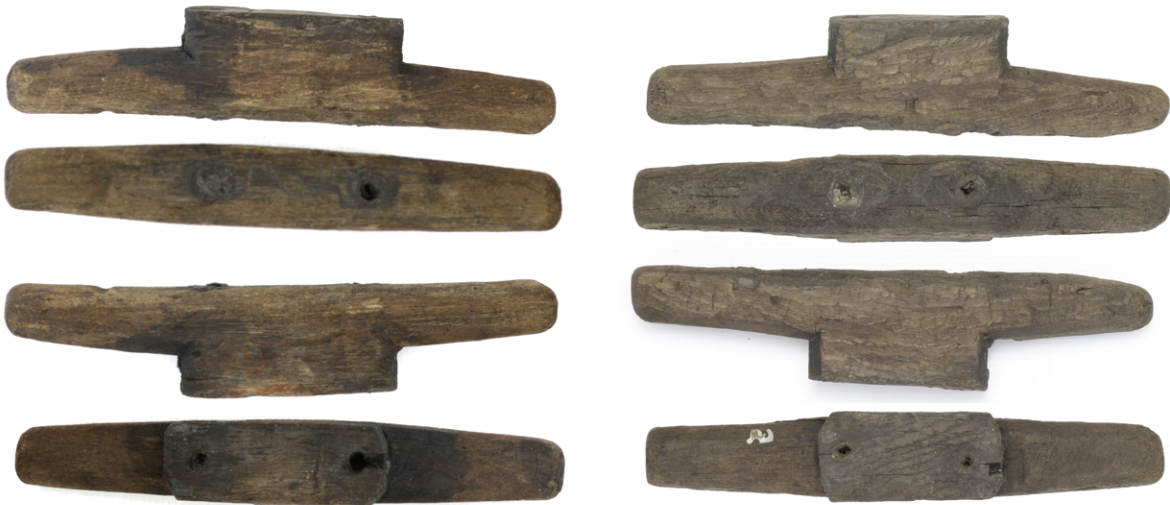
SCW788 (Figure 5.24) is the most complete of the hanks, with both ends surviving. Estimated to be at least 100m of rope, approximately 9–10mm diameter (1½ – 1¼" circumference), each strand S-laid, from four Z-laid yarns. It was originally made up as a coil or hank measuring more than 650mm long, which it currently measures in a very relaxed state.

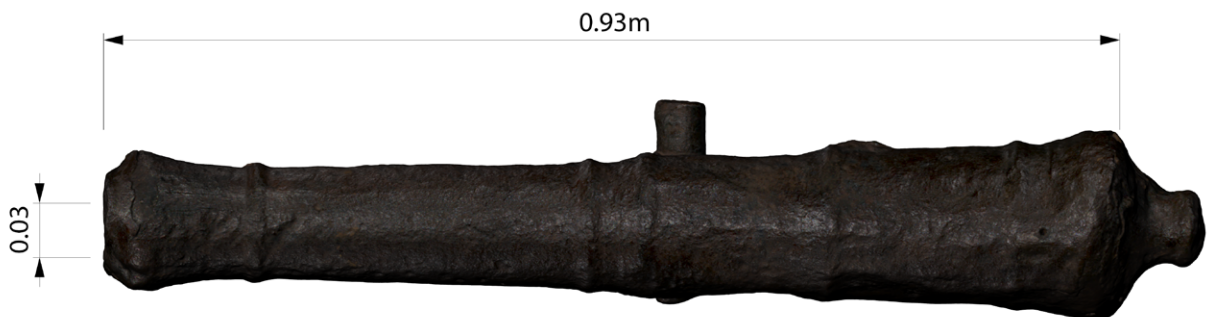
Figure 6.5. Gun SCW689

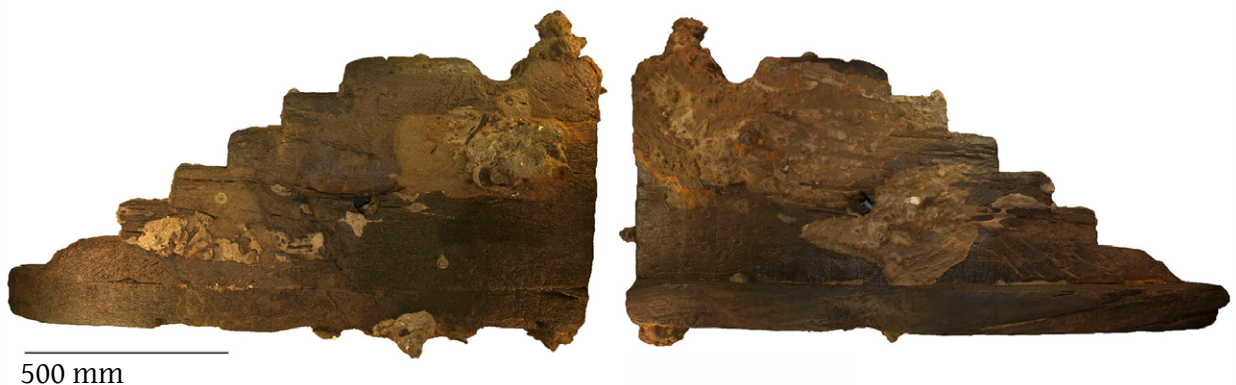
Figure 6.9. SCW52 carriage cheek

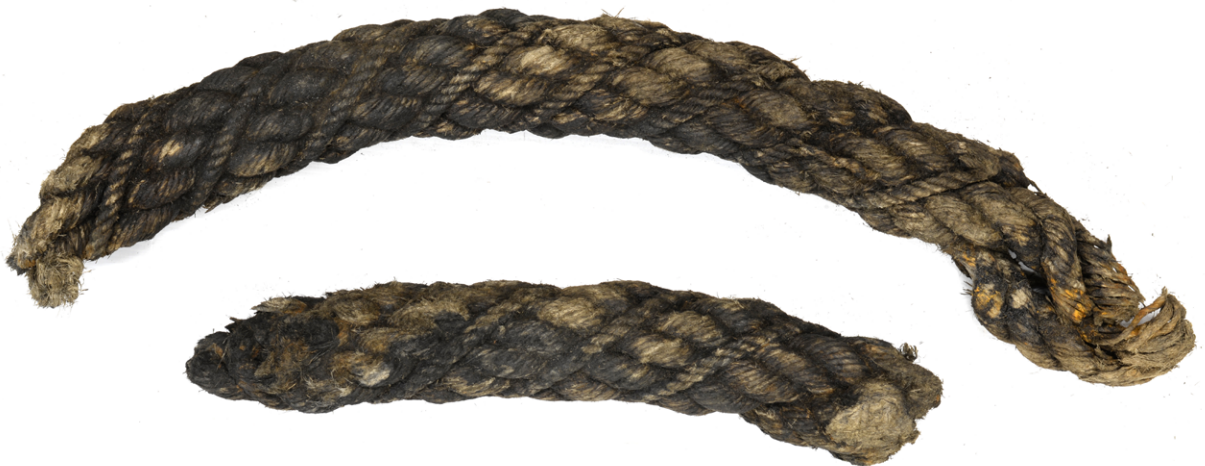
In addition, 17th-century carriages of a similar construction but with differing rears can be compared to give a general idea of guns at sea, such as the chock-based carriage on the *Swan* (Martin 2004), the three-wheeled carriage from the late 16th-century shipwreck *Scheurrak SO 1* near the Texel (Puype 2000) and the Windsor Castle cannon (Smith 2001).

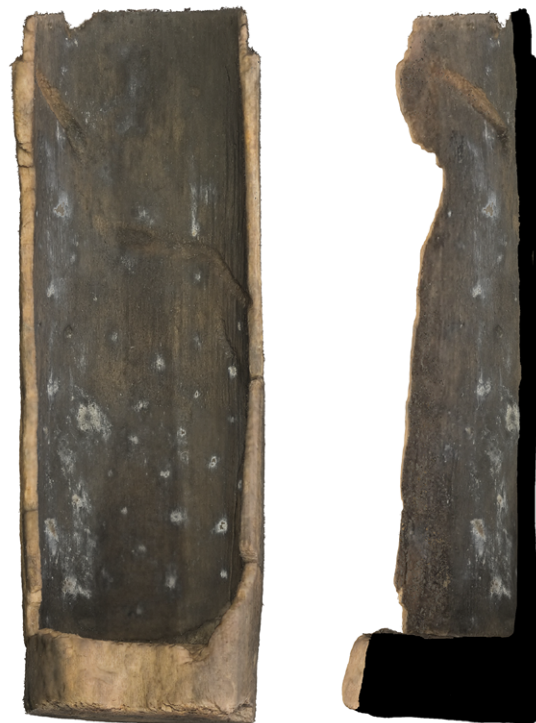
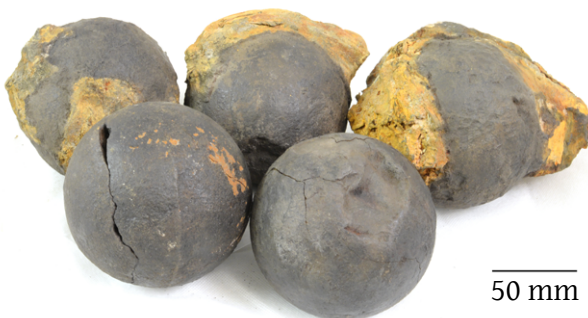
Figure 6.14. 120mm round shot

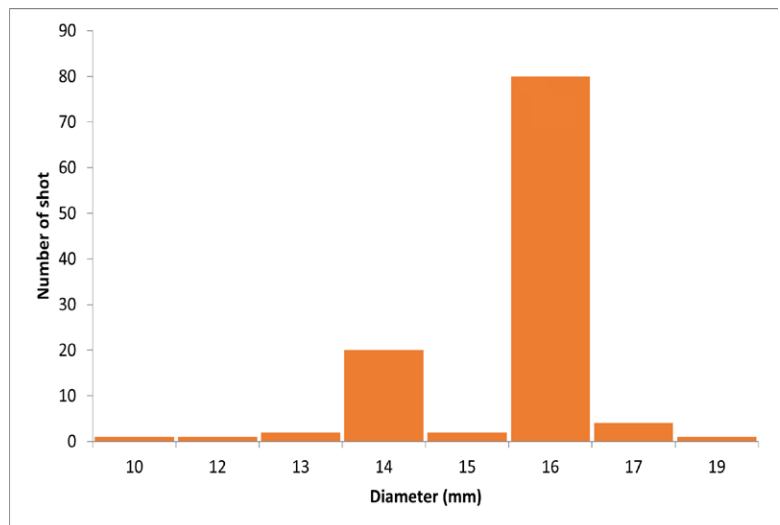
Figure 6.16. Diameters of shot found within canister SCW740

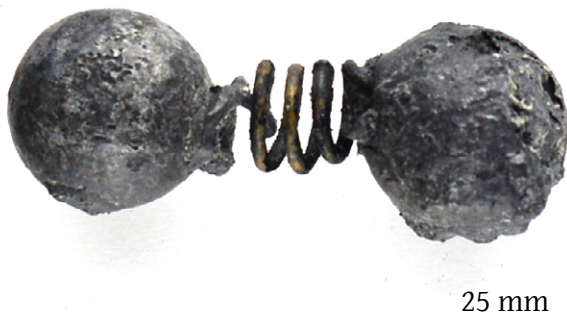
Figure 6.18. Expanding shot SCW759

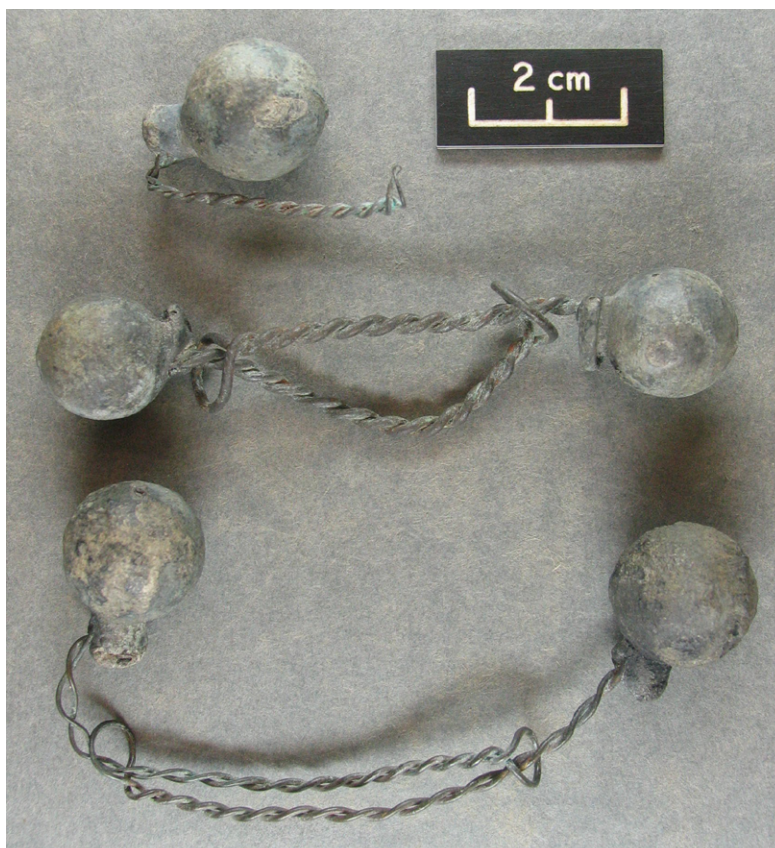
Figure 6.19. Sliding shot from SCW740

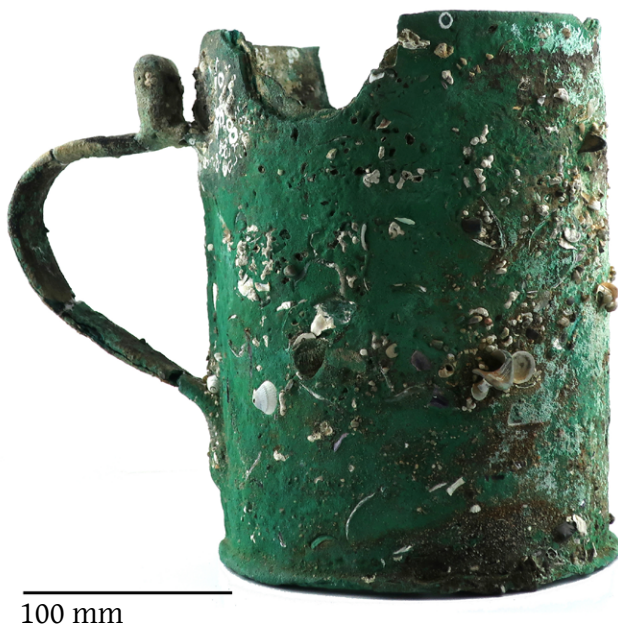
Figure 6.22. SCW16 Powder measure

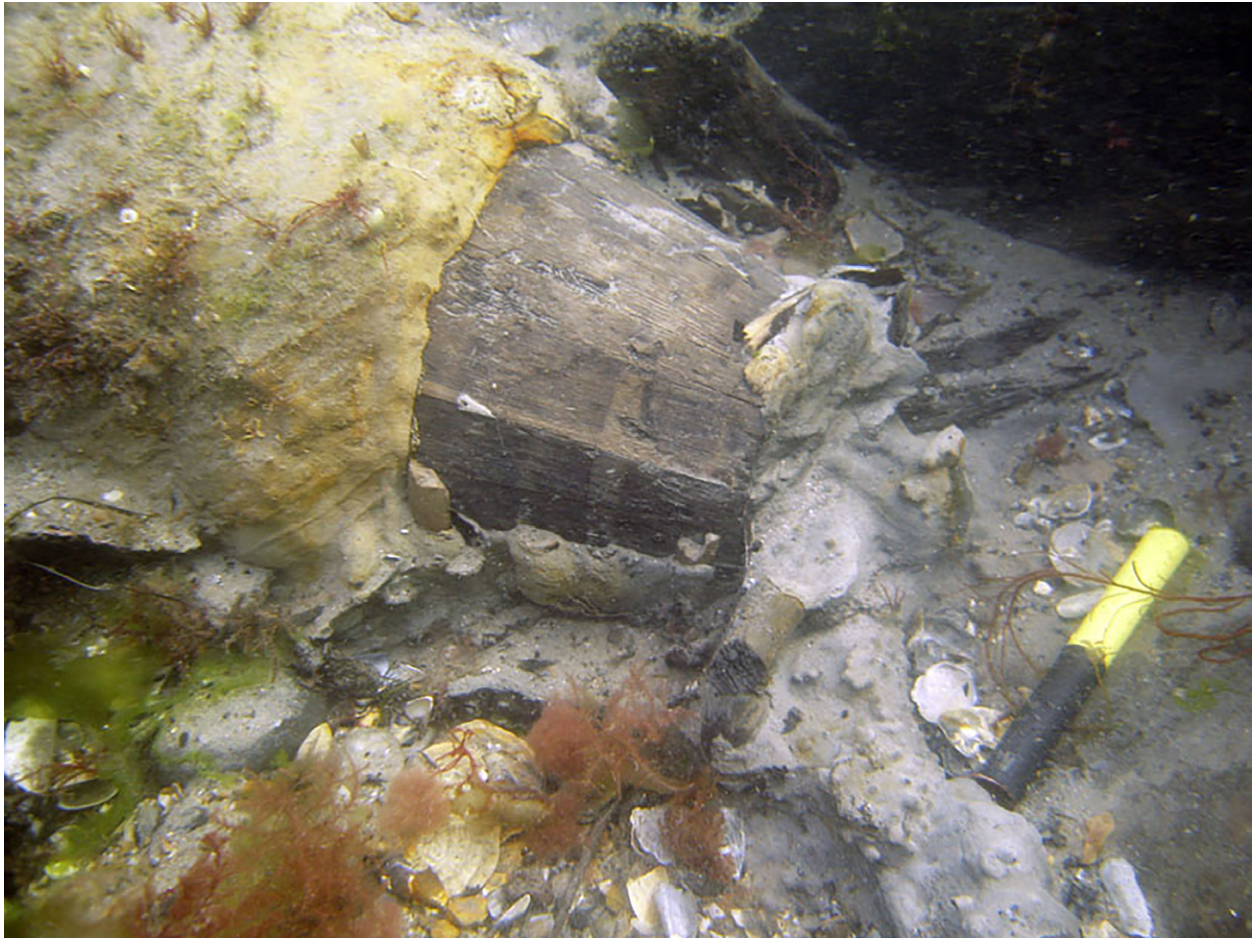
Figure 6.23. Conical container *in situ*

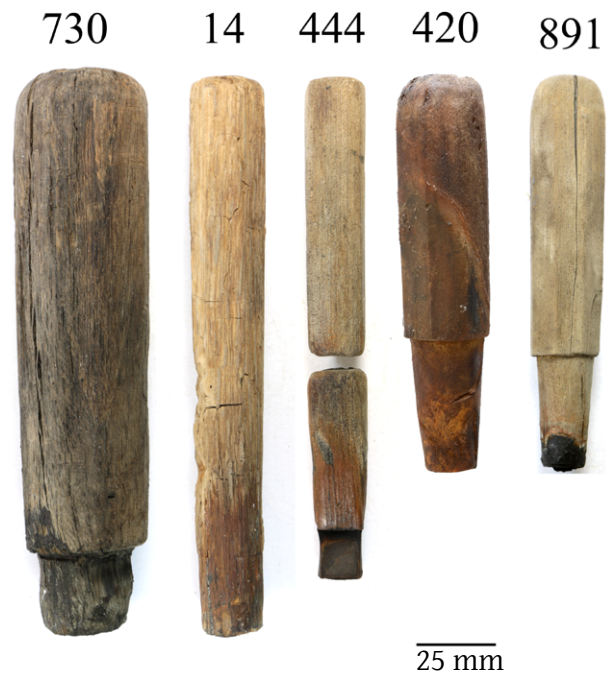
Figure 7.1. Tool handles recovered from the Swash Channel Wreck

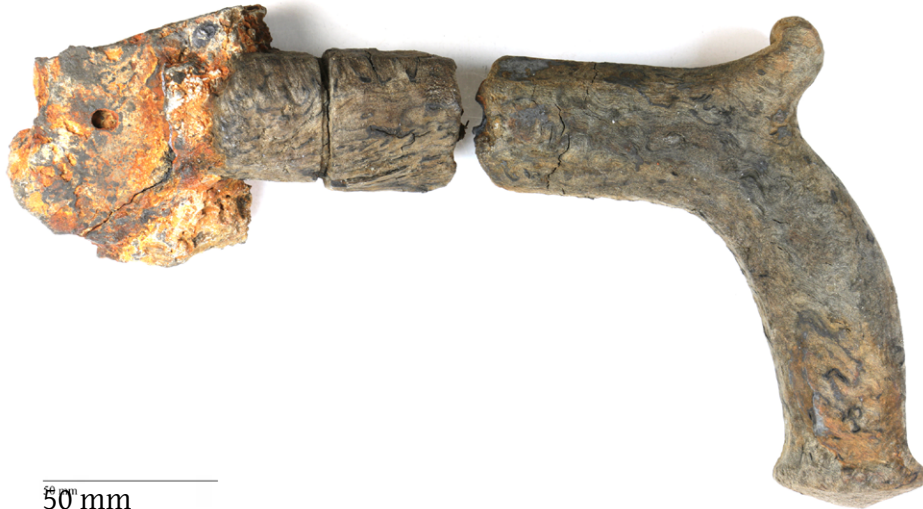
Figure 7.4. SCW789 handsaw handle

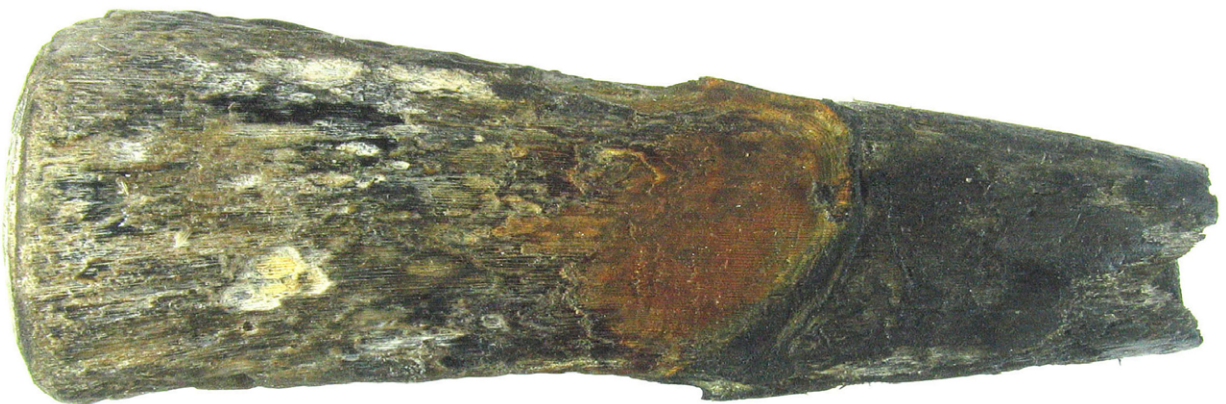
Figure 7.7. SCW890 horn tool handle

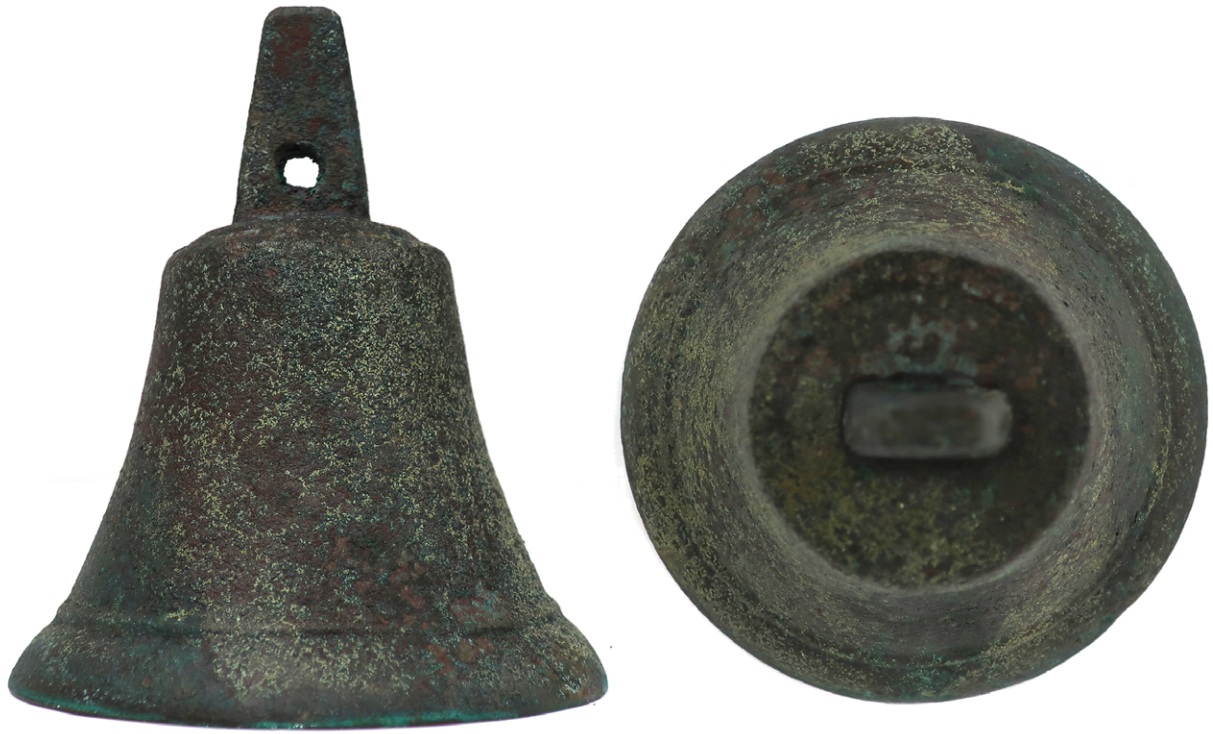
These items are likely to be horn 'lights' from wooden lanterns, although lanterns made principally of leather

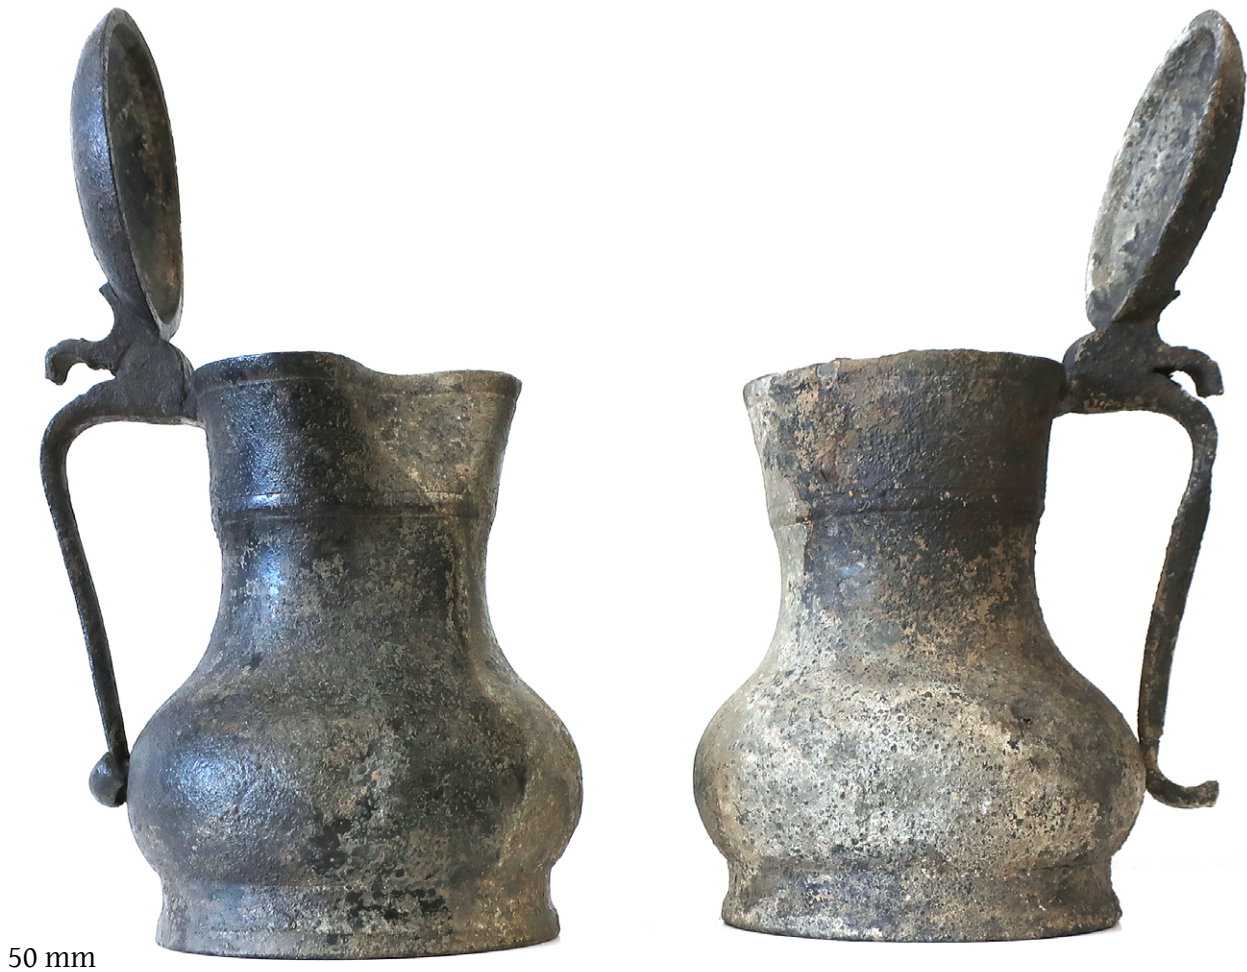
Figure 7.23. Pewter wine flagons SCW889 (left) and SCW897 (right)

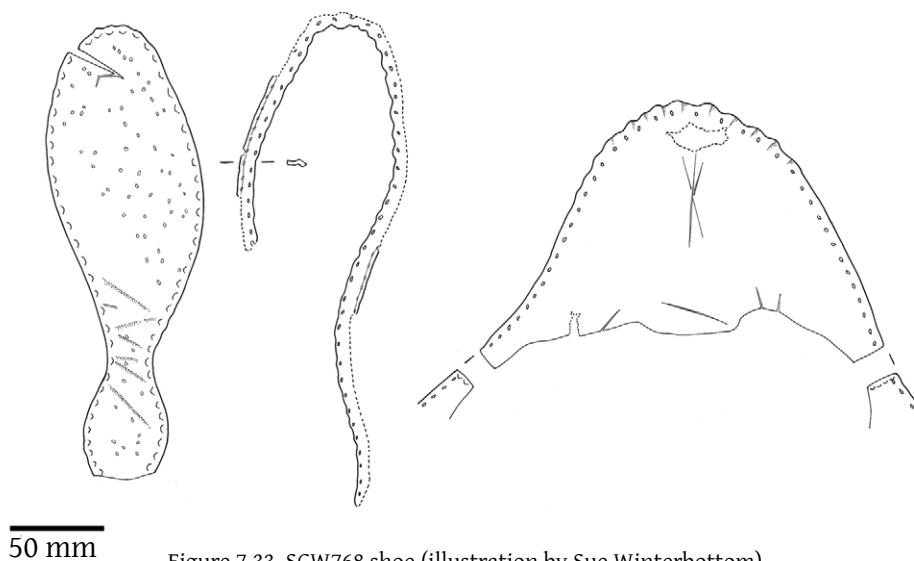
Figure 7.33. SCW768 shoe (illustration by Sue Winterbottom)

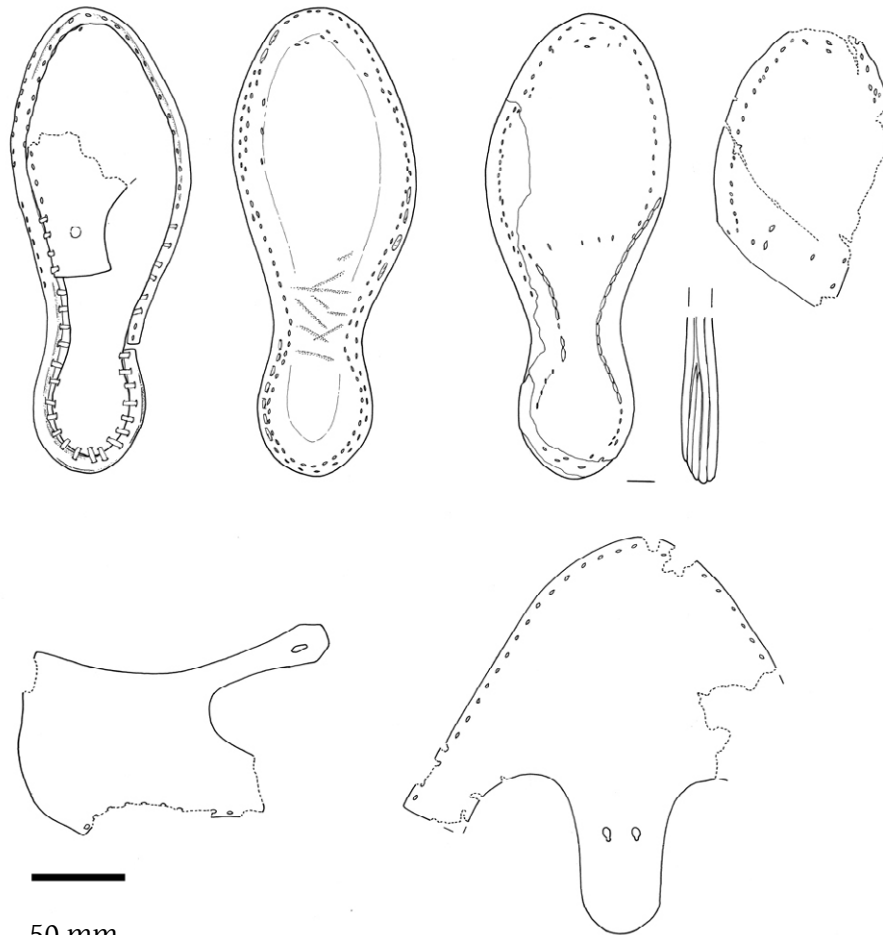
Figure 7.34. SCW46 shoe (illustration by Sue Winterbottom)

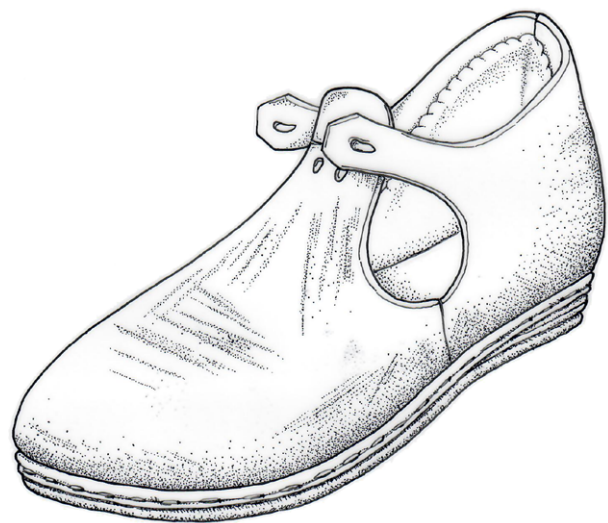
Figure 7.37. Shoe style represented by the Swash Channel Wreck finds (not to scale) (illustration by Sue Winterbottom)

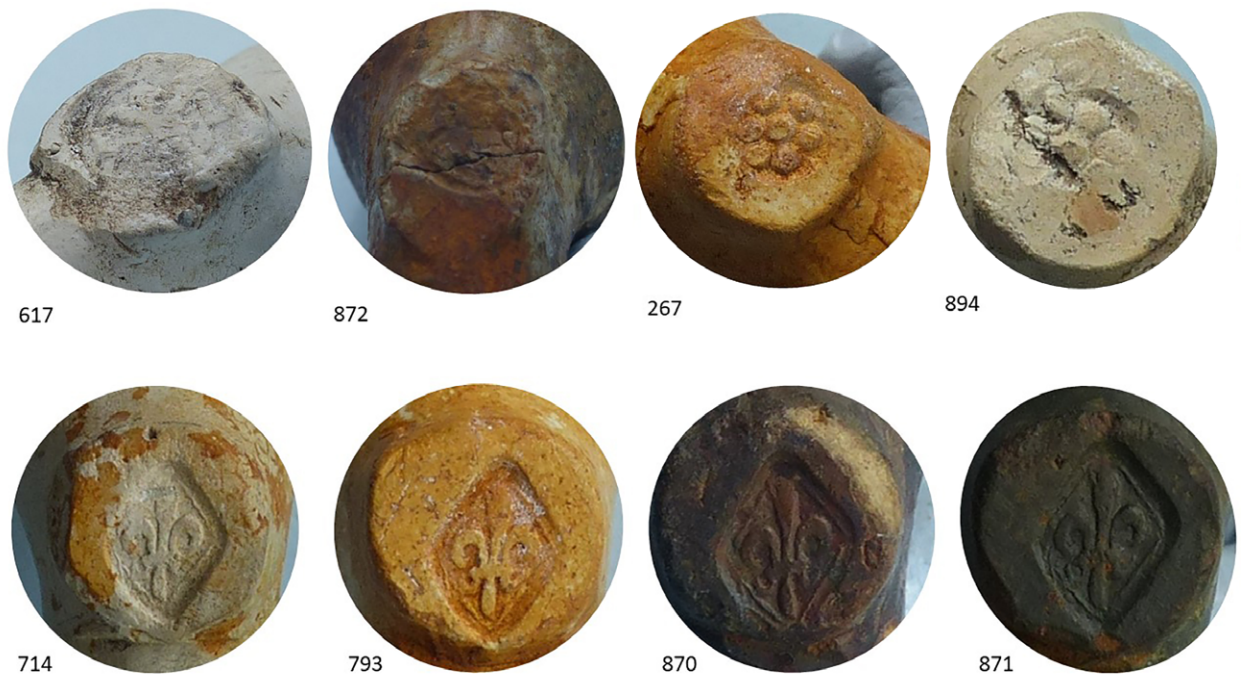
Figure 7.39. Stamps on the non-intrusive pipes
