# THE THEATER AT STOBI

RESULTS OF THE JOINT  
US-YUGOSLAV ARCHAEOLOGICAL  
INVESTIGATIONS, 1970-1981

ELIZABETH R. GEBHARD

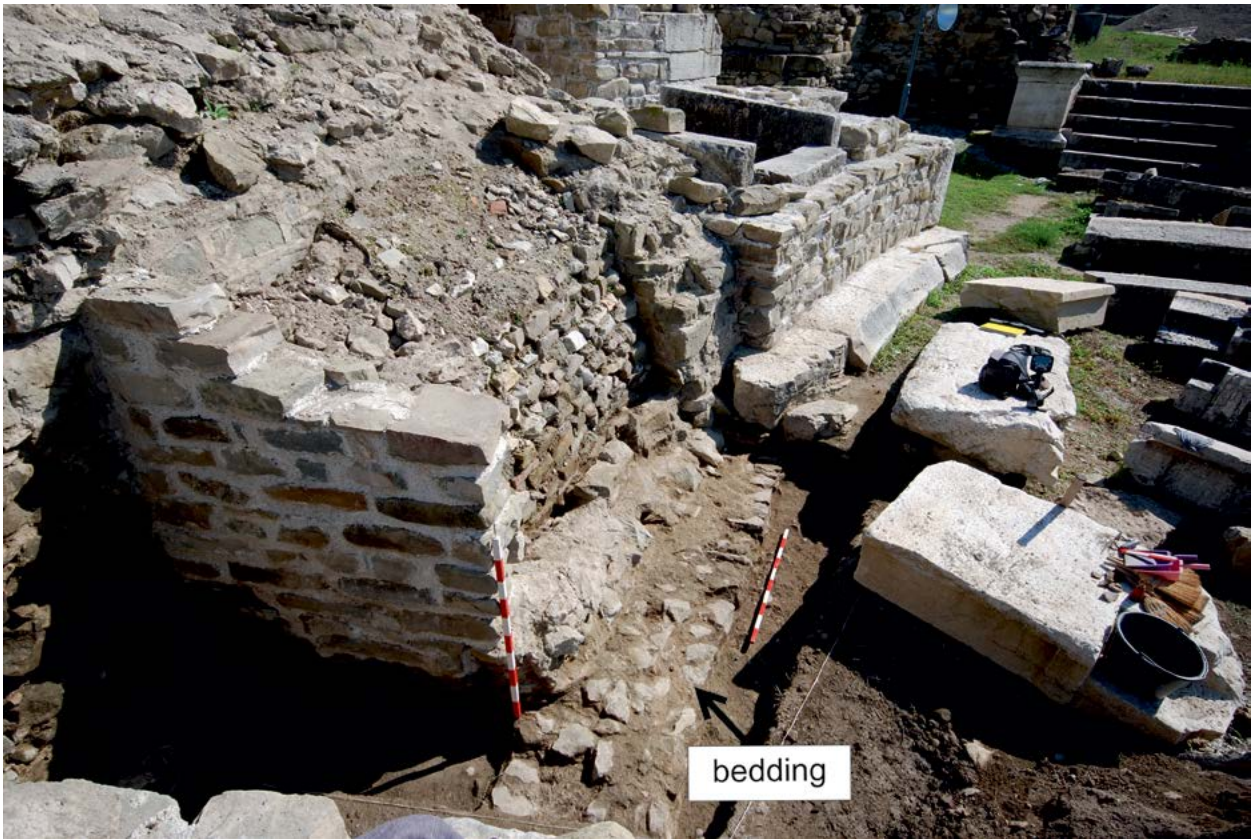
Figure 16. Foundation for podium in Phase I, east end.

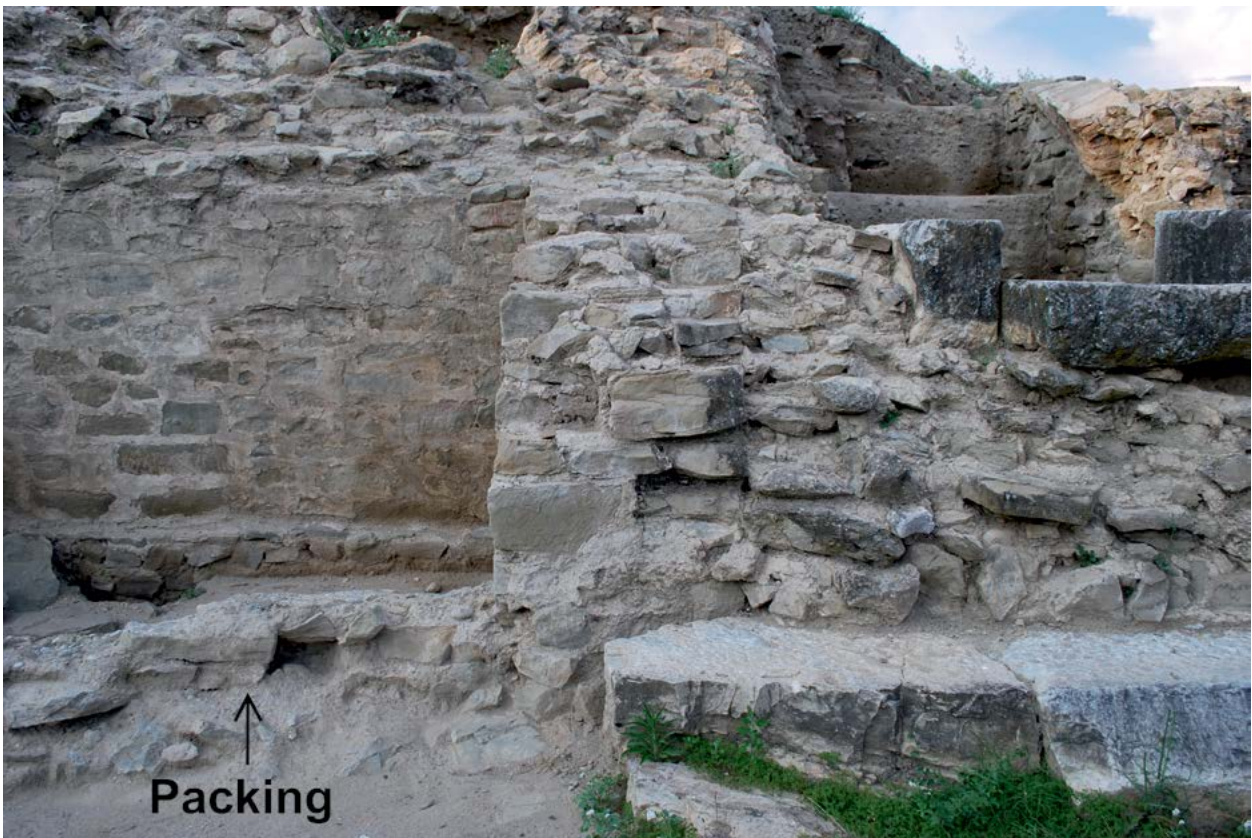
Figure 17. First phase wall 9 and east additus = East radial corridor, Phase I, first circular wall at left bonded to wall 9.

The orchestra and podium are contemporary, with the line of the podium's bedding roughly following the curve of the orchestra. The base course of the podium included a packing and bedding for a course of orthostates, evident at the east end (the orthostates and base course are missing) (Fig. 16). The first stretch consists of a band of mortared rubble encrusted with gray marble chips of the same stone as the seat blocks, which would have been packed behind the orthostates when they were in place. The packing is about 0.35m high, that is, the same height as the base course of the podium, and it is preserved for 2.24m (Fig. 16, Fig. 17). Excavation in 2013 revealed that the bedding runs south under the base course of the podium, continuing under the final block left in place.<sup>11</sup> The bedding, composed of small stones set in mortar, is exposed for 2.86m with a total width of 0.80m, of which 0.50m lies beyond the band of mortared rubble. The association of the packing with Phase I is shown by the fact that it is bonded to the analemma of the east aditus maximus, wall 9 (Fig. 17).<sup>12</sup> The following sequence is evident:

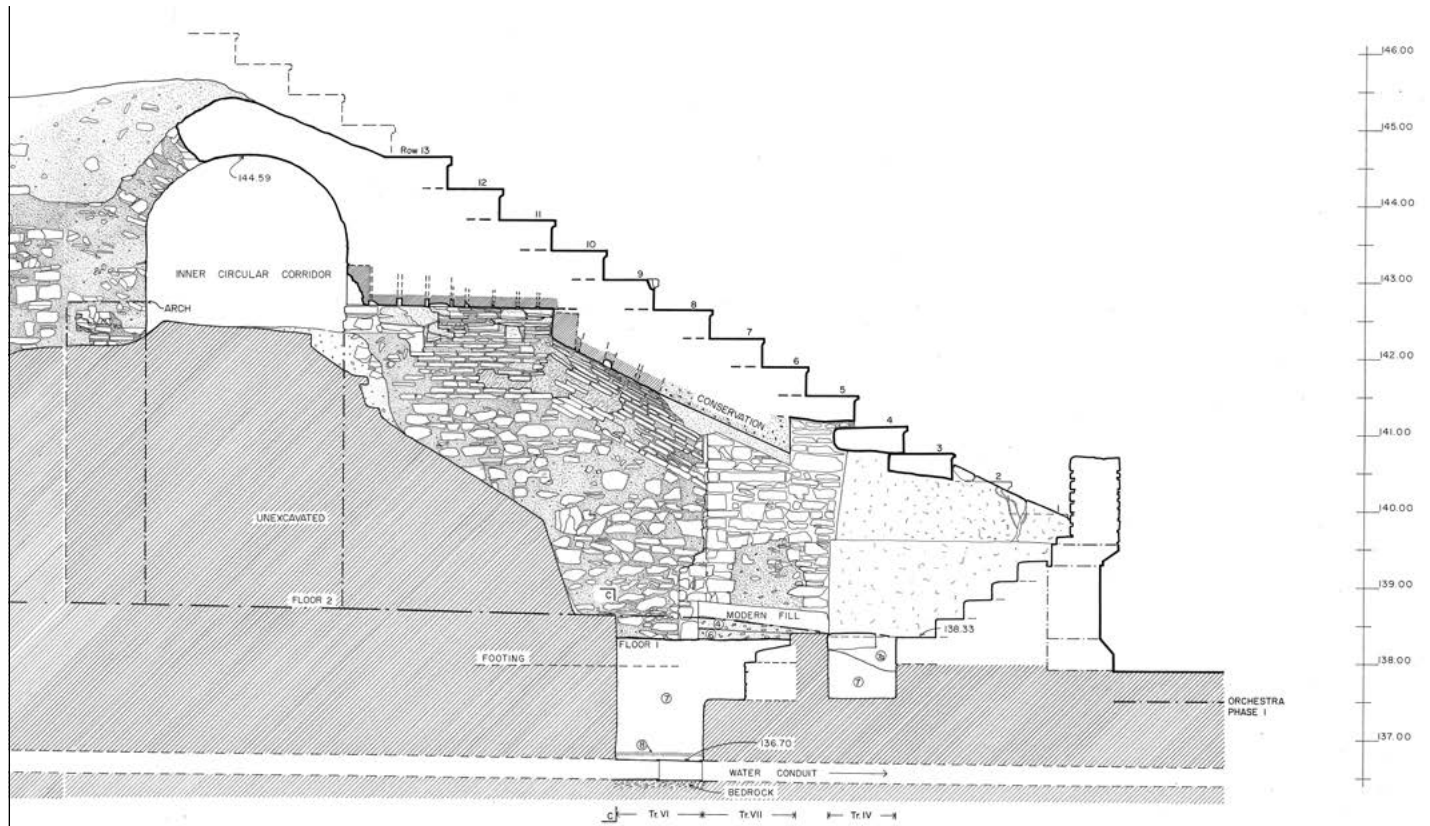
Figure 25. Section P-P, West Radial Corridor, west end (R.P., Caroline J. Hemans 1974,1988).

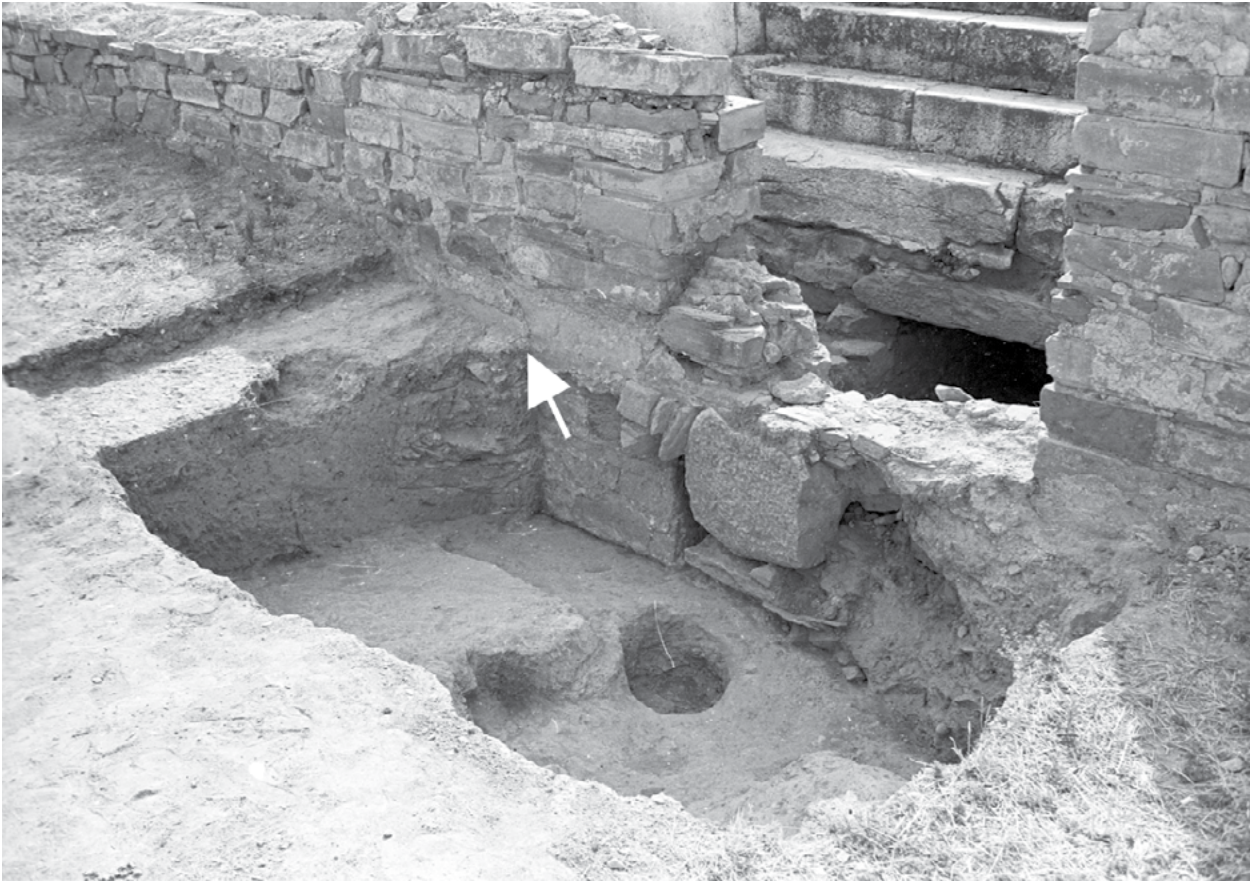
Figure 31. Orchestra center door of arena wall, Trench XII, looking southeast. Deposits in section I-I at left.

Small sections of the foundation below orchestra level were uncovered in Trenches V (Fig. 30), XVI (Fig. 29), XII (Figs. 20, 31), XX (Fig. 32), and XXV (Figs. 14, 33). Trench XXXII (Fig. 34) exposed a footing trench 0.60 to 0.70m wide along the face of the foundation, ensuring that the masons had room to work. Trench XXV uncovered a well-defined construction sequence that shows bonding of the east end of the foundation with wall 4 (Figs. 35, 36): six courses for the platform were laid to a height of c. 0.80-0.85m above sterile soil, then the concrete core was poured, exterior joints troweled, and the footing trench filled with soil (Deposit 1.7 = Fig. 29, no. 5).<sup>31</sup> Next, the trench for wall 4, abutting the face of the foundation, was opened and concrete poured directly into the trench (Fig. 36). A thin ridge of mortar spilled onto the floor at the side of the wall (at left in Fig. 36).<sup>32</sup> Above the floor, wall 4 was bonded to the scaena foundation and above that to the core of the east porch. Recent excavations have exposed the foundation and remains of wall 4 where it met the analemma of the first theater (wall 6).<sup>33</sup> In Phase II removal of wall 4 left a jagged surface on the face of the foundation and on the core of the porch in the area of the bond (Figs. 37, 38). The same type of rough surface appears at the west end of the west porch where wall 2 had been bonded to the porch and then removed (Figs. 39, 40). The jagged surface left from the removal of wall 2 continues above

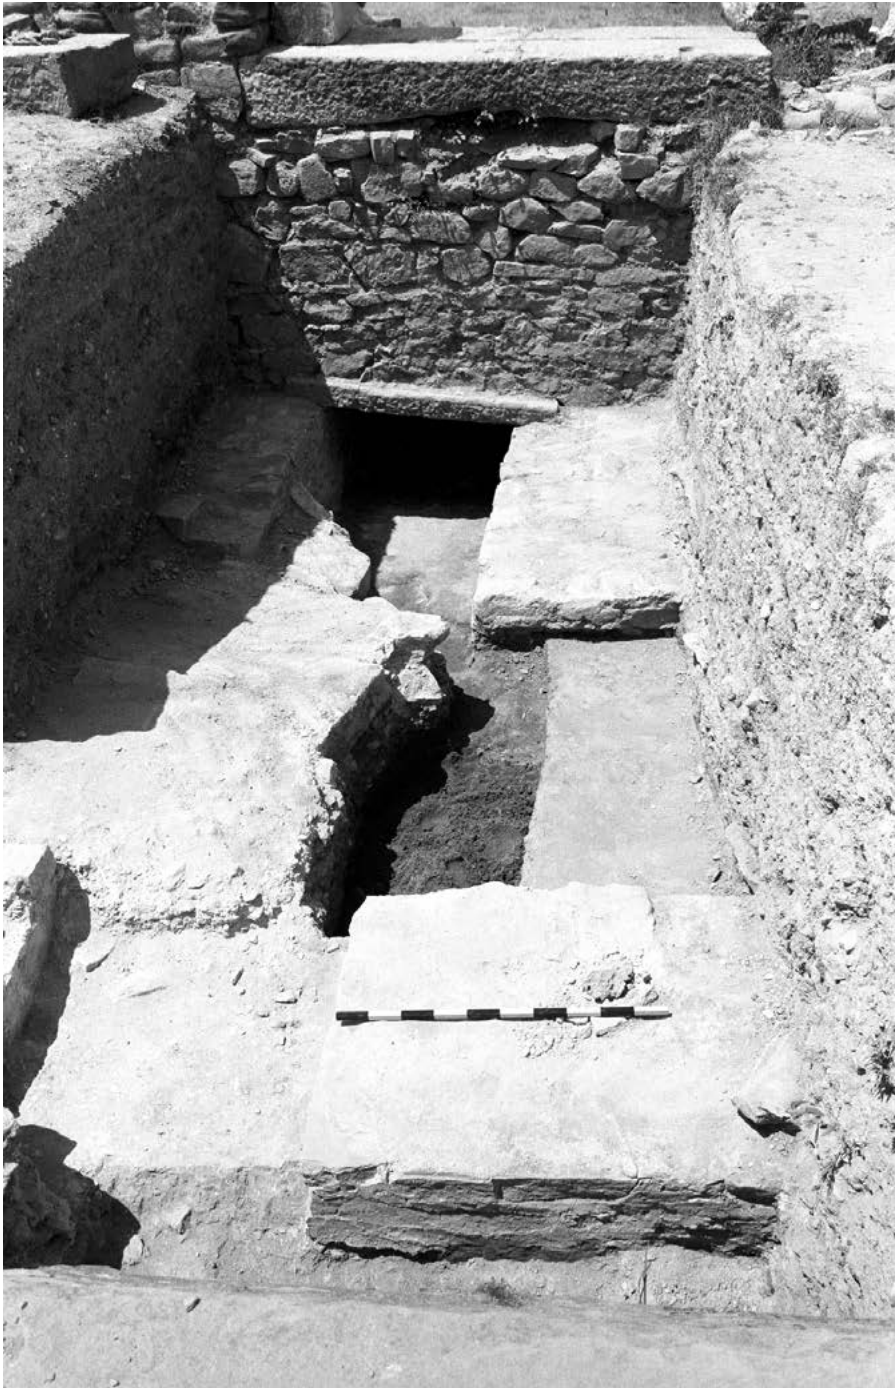
Figure 33. Center Room, Trench III, looking north, wall 1 in foreground, wall 3 with doorway at rear.

the core of the west porch to the point where it met the front wall (wall 3, Fig. 39).<sup>34</sup> Trench III uncovered the center and south side of the scaena foundation (Figs. 13, 14, 33). A passage 1.10m wide was reserved through the foundation, placed slightly west of the north-south axis of the cavea (Figs. 5, 14, 33). It connected the interior of the scene-building with the area under the stage (hyposcaenum) and probably with the orchestra. A ramp led down to it from a rear door in wall 1, its surface embedded with small river pebbles.<sup>35</sup> The hard, compact floor bears witness to a considerable period of use (floor 1, Fig. 13; views in Figs. 14, 33). Since the foundation was originally much higher, what remains is the lower portion of the corridor. In Phase I when the foundation for the façade was complete, the passage would have had an interior height of perhaps 2.74m.<sup>36</sup>

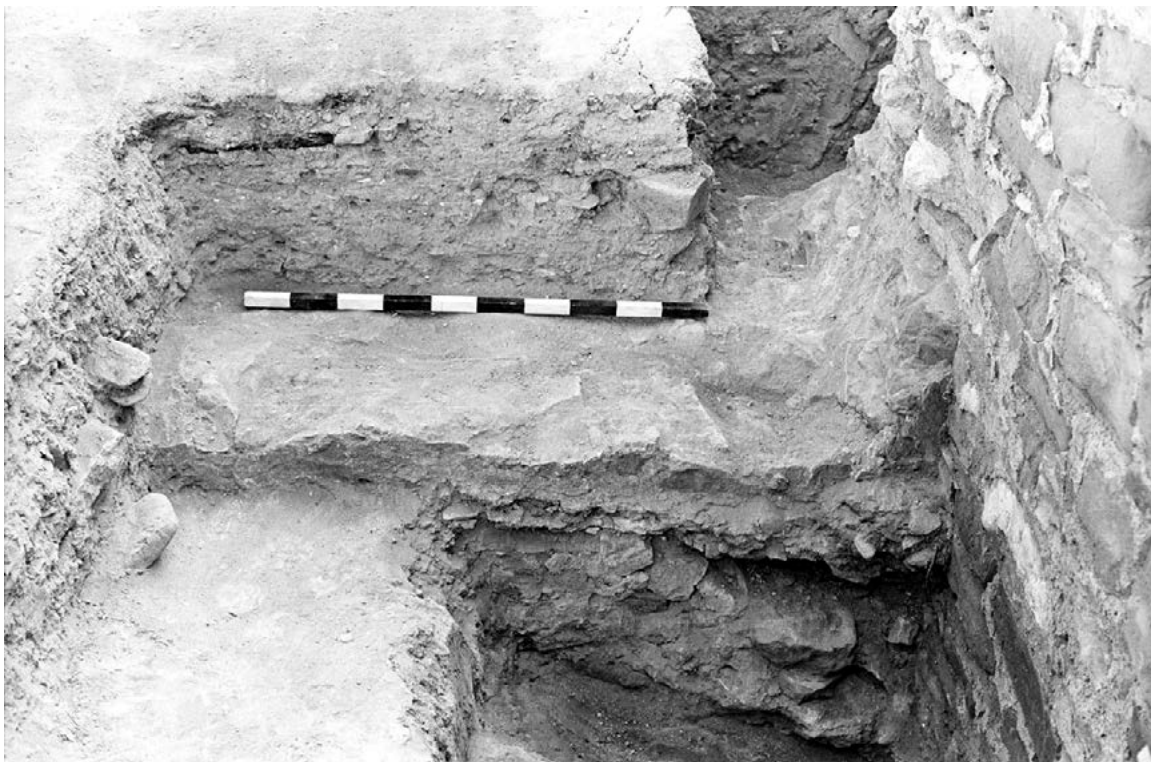
Figure 36. Wall 4 bonded to east porch foundation Phase I, looking east.

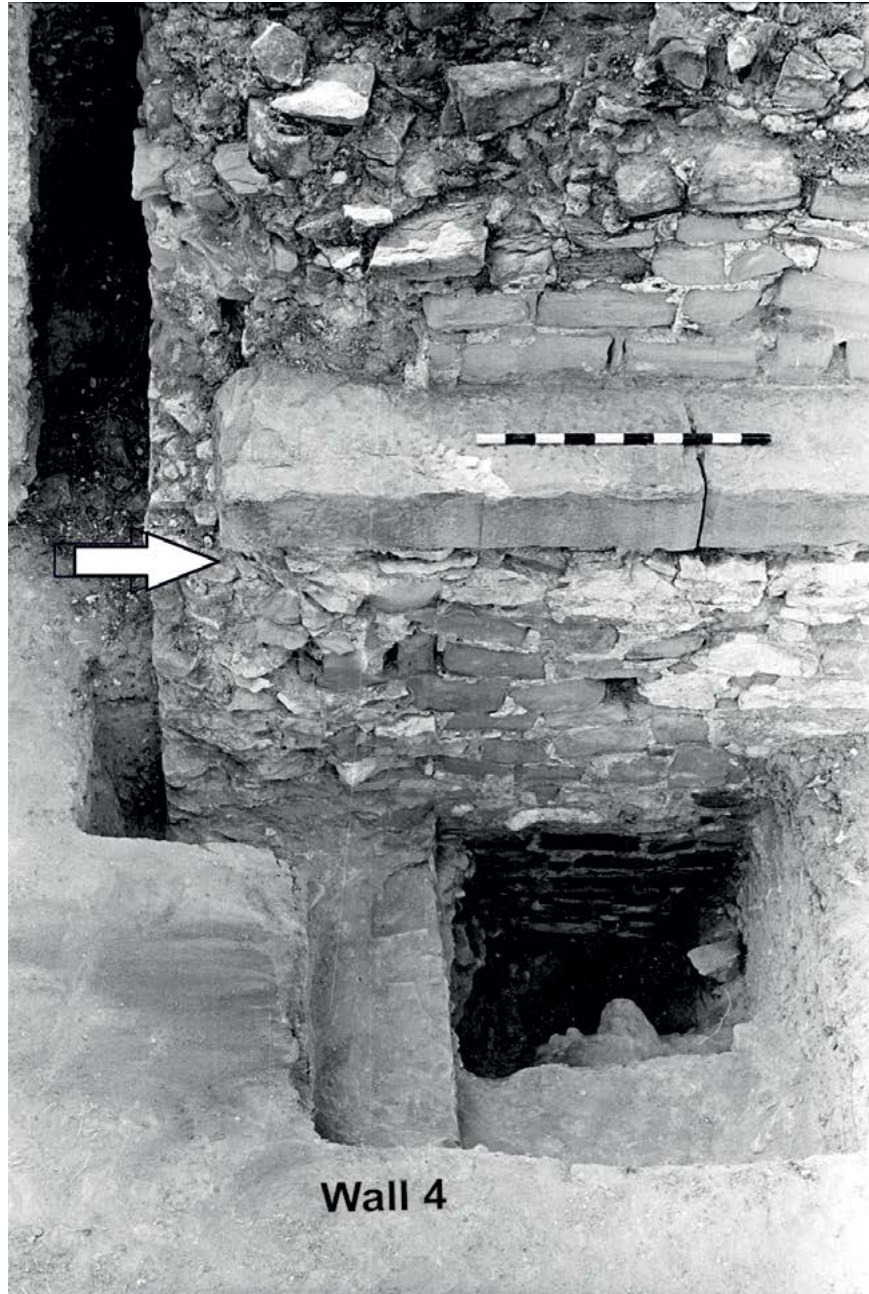
Figure 38. East end of East Porch showing rough surface on north face after wall 4 was dismantled. Remains of wall 4 below. Note: scaffolding hole. Trench XXV in foreground.

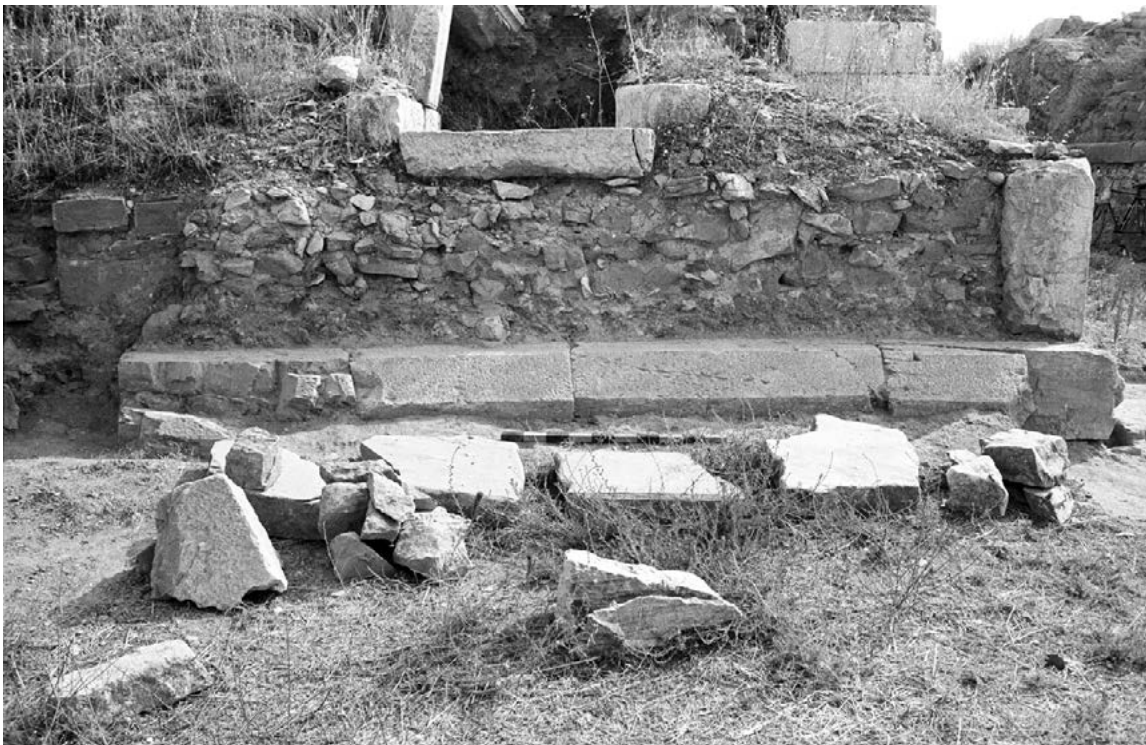
Figure 165. Packing behind podium at east end where orthostates are missing (1974).

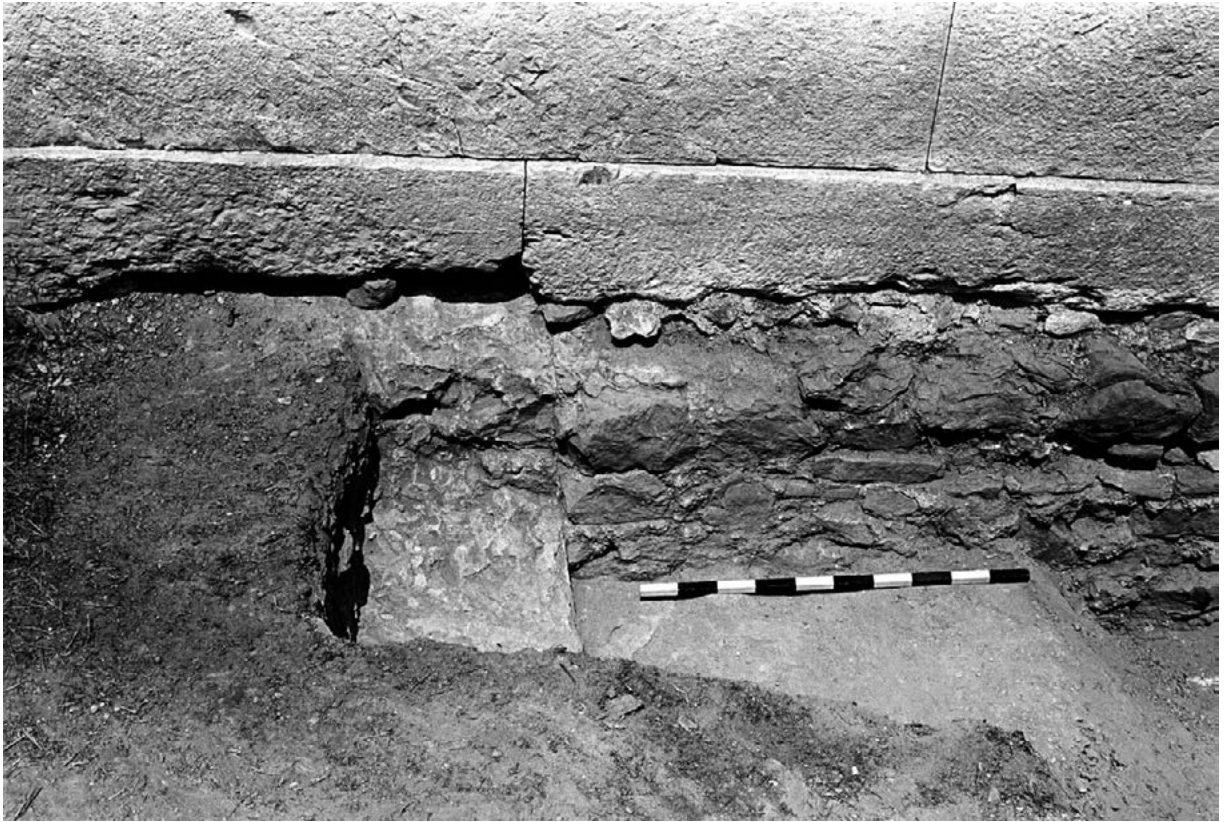
Figure 205. Foundation and base course of east analemma built over north end of Phase I wall 4. Trench XXV in foreground.
