Archaeoseismology in a Mediterranean City

Siena and the PROTECT Project

Andrea Arrighetti

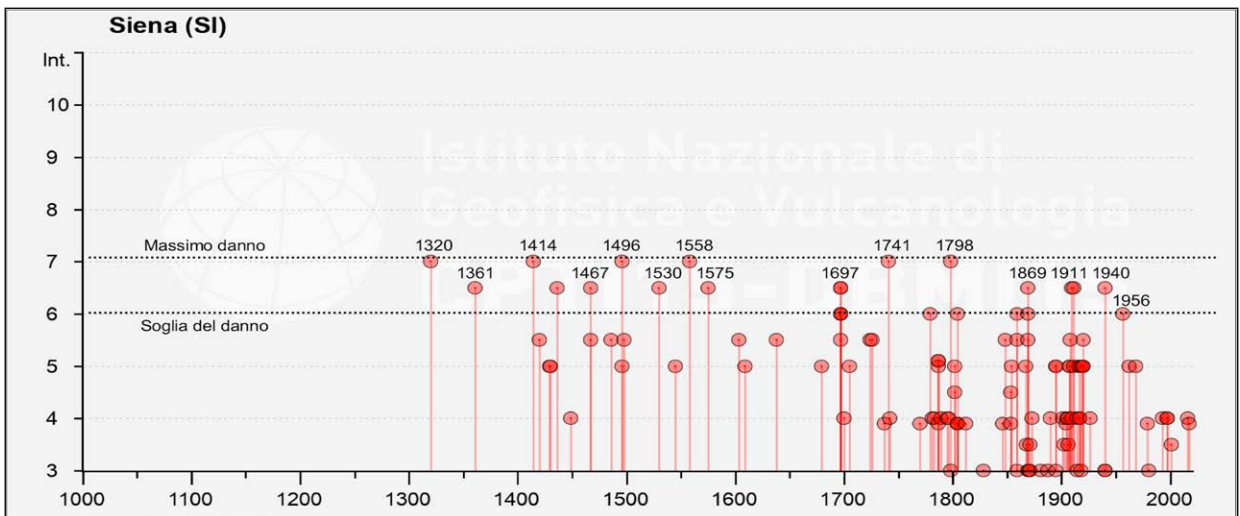
Figure 2.6 - Seismic history of Siena with major intensity earthquakes highlighted (Locati et al., 2022). Image taken from: Castelli 2023.

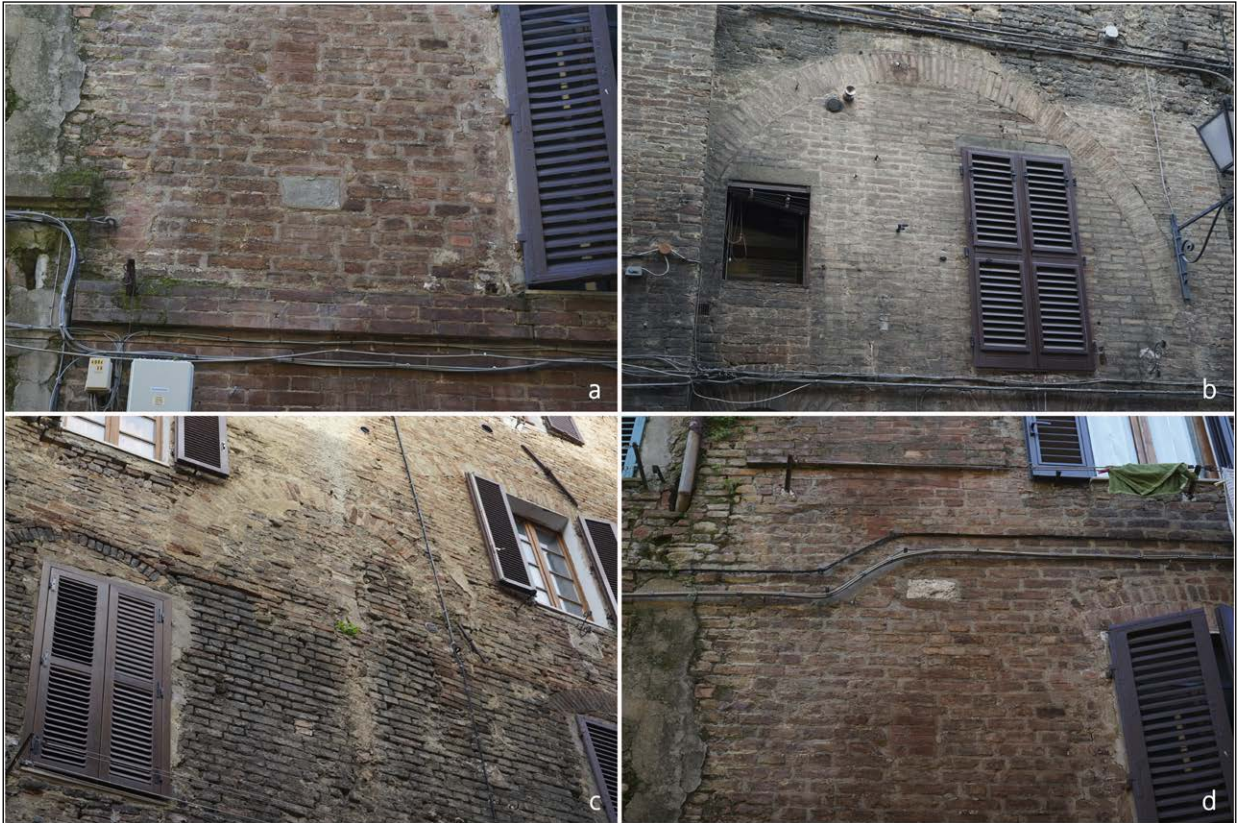
Figure 3.1 - Some examples of post-seismic techniques documented during the archaeoseismological fieldwork survey: bond stones (a and d) and relieving arch (b and c).

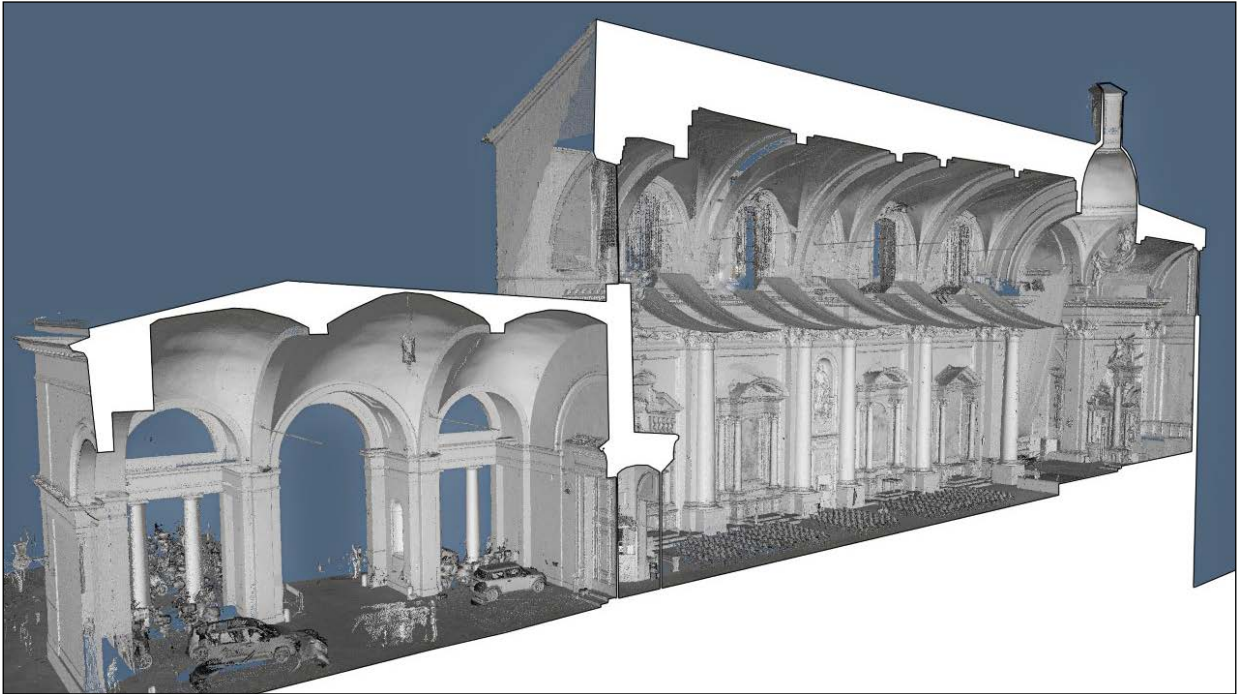
Figure 3.2 - Longitudinal section of the three-dimensional model of the Church of St. Augustine obtained by laser scanner and photogrammetric survey (elaboration: Marco Repole).

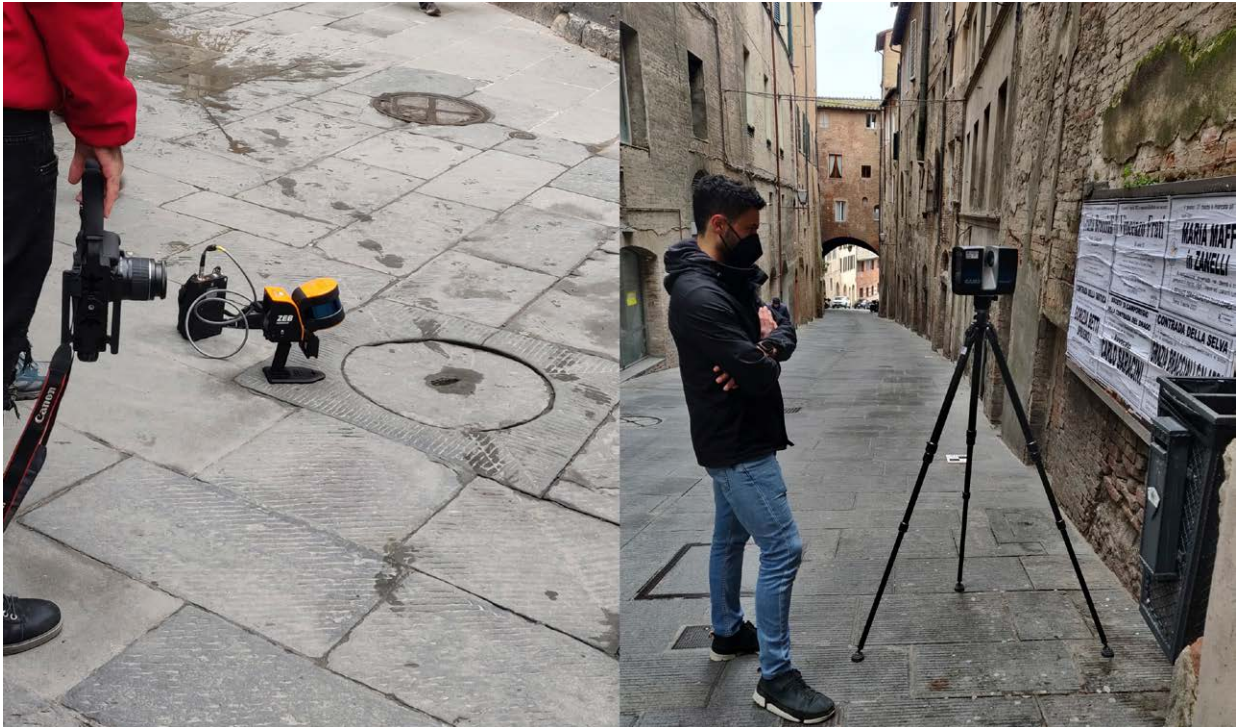
Figure 3.4 - Images of the survey fieldwork carried out using mobile and terrestrial laser scanners.

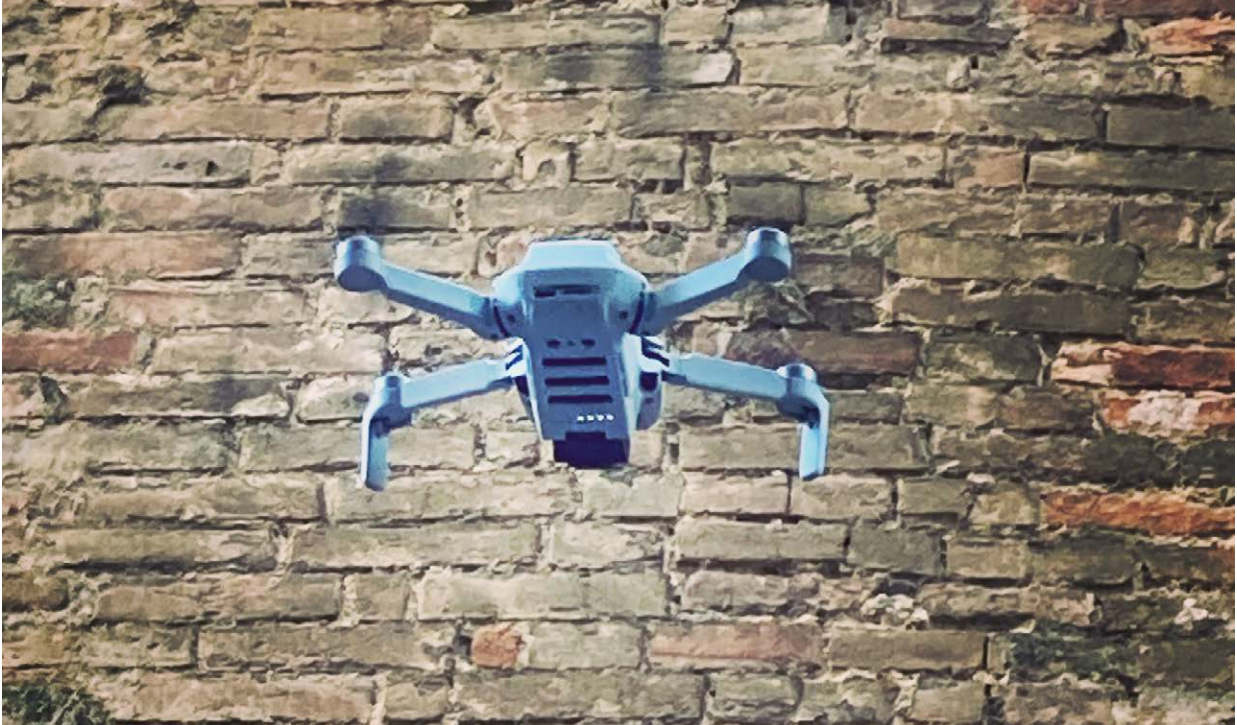
Figure 3.5 - Detail of a moment of photographic data acquisition with a drone.

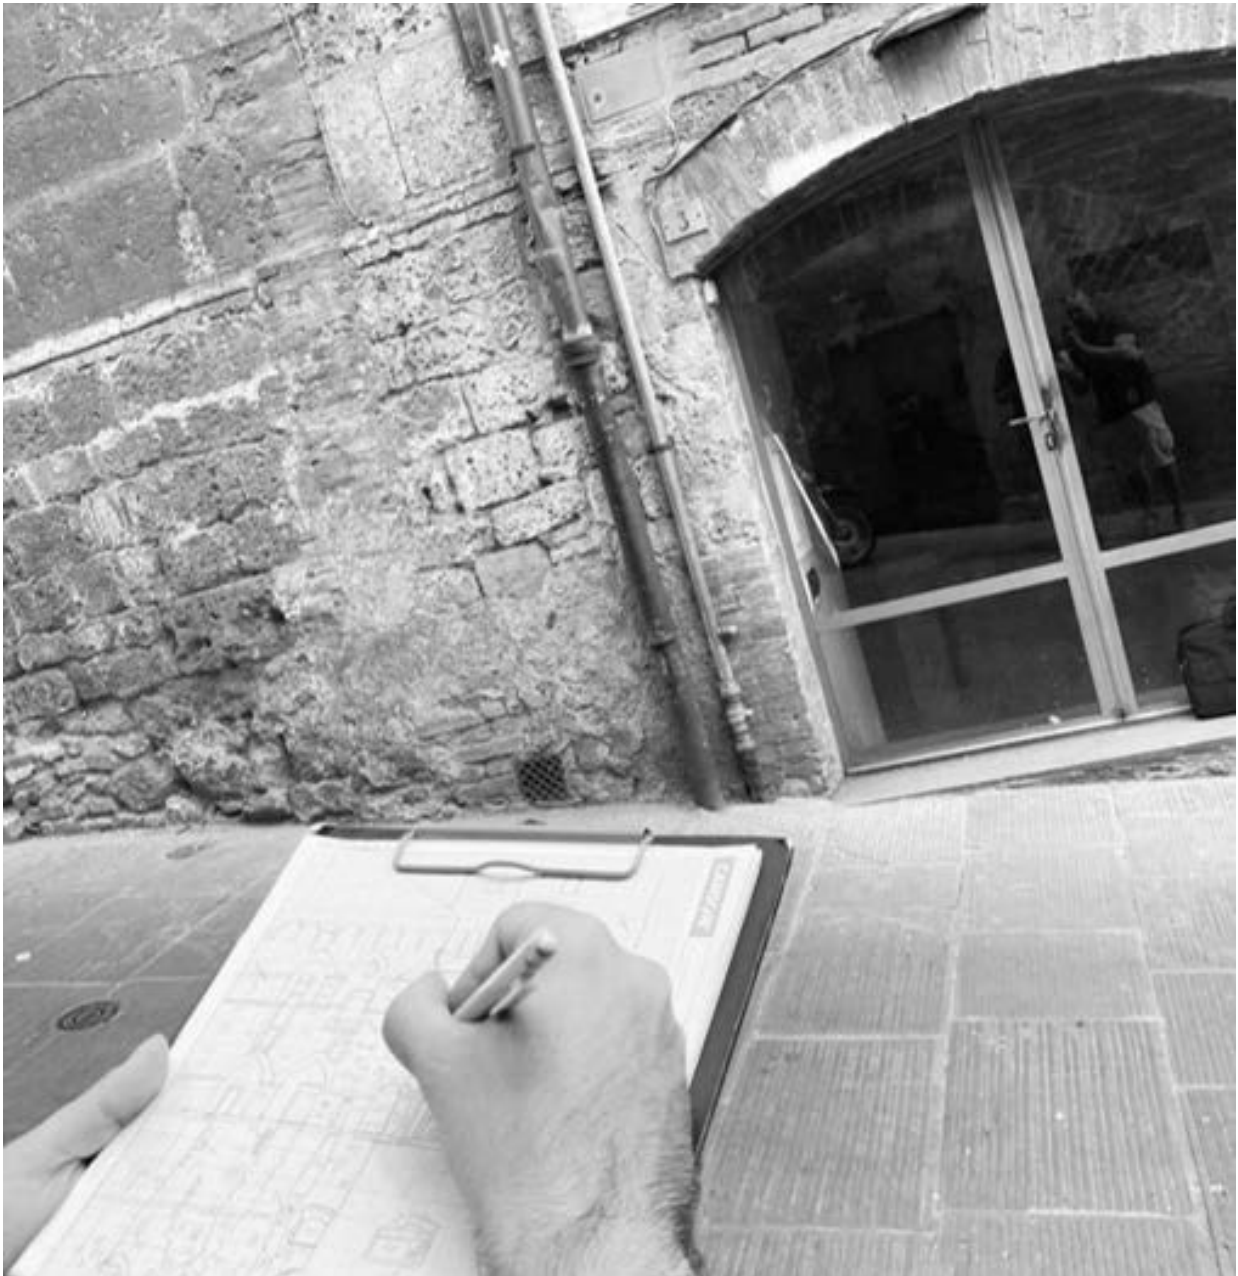
Figure 3.6 - Detail of the archaeological analysis of the architecture carried out in the field.

For the PROTECT project, the phase of archaeoseismological interpretation of standing remains was conducted by means of a first-hand observation and examination of study contexts. For every masonry part of interest, on-site sketches were made of the elevations, showing the respective Stratigraphic Units (Unità Stratigrafiche) identified in the course of the archaeological analysis (fig.3.6). In addition, site record sheets, specially designed for the various situations encountered in the course of investigations, were filled out. These adopt differing criteria of analysis depending on the various different objectives set for each study context (fig.3.7). These data were later transferred to renderings produced by digital survey, where all the features of interest found by fieldwork were documented and recorded (fig.3.8).

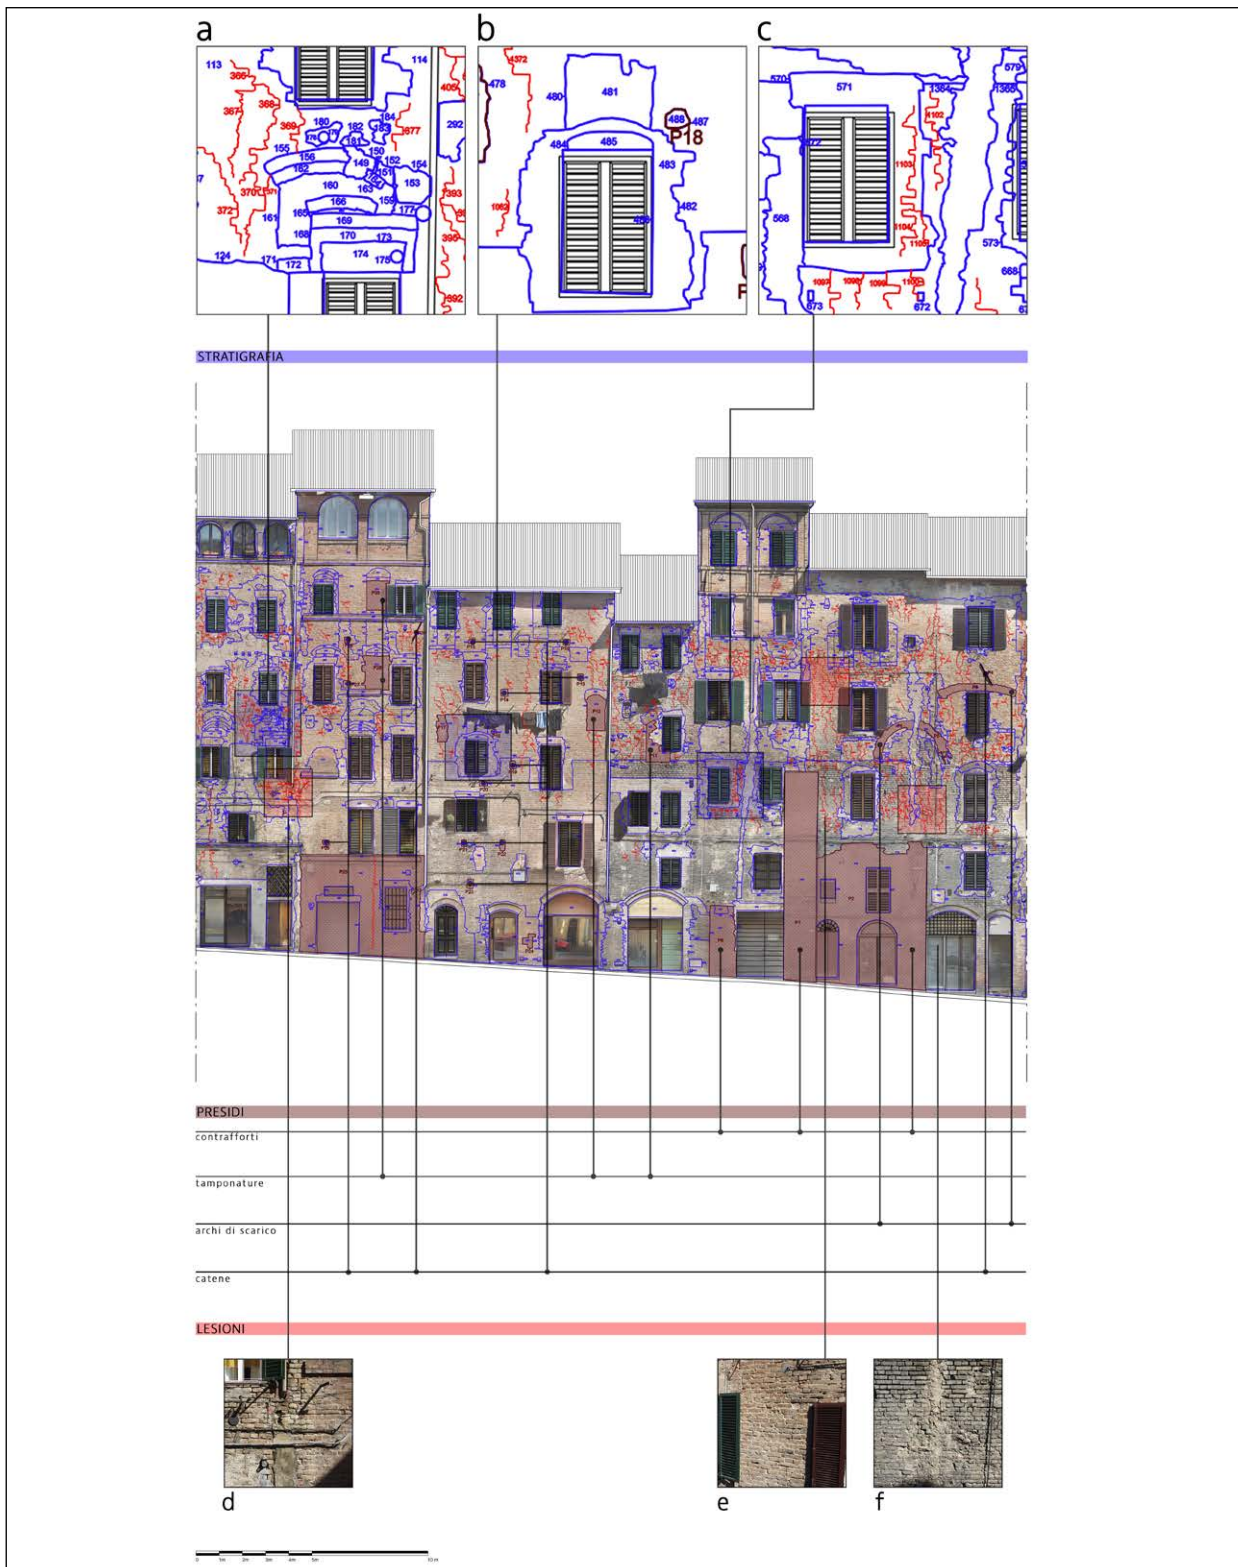
Figure 3.8 - Methodological table illustrating the digitization of the archaeological analyses carried out on the street front of Via Pendola. In the centre of the image is shown a photo-plan of a portion of the street front where the stratigraphic analysis, the characterization of the cracking framework and the documentation of the post-seismic techniques were carried out. Above are shown portions of the elevation (a, b, c) with enlargements of the stratigraphic analysis (in blue) and of the cracks pattern (in red). At the bottom, the post-seismic techniques and cracks are shown (d, e, f) (Elaboration: Marco Repole).

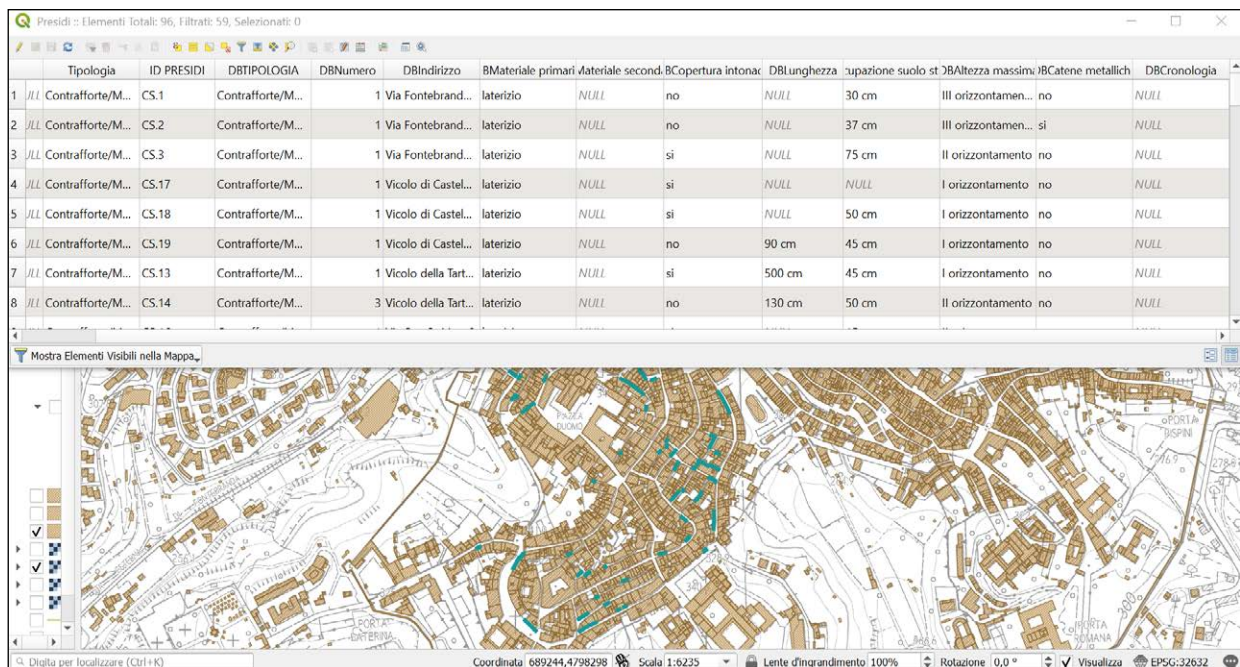
Figure 4.6 - The GIS platform created to record the construction techniques identified in the Terzo di Città with the table with elements characterizing buttresses and scarped walls (Elaboration: Valeria Razzante)

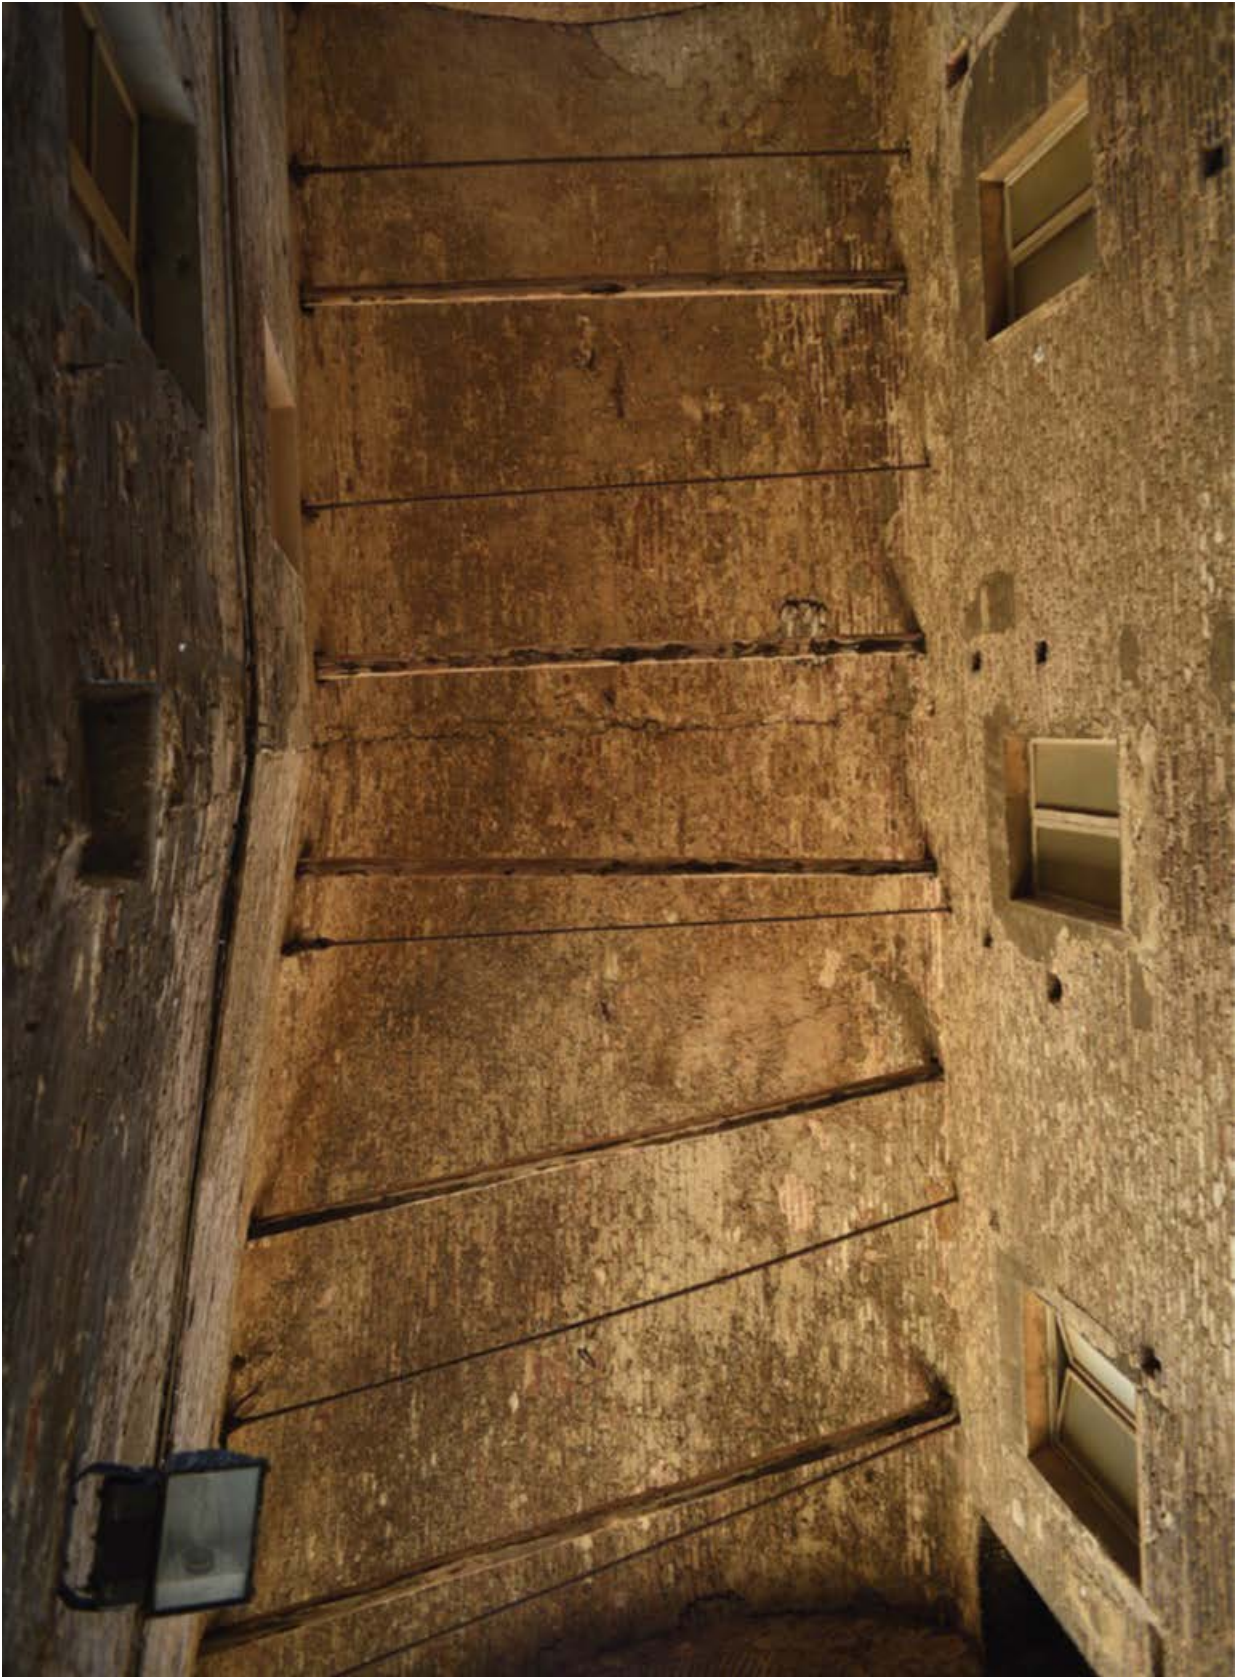
Figure 4.7 - Example of a wooden beam set inside wall masonry (Photo: Andrea Arrighetti)

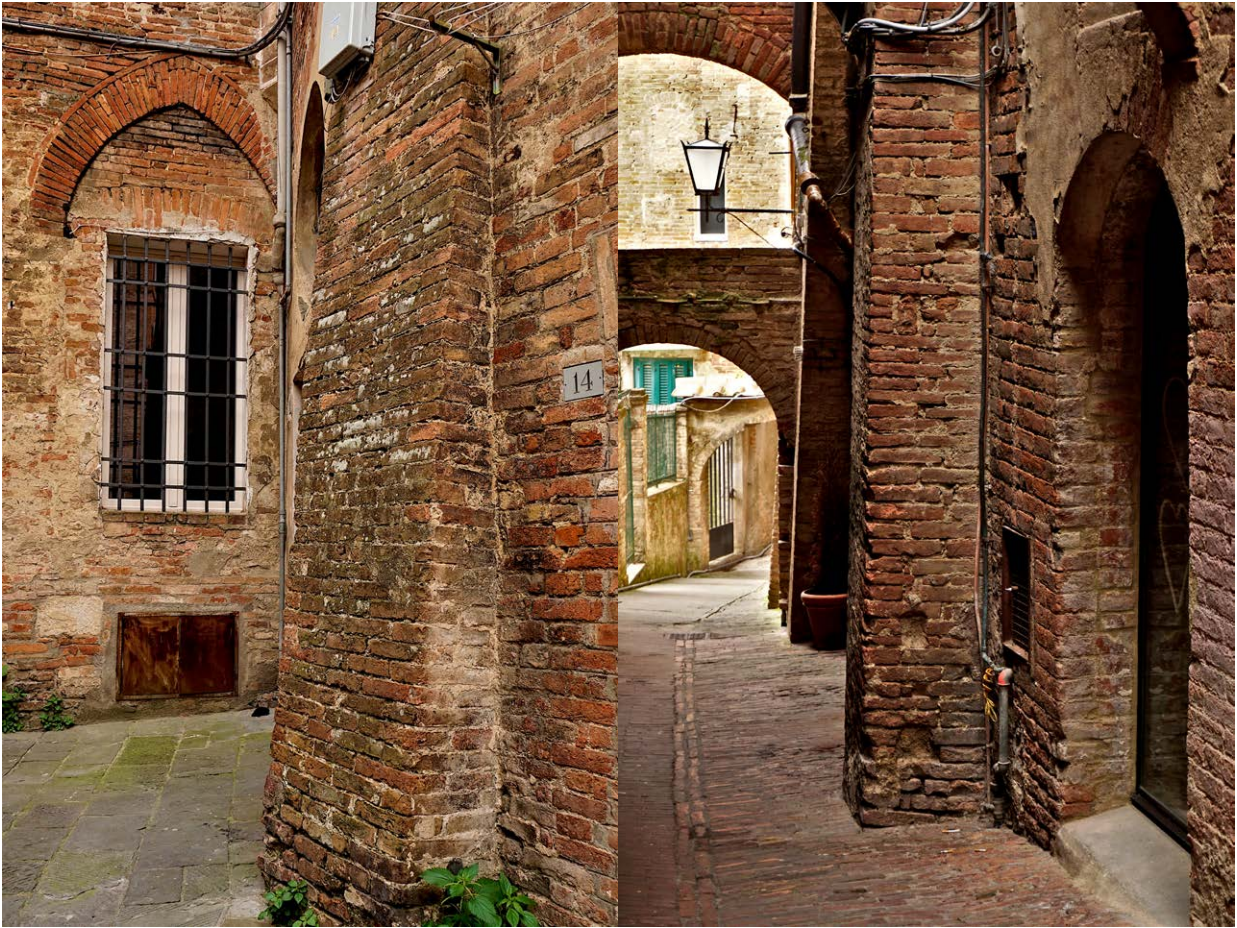
Figure 4.8 - Example of buttresses inserted above wall (Photo: Valeria Razzante)

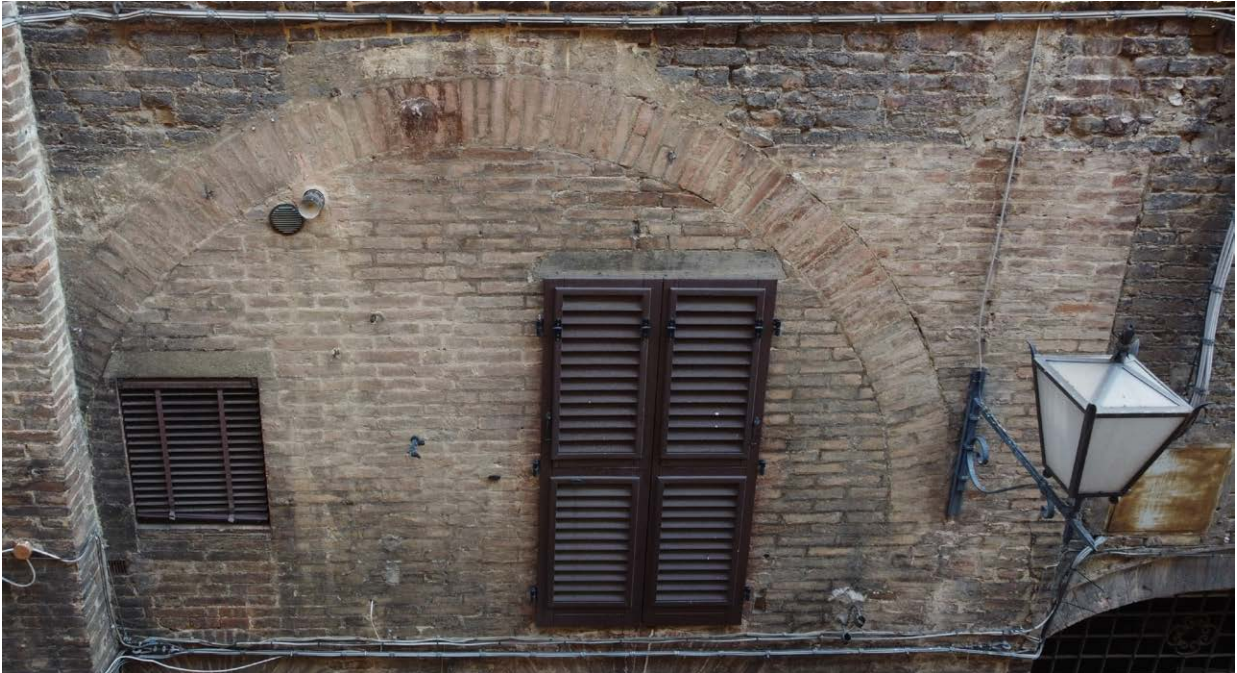
Figure 4.9 - Relieving arch inserted into the façade of a building in Via Pendola (Photo: Gianluca Fenili).

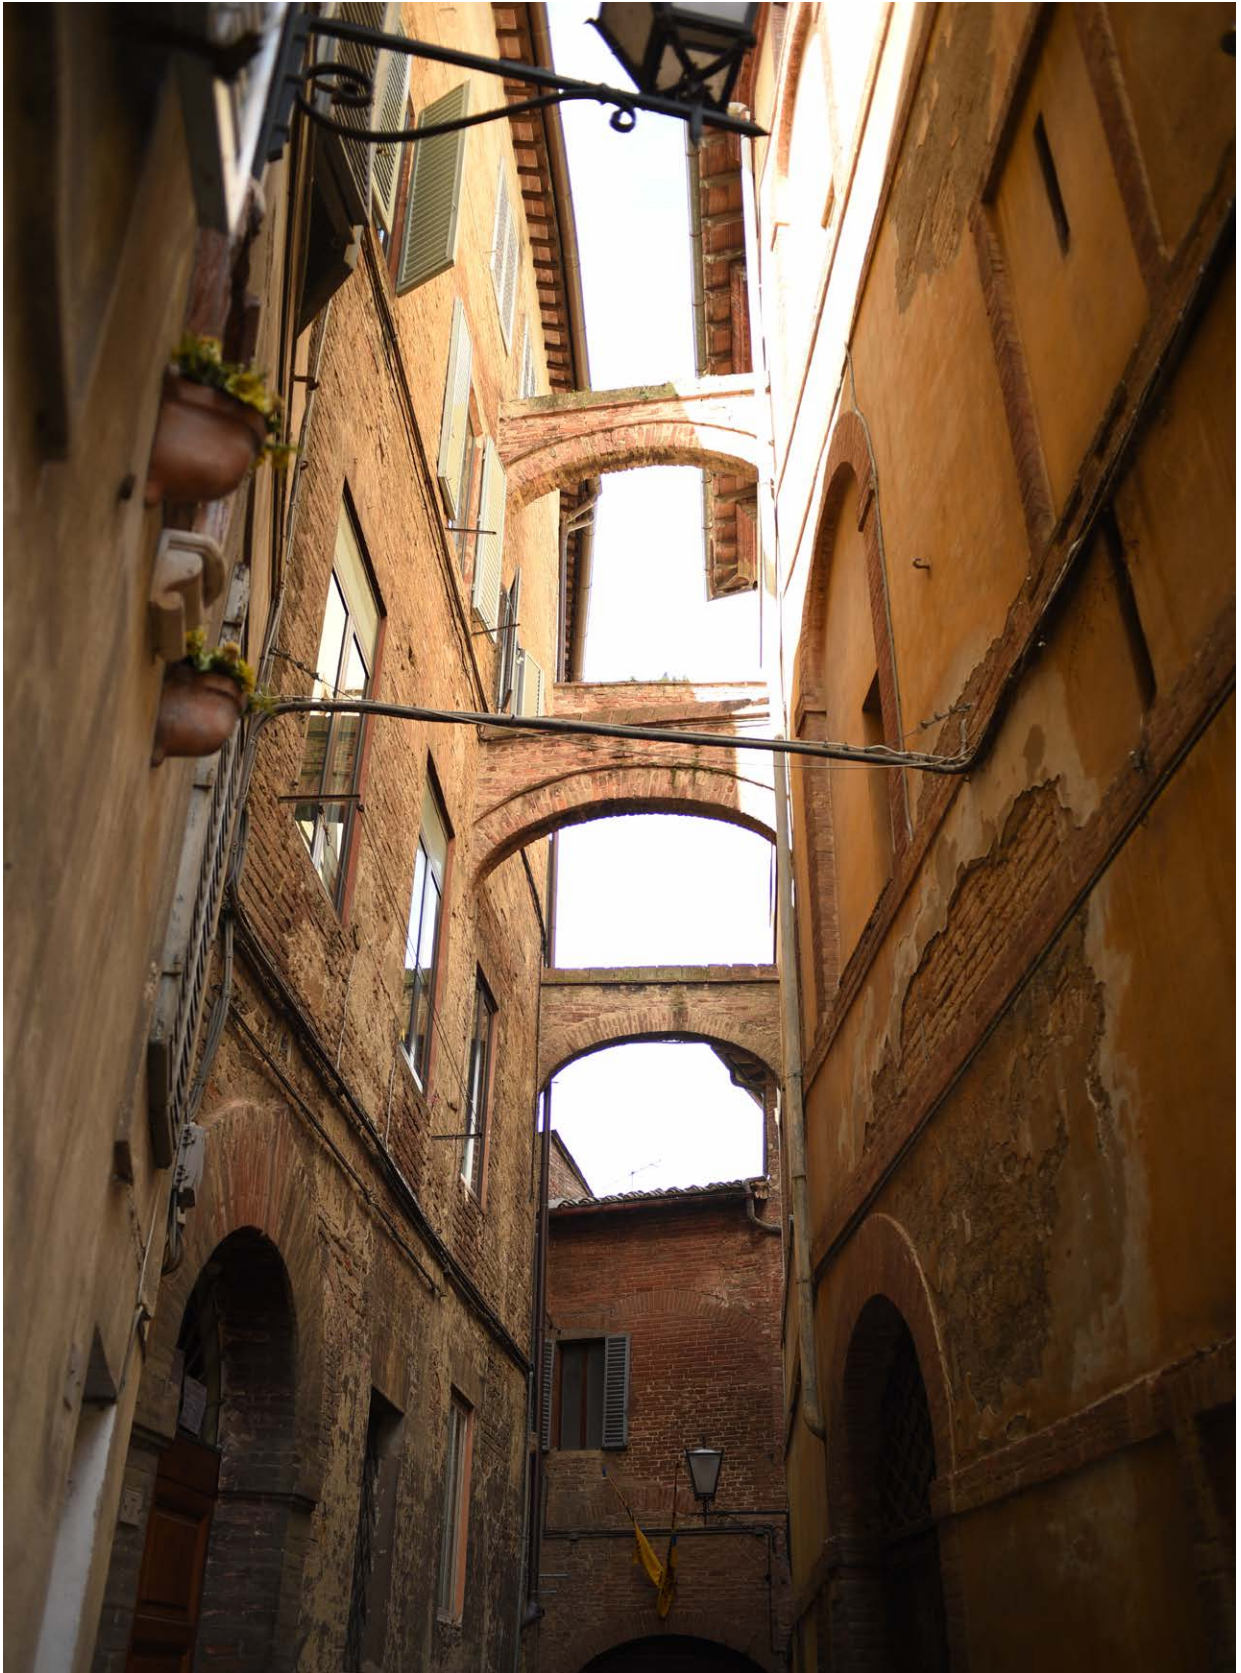
Figure 4.10a - Examples of buttressing arches

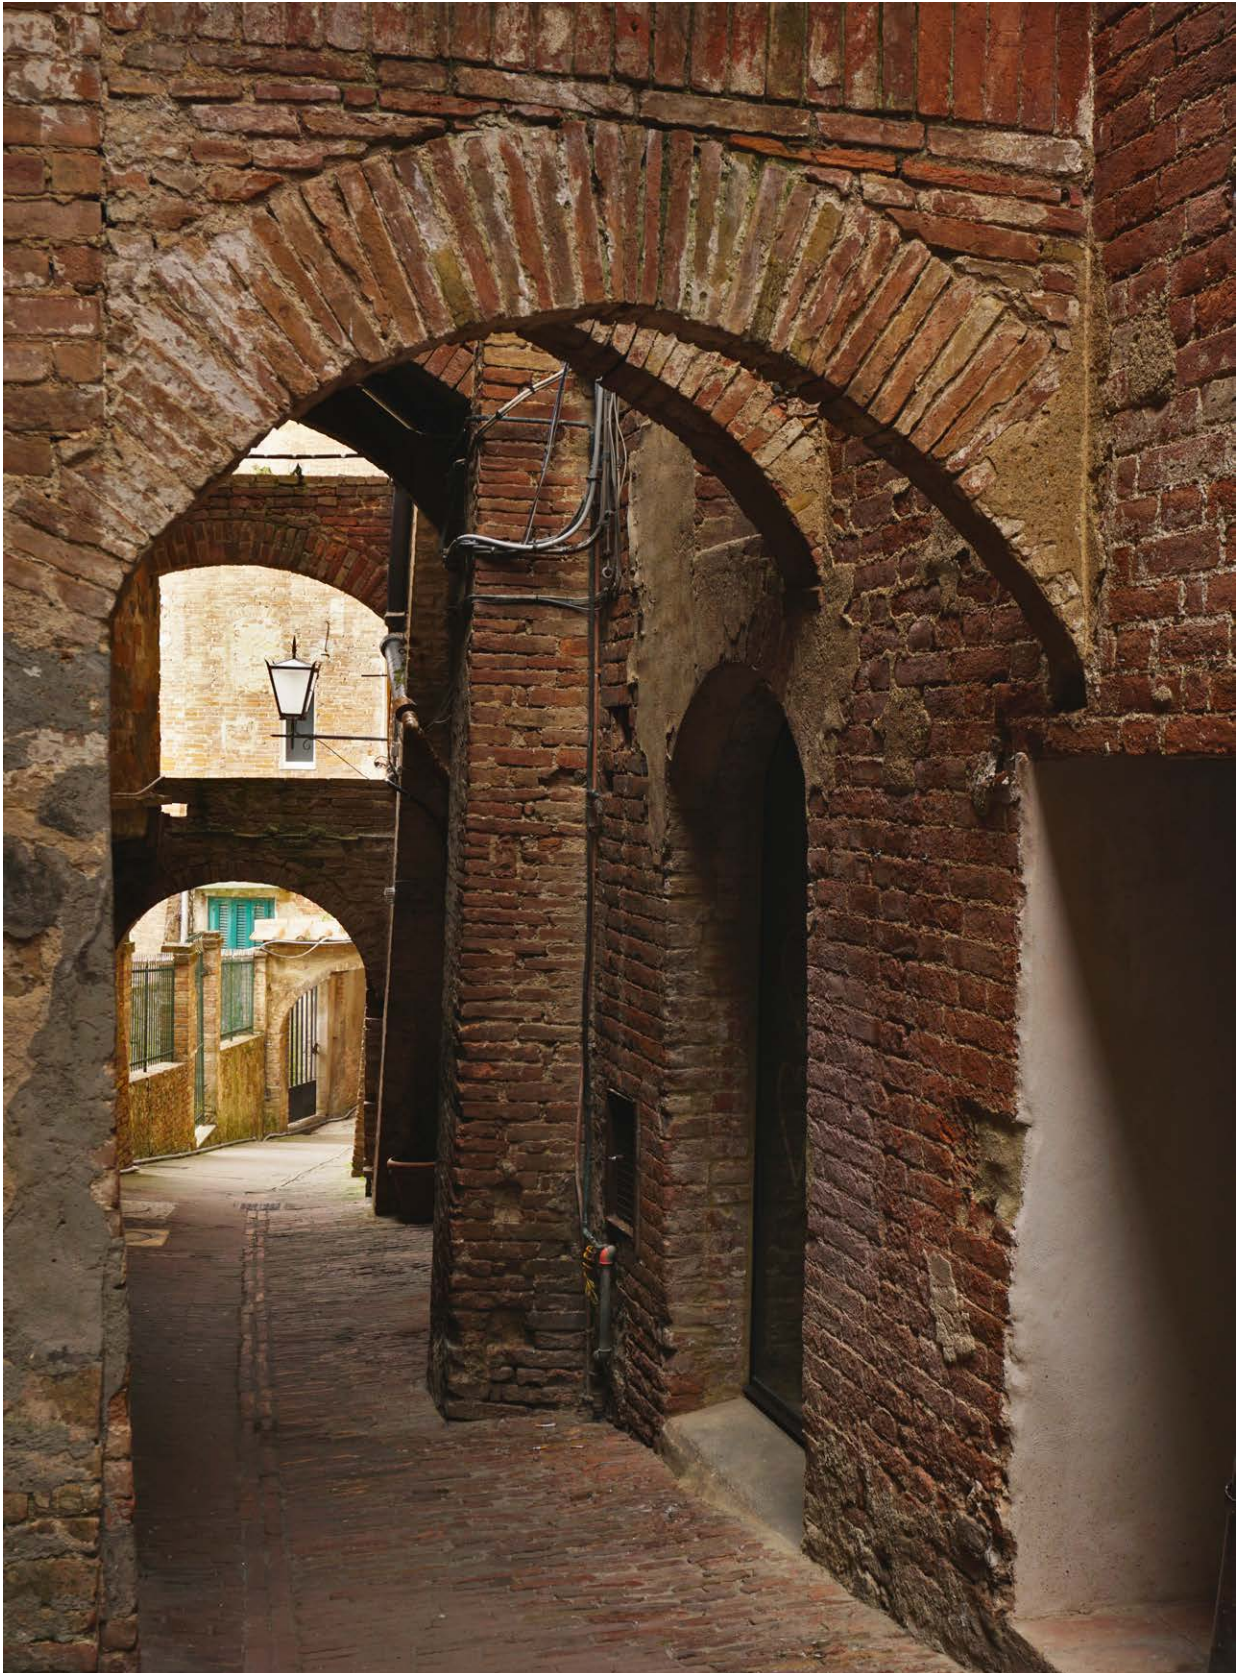
Figure 4.10b - Examples of buttressing arches.

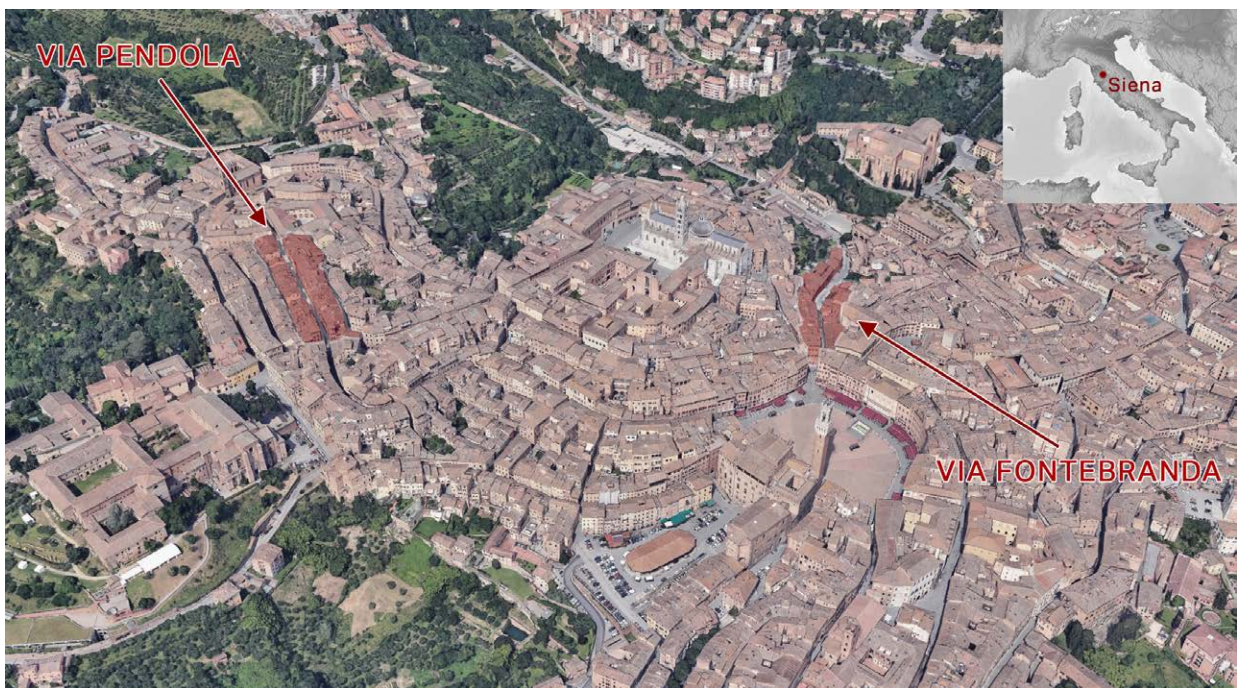
Figure 4.12 - Aerial view of the historic centre of Siena with the two road fronts under investigation highlighted: Via Fontebranda and Via Pendola. (Map data Google, Landsat / Copernicus. Re-elaboration: Marco Repole).

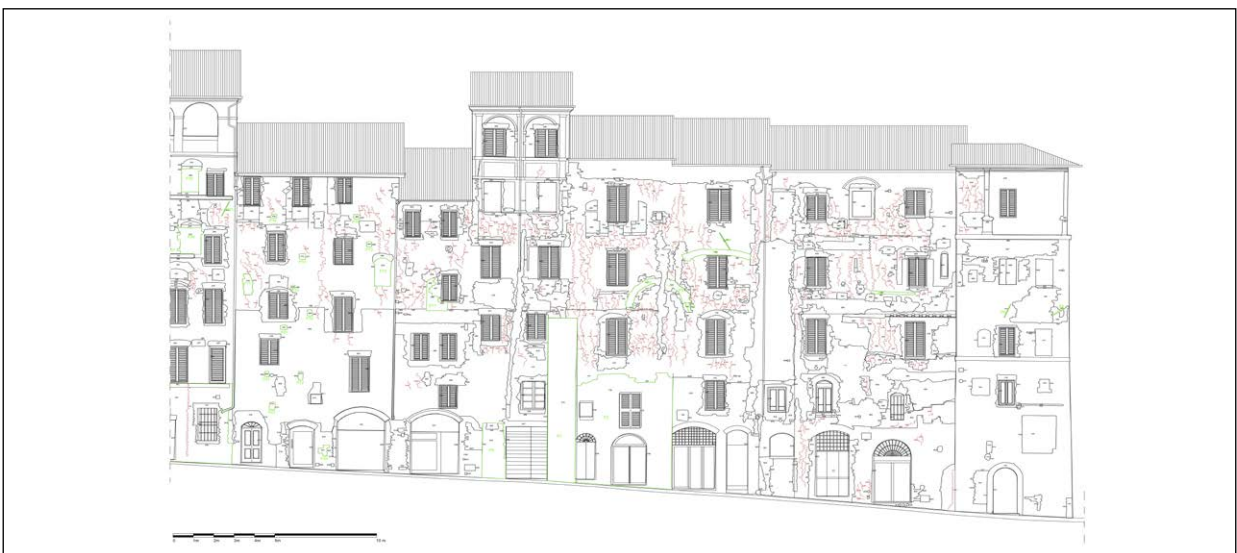
Figure 4.14 - Stratigraphic analysis of a portion of the street front in Via Pendola containing: stratigraphy (black colour), crack pattern (red colour), post-seismic construction techniques (green colour) Elaboration: Marco Repole.

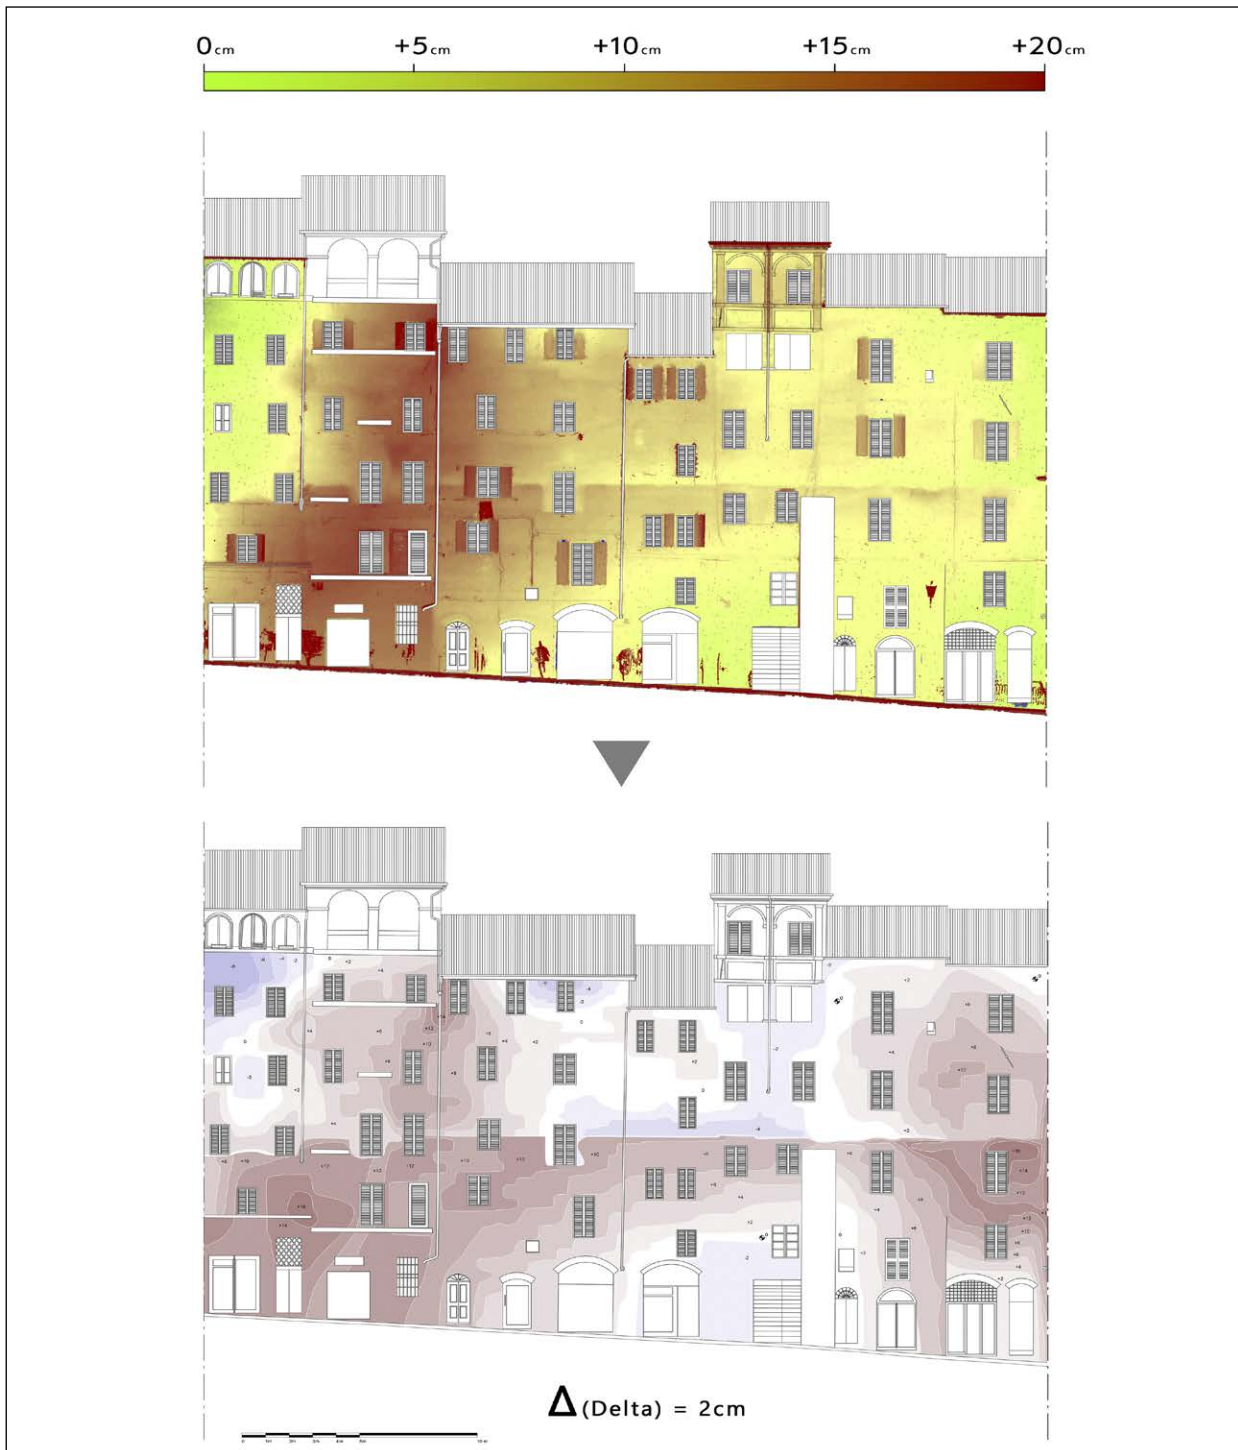
Figure 4.16 - The image shows the difference in graphic rendering of the deformation data of a portion of the external road frontage related to Via Pendola. In particular, from the image, it is possible to appreciate how the deformations visible on the Elevation Map on the top (composed of a colour gradient that ranges from green corresponding to an elevation of 0 cm to a maximum displacement in red of 20 cm) provide generic information on the trend of the entire frontage, while in the Map on the bottom (composed of isohypses with a Δ variation of 2 cm) they provide not only a general view but also a precise measurement of the extent of the displacement in that given area. The use of contour lines also allows for more detailed references on the frontage, moving by individual standing building, which made it possible to identify deformations (such as those on the right of the framed frontage) that were difficult to see with the colour gradient method. In our opinion, for the colour gradient to be graphically clear, more detailed measurements on the façade plane are necessary (Image taken from: Arrighetti and Repole 2024)
