Archaeoseismology in a Mediterranean City

Siena and the PROTECT Project

Andrea Arrighetti

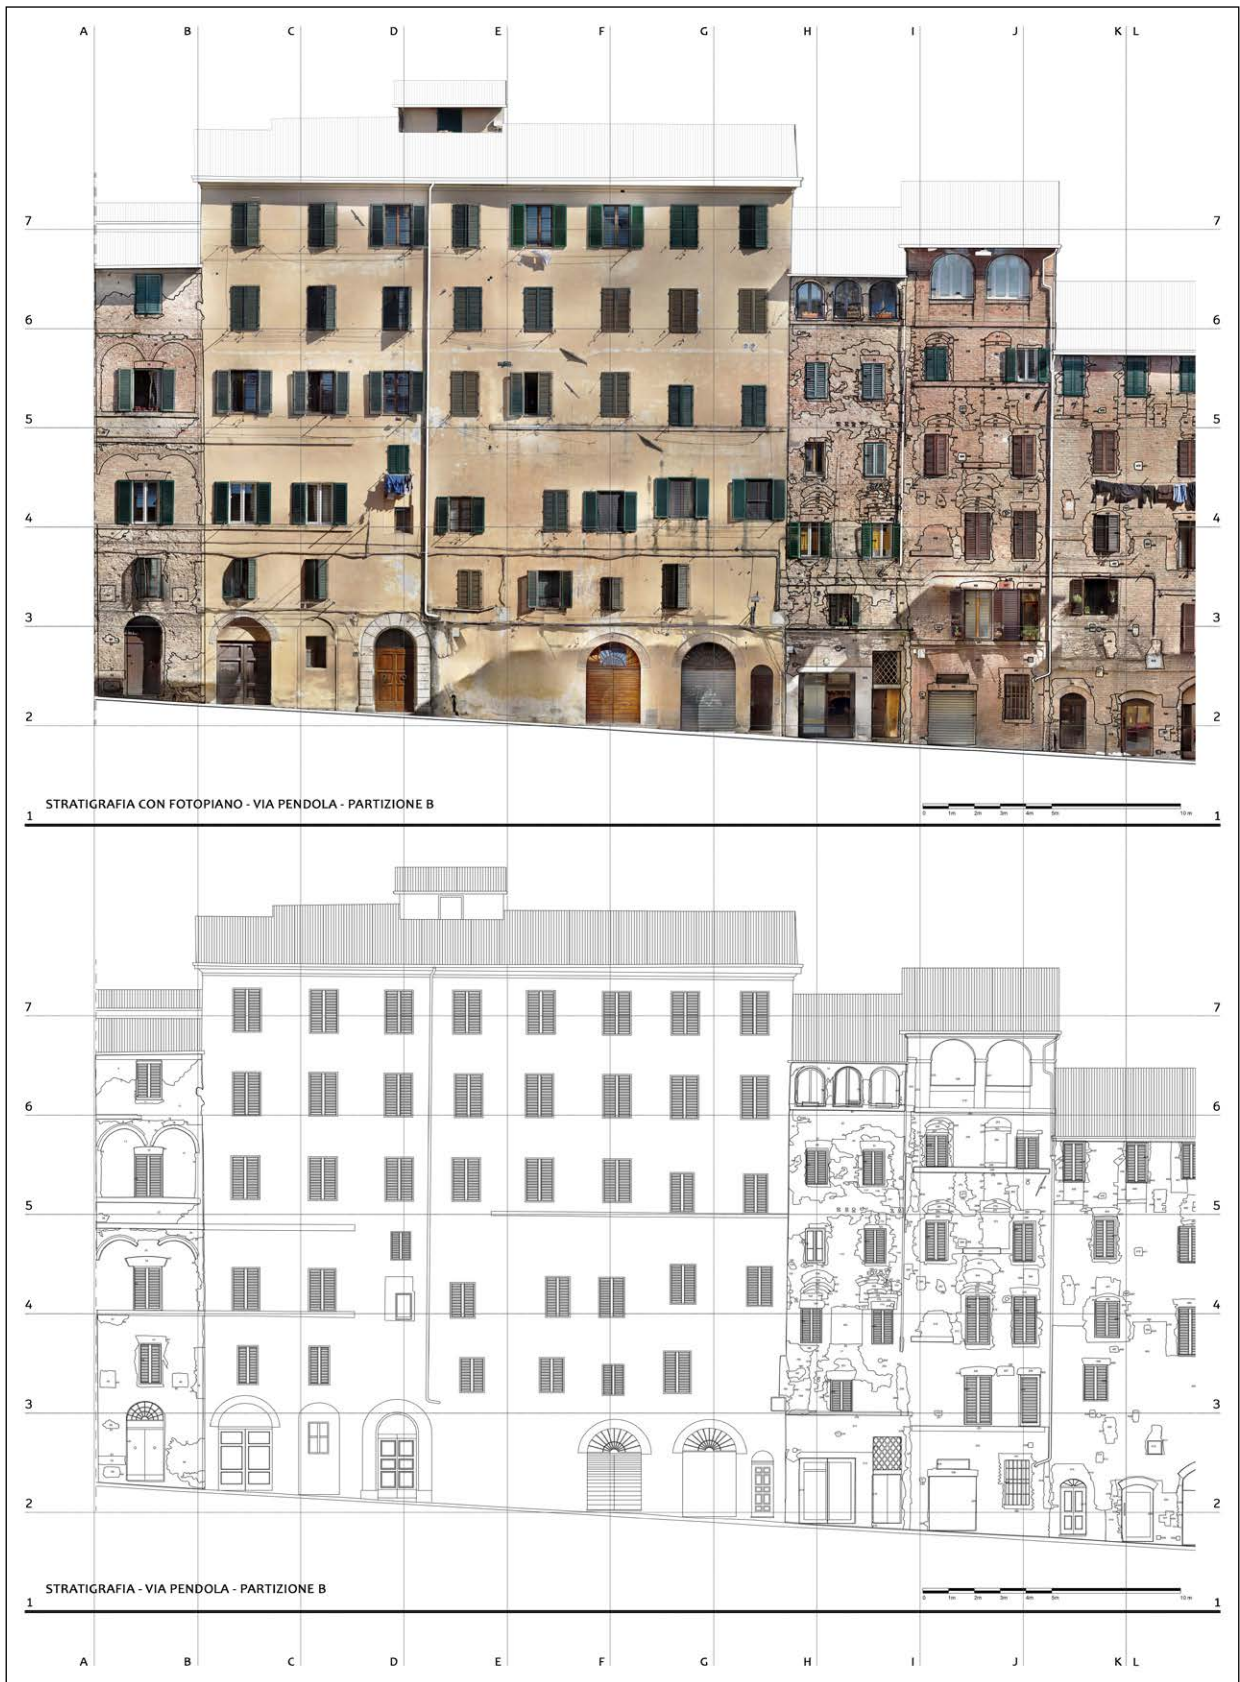
Figure 4.17a - Orthophoto plan (top) and stratigraphic analysis (bottom) of the west street front of Via Pendola.

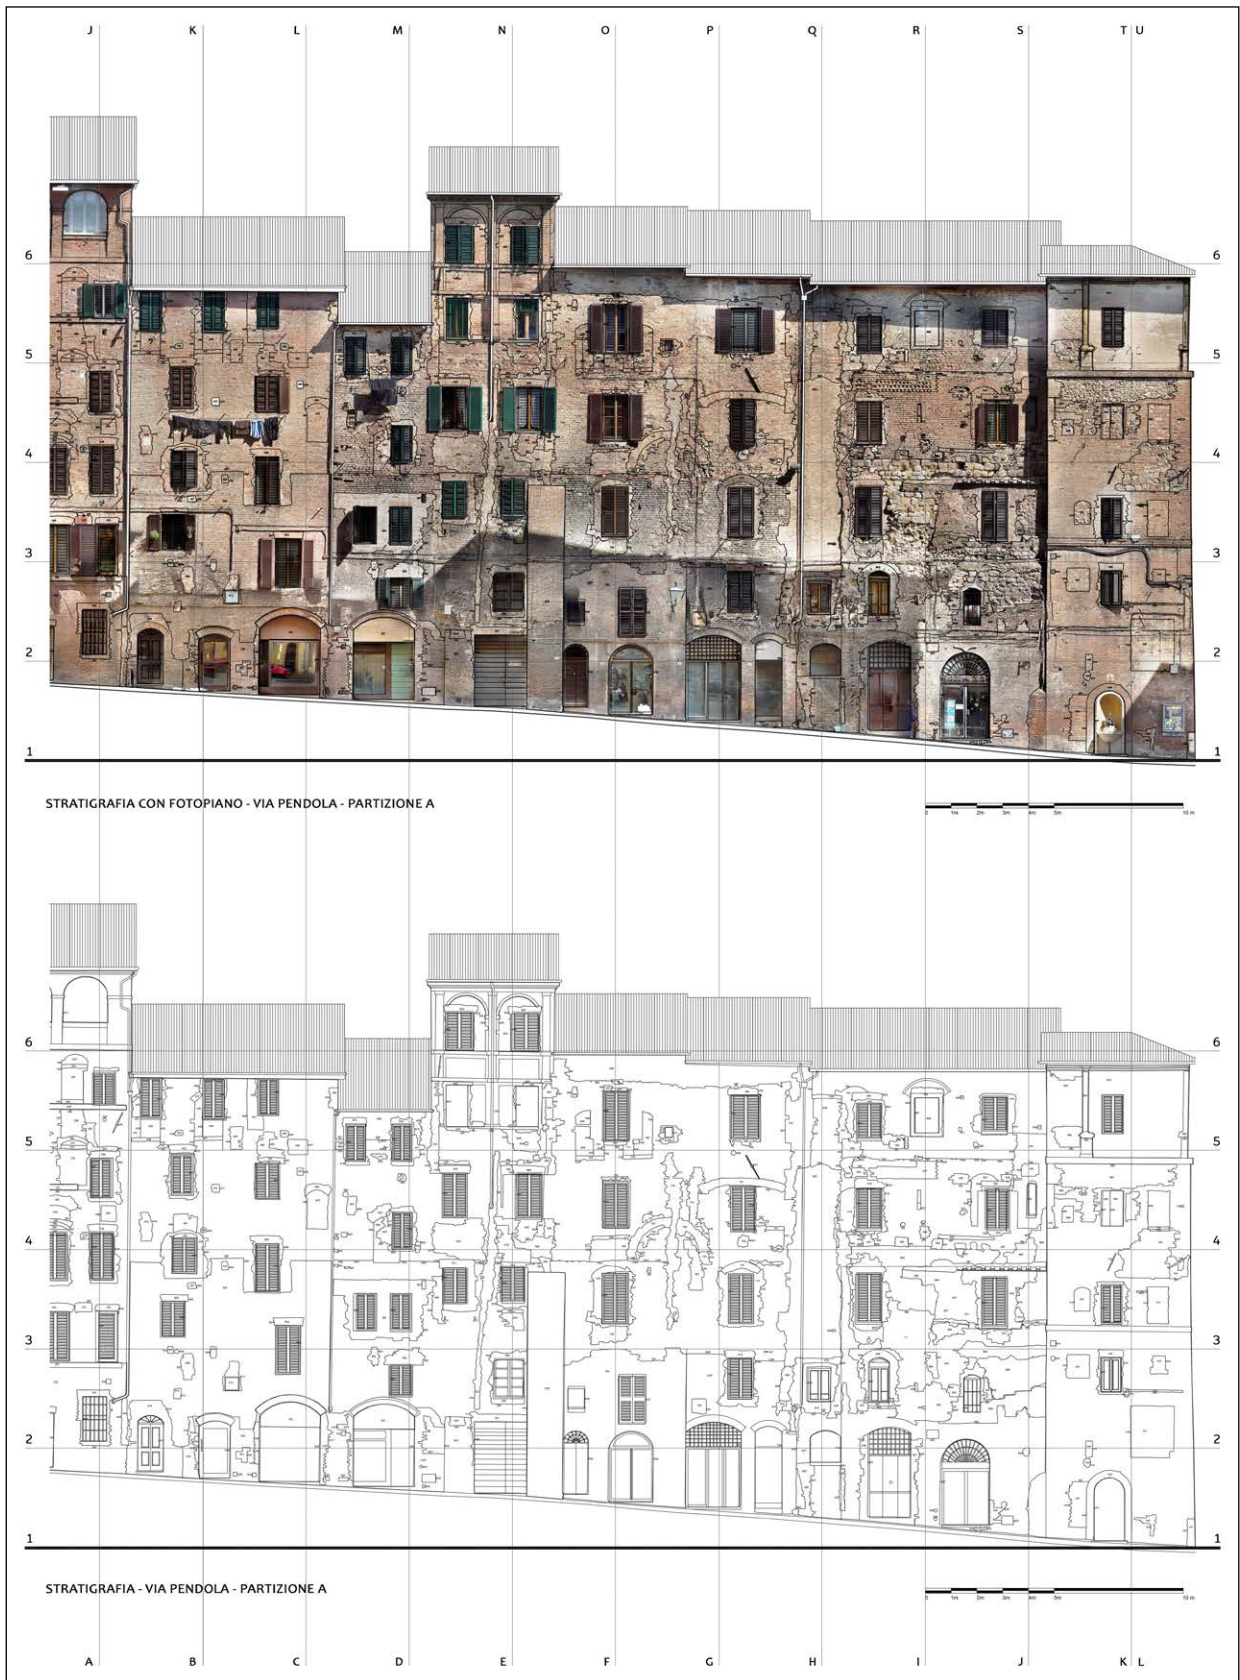
Figure 4.17b - Orthophoto plan (top) and stratigraphic analysis (bottom) of the east street front of Via Pendola.

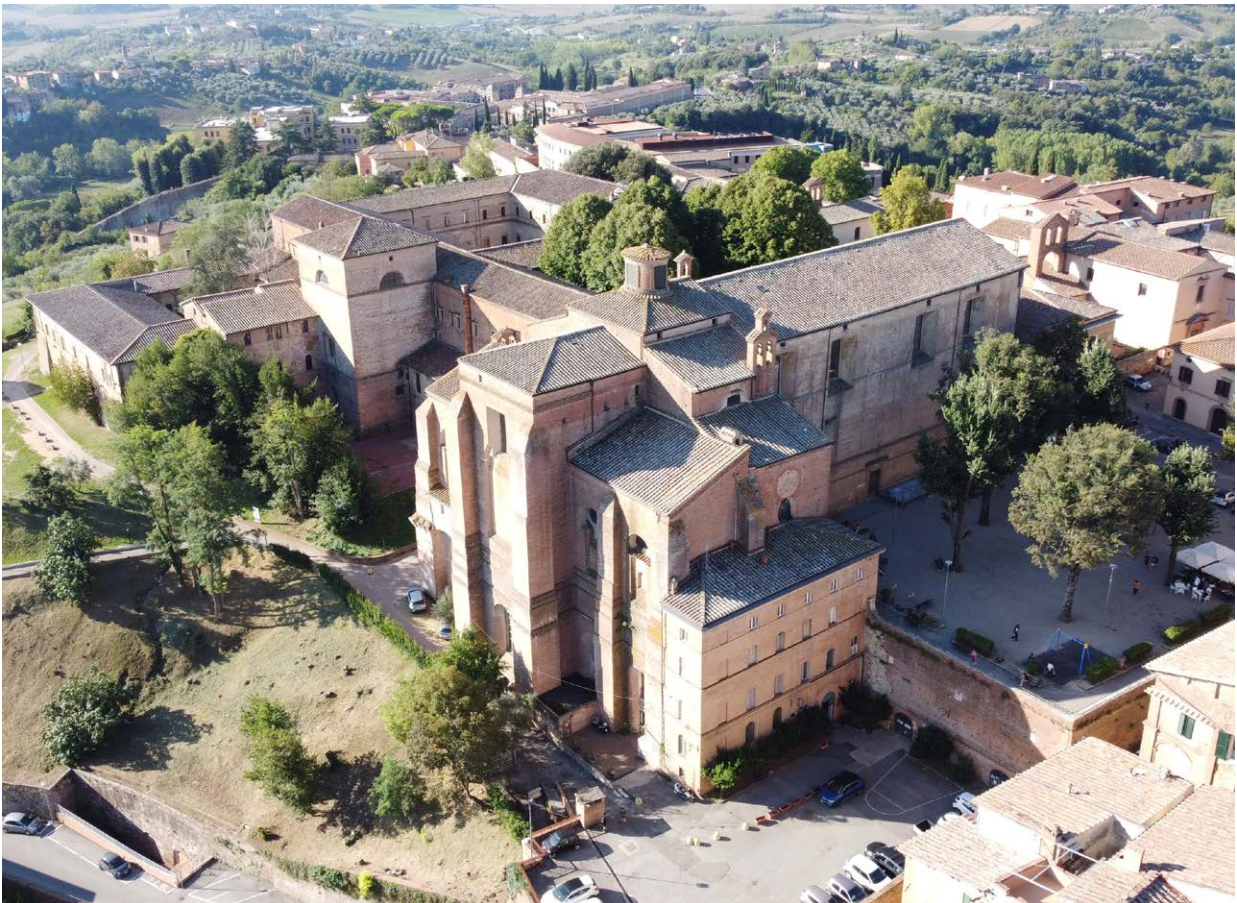
Figure 4.22 - The church of Sant'Agostino (Image: Gianluca Fenili)

The church of Sant'Agostino (fig.4.22) is one of the most important religious buildings in the city of Siena. The building's history stretches far back into the past, having originated in the 13th century. It dates to 1259, the year when there is evidence for the monastery's foundation stone being laid, in an area where the former church of Sant'Agata already stood. During building work on the new religious complex of Sant'Agostino, this earlier church, in a precarious state of conservation, was incorporated within the rear part of the building and in the new crypt, thereby forming a single architectural complex. Topographically speaking, the church of Sant'Agostino is situated in the Terzo di Città, namely the area in Siena's old city centre which written sources tell us was one of the zones with the highest incidence of recorded damage and disrepair of telluric origin, with special reference to the seismic periods that marked the 14th, 15th and 18th centuries (Rovida et al., 2022; Castelli et al., 1996). Furthermore, Sant'Agostino presents numerous indirect sources that inform us of its past, some of which are chronologically detailed and rich in information. This is the case with iconographic sources, first and foremost views of the city of Siena. In these, as of the 15th century, the church stands out clearly, since it was surrounded by a clear space that enabled it to be seen in its complete form.

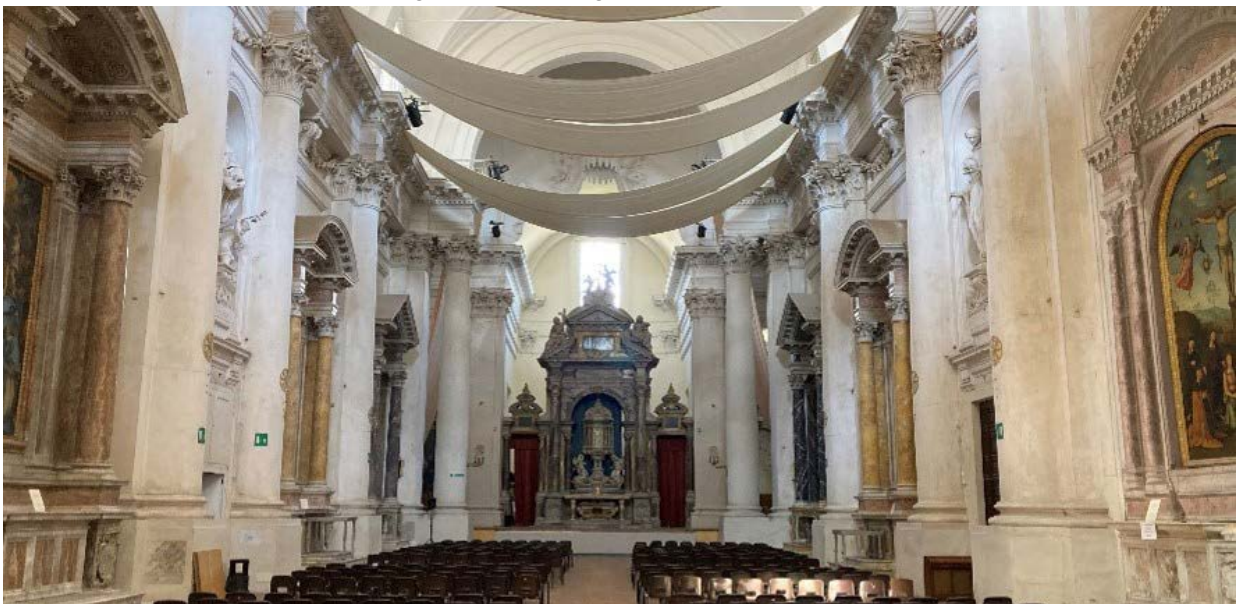
Figure 4.23 - The interior of the church in Baroque style.

In terms of its construction, the religious building features a Latin cross plan with exposed exterior elevations, apart from the south-east (the façade) and south-west sides (side wall), while the interior is totally plastered and was rebuilt in the Baroque period (fig.4.23). The outside lends itself very clearly to analysis, with extensive multistratification of the transformations which the building has undergone, starting with the original fabric and including the changes made in the contemporary era. It also has extensive signs of disrepair (lesions and deformations) and structural reinforcements (bonding stones, anchor plates, counterforts). In the south-western part we see the construction of a modern portico (CF2). The earliest building had six large ogive windows on both sides. The rear part has an apse and a transept, both made in modern times, in addition to the apsidal section, which it supported, and which has been incorporated within the modern structures.

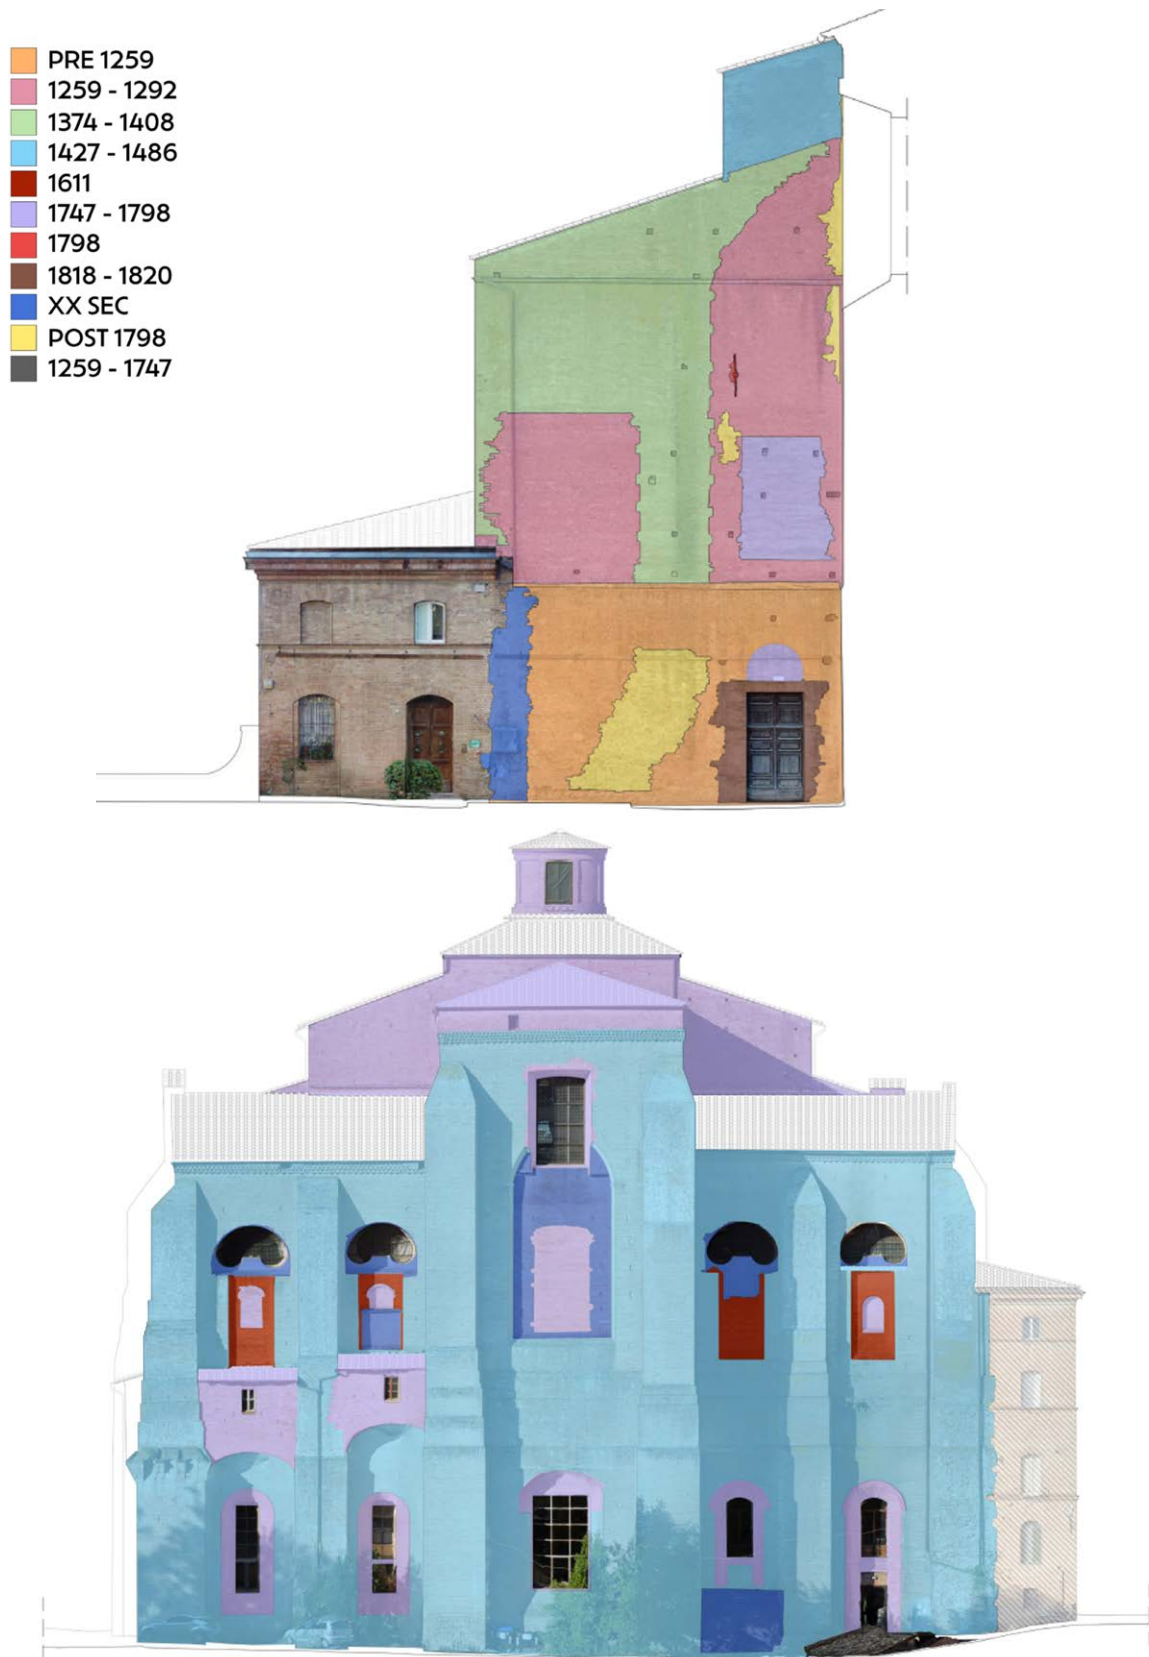
Figure 4.28 - Restitution of the exterior fronts of the church by construction phases.

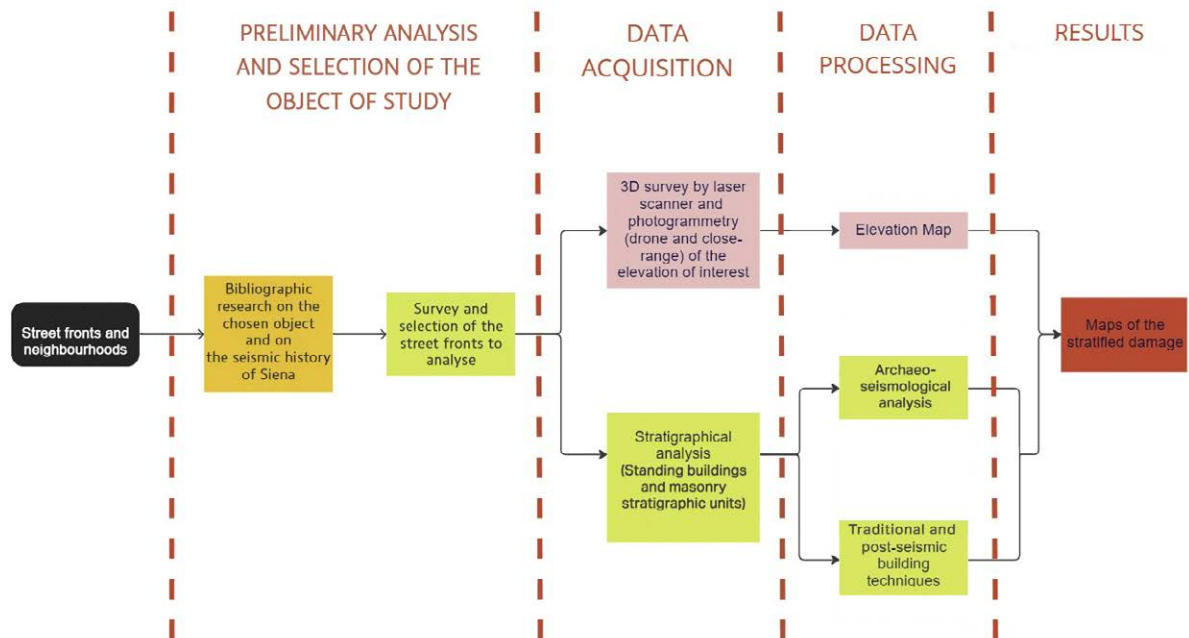
Figure 5.3 - Flow chart illustrating the conceptual framework underpinning the Level 2 of the medium-analysis of the historical centre of Siena: the expeditious investigation of street fronts.

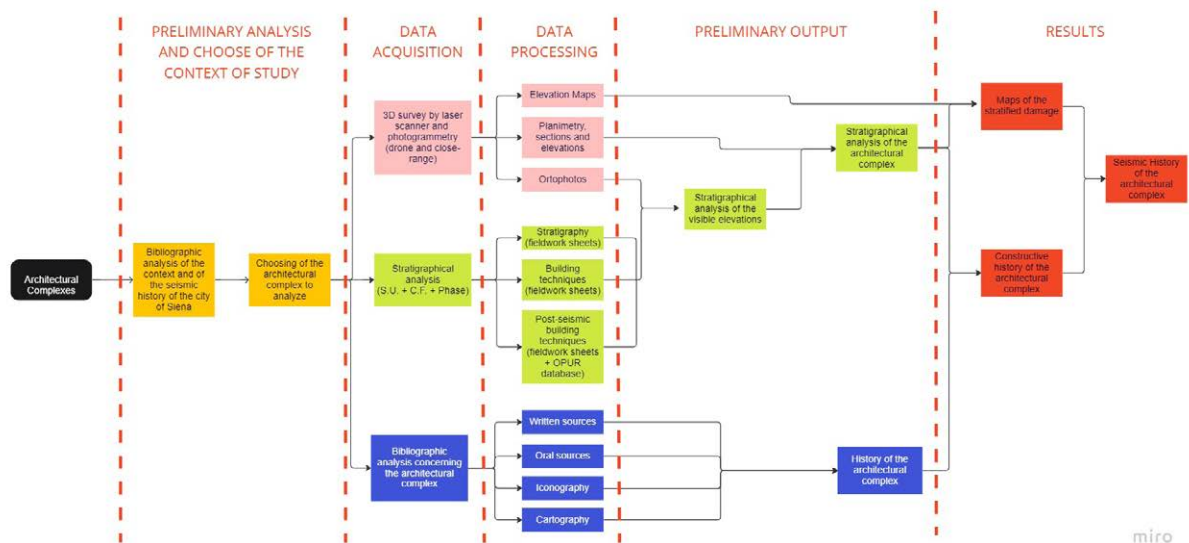
Figure 5.4 - Flow chart illustrating the conceptual framework underpinning the Level 3 of the micro-analysis of the historical centre of Siena: the architectural complexes.
