# Bar Locks and Early Church Security in the British Isles

John F. Potter

Access Archaeology

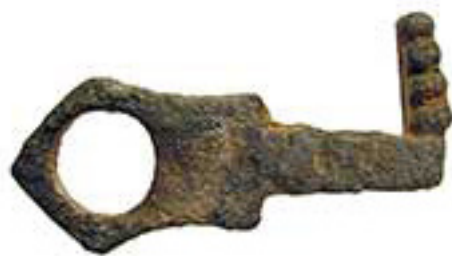
Figure 1.4. A bronze key with a clawed blade probably of Viking origin dated to about AD 300.

key, used to manually release different locking systems. They were probably of Viking (Celtic) age and were found in the Värnamo area of Sweden. They were in all probability used in much the same manner as described by Homer. Figure 1.4 illustrates a bronze key identified as of Viking source with a clawed blade (*Historia om nycklar 3 liten*) which is believed to have been used about AD 300; while Figure 1.5, which is a similar clawed key, has been described as of Anglo-Viking origin and dated to about AD 900 (author J. F. Smith). Dr Raine Borg holds a large personal collection of keys, and he has produced a drawing of one of his keys from southern Sweden which is thought to date from the early 1100s. It is believed to have been operated as a metallic (iron) mechanism within a block of wood and, as the key is more than 150mm long, it is possible to presume that locking could be achieved from either side (of a door) by means of a keyhole. In many locking mechanisms little of the action can be readily viewed and the workings may be encased. The pull-ring lock from Sweden (shown in Figure 1.6) required two hands to operate, one for pulling the ring whilst the other turned the key. It is dated to 1312-13 and is photographed here by Raine Borg.

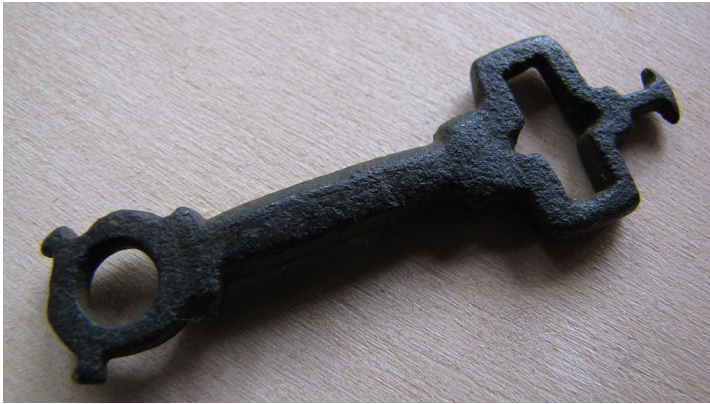
Figure 1.5. A further clawed key thought to be of Anglo-Viking origin and dated to about AD 900.

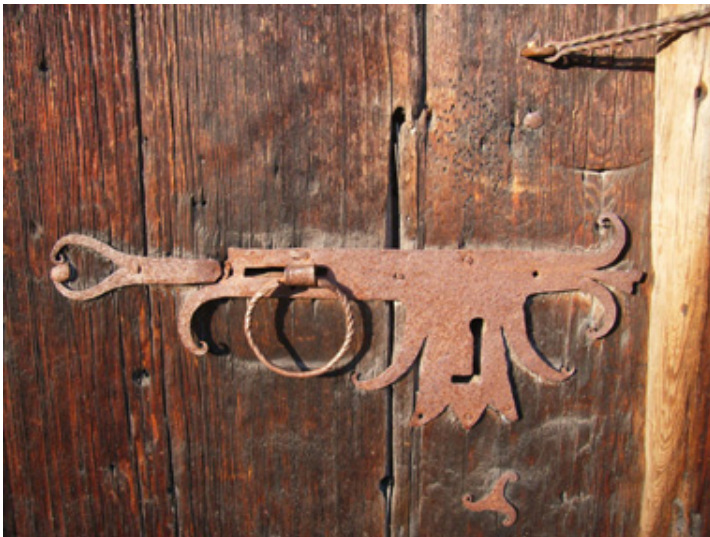
Figure 1.6. A pull-ring lock Swedish key (dated to 1312-1313) photographed by Dr R. Borg. The mechanism requires two hands operate - one to draw the bolt, the other to turn the key.

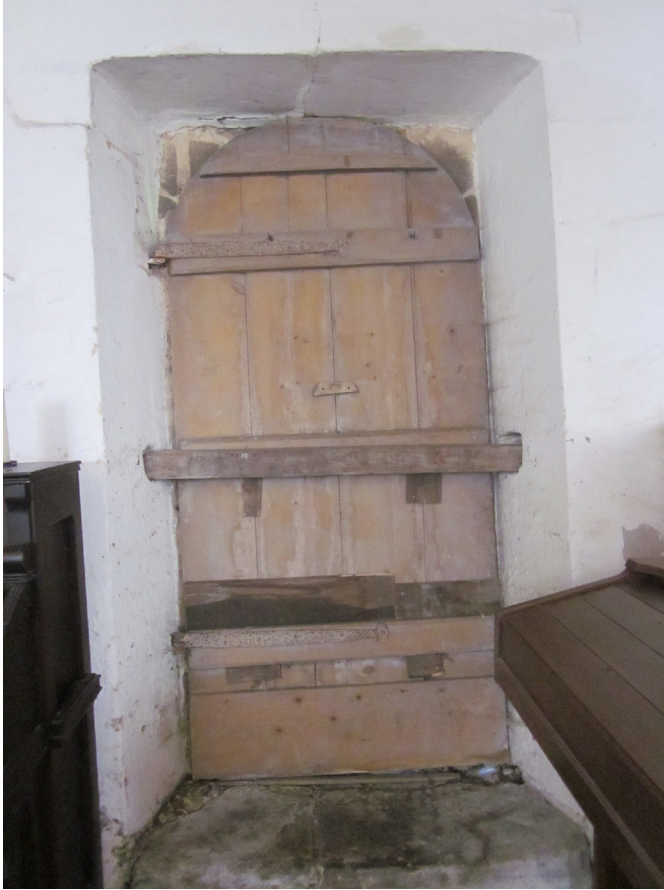
Figure 1.7. The north aisle door at Stragglethorpe, Lincolnshire (SK 913 524) which is retained in position by a bar lock.

Cover: The north aisle door at Stragglethorpe, Lincolnshire (SK 913 524) which is retained in position by a bar lock.

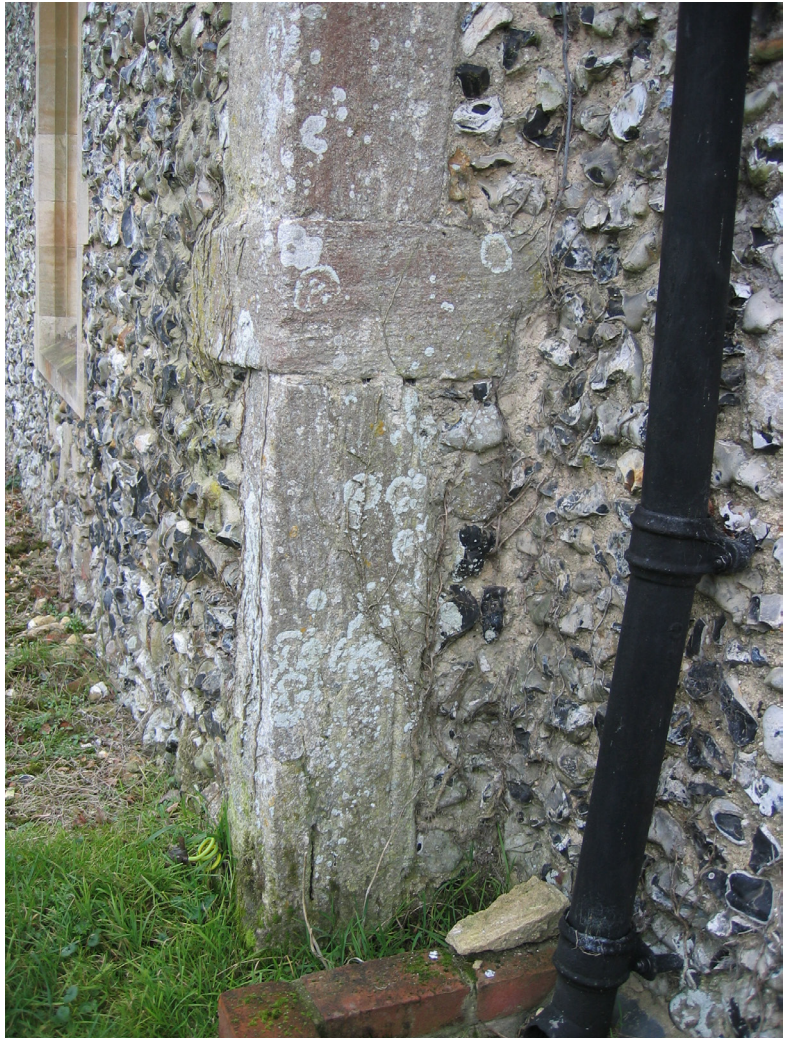
*Figure 1.10. Detail of the lowest three stones (in the long and short Anglo-Saxon style) in the south-west nave quoin at Strethall church (TL 484 398) in Essex (after Potter, 2009c). From the lowest stone upwards, the bedding orientations are BVFR, BH, BVFL. The rock type used is Barnack Stone, imported into the region.*

Some of the significant differences between the stonework of Anglo-Saxon and Norman doorways and windows are shown in Figures 1.10 and 1.11. There are further differences between the stylistic details of the two periods of building - evident in the structure of features such as pilasters and walls - or

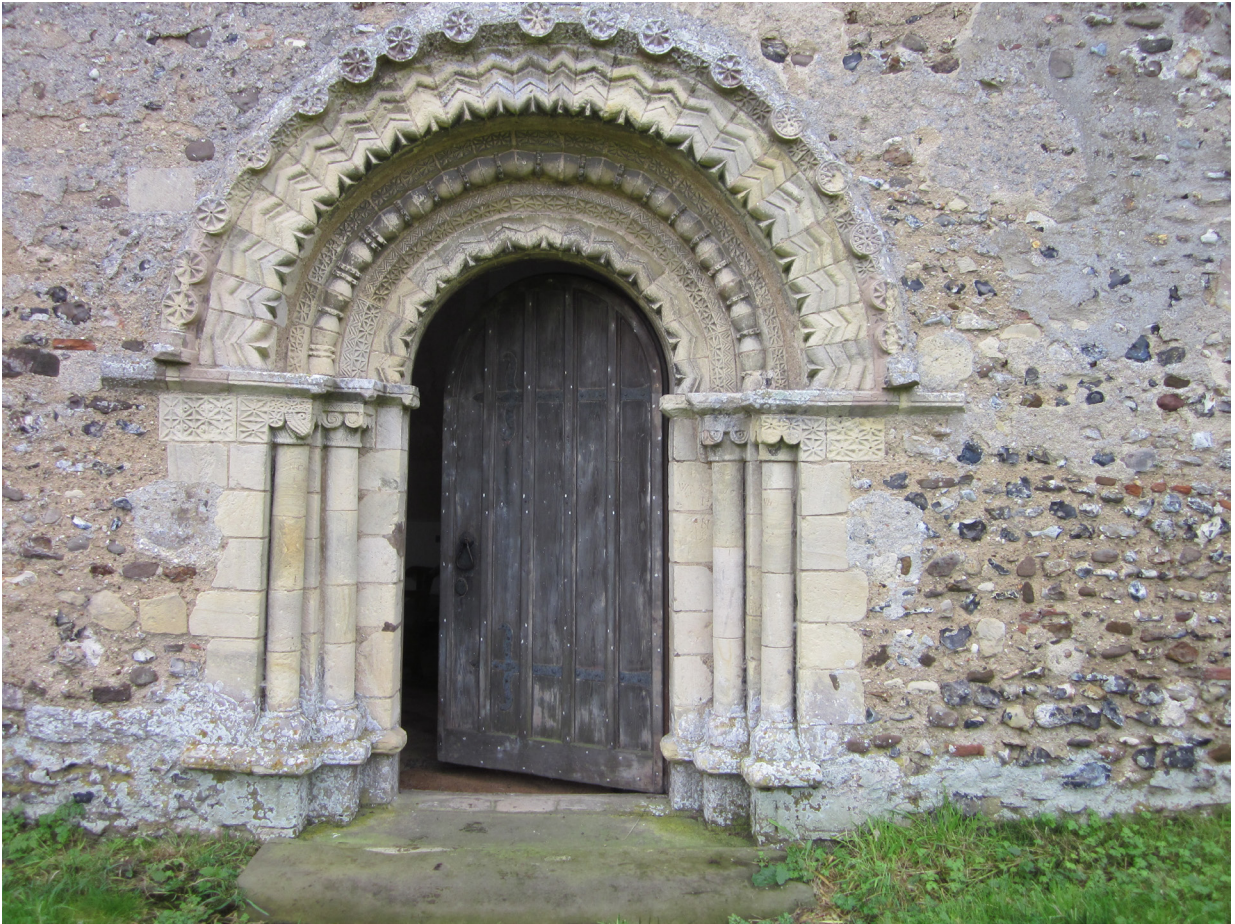
Figure 1.12. The Norman north nave door at Hales Church, Norfolk (TM 383 960). Note all stone carving occurs on the relatively smooth bedding plane surfaces of stones which face to the north (or BVEIA).

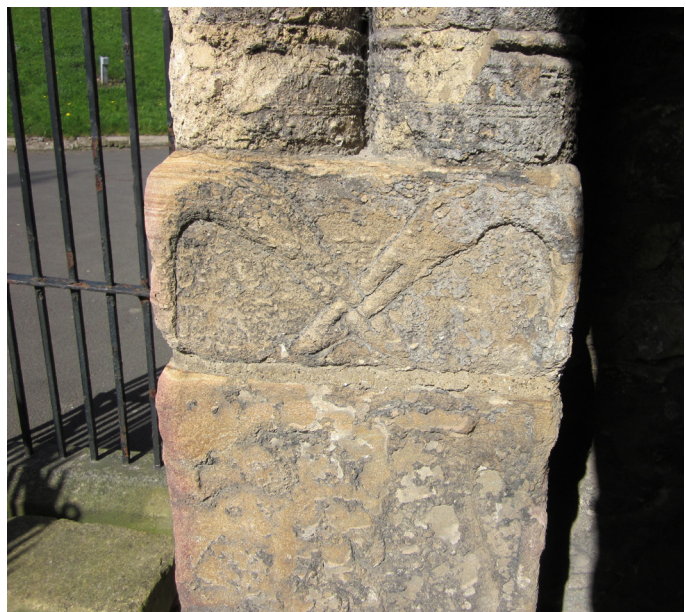
Figure 1.13. At Monkwearmouth, Durham (NZ 402 577) the Anglo-Saxon sea-bird carvings related to the west doorway can be seen on the relatively smooth bedding plane surfaces in the north jamb, and therefore on stones orientated BVFIA.

the presence of Anglo-Saxon cut backs. These, however, have been described elsewhere as in Potter, 2009c and Potter 2009d. It has been shown that the differences between Anglo-Saxon and Norman stonework relates to the manner in which the stone was used. In both periods, the smoothest faces of the stones were decorated with carvings and the masonry was appropriately orientated. The Norman doorway typically displays these carvings being best illustrated as the doorway is approached; the mason preferred to work on the BVEIA stones to utilise the flattest outward facing rock surface available (Figure 1.12). Anglo-Saxon masons selected the smooth BVFIA stonework to carve and their resulting carvings may be observed where they face into the arch (as at Monkwearmouth church, NZ 402 577, in Durham; Figure 1.13).

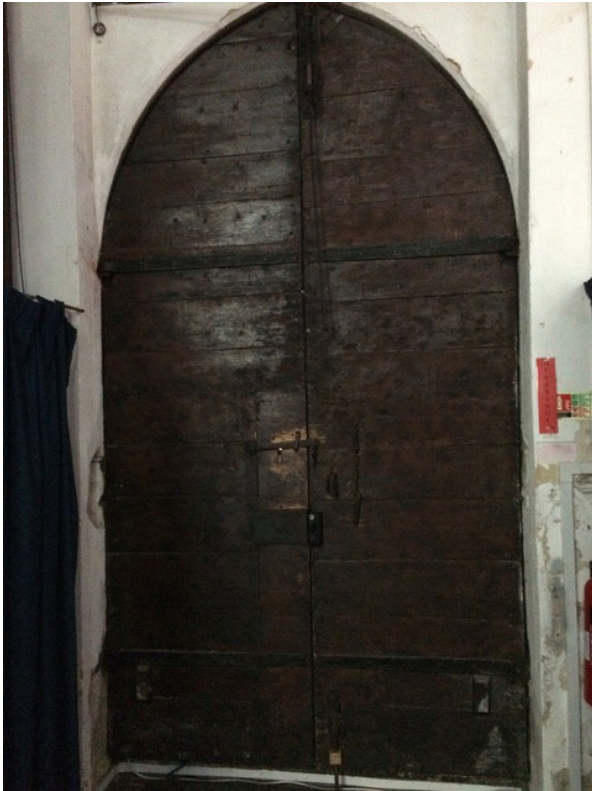
Figure 2.2

Figure 2.2. (Table 2.1). Attention was kindly drawn to Meldreth church, South Cambridgeshire (TL 375 466) by Peter Draper, FSA. The church south aisle was rebuilt in the 15th C. and the south doorway appears to be of this date. The interior of the doorway is shown here.

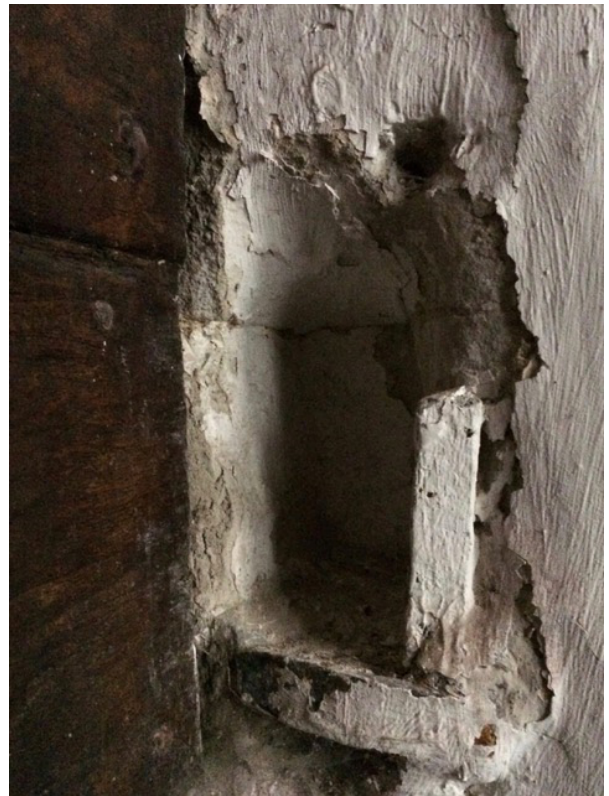
Figure 2.3

Figure 2.3. (Table 2.1). At Meldreth church the bar lock holes for the south aisle doorway survive, they were probably created in the 15th C. The west hole shown has in the past been repaired with wood.

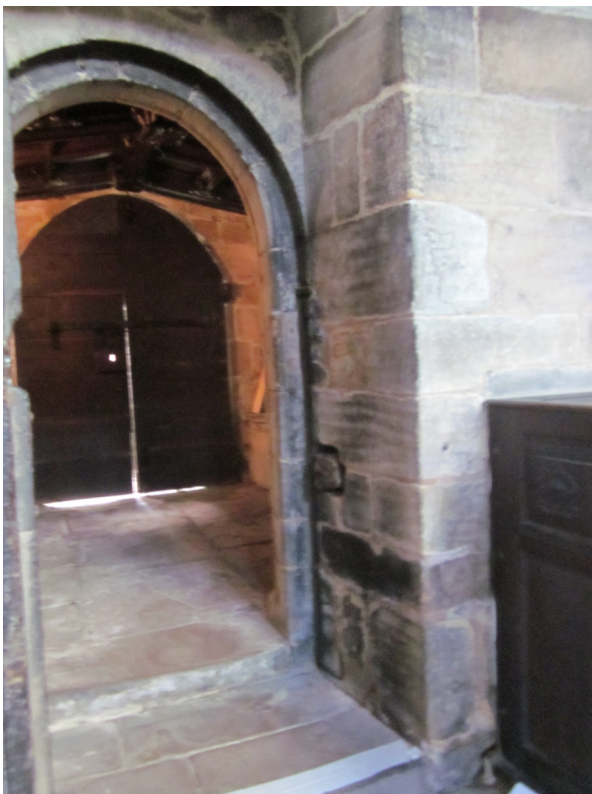
Figure 2.4

Figure 2.4. (Table 2.1). Astbury church, Cheshire (SJ 846 616), door to the north aisle showing partially blocked deep bar lock hole.

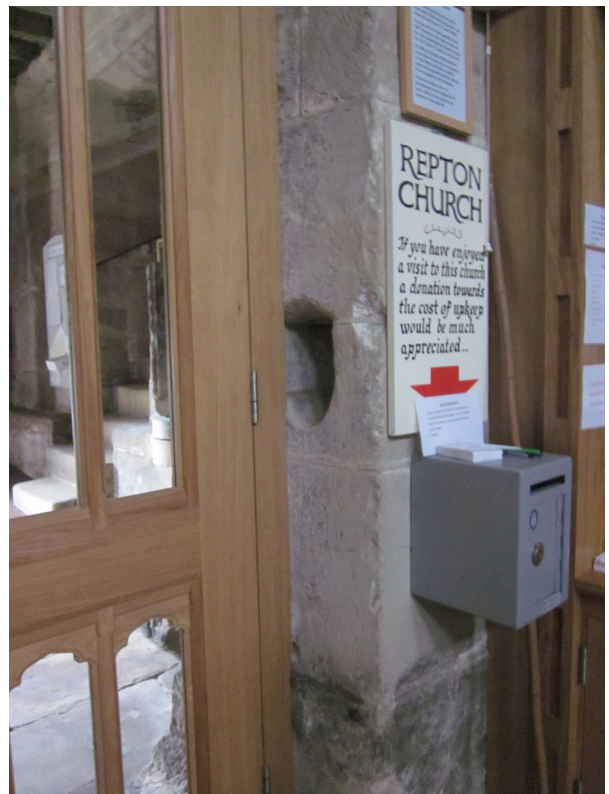
Figure 2.5

Figure 2.5. (Table 2.1). Evidence of an earlier bar lock, or more precisely its hole, may be seen in the west jamb, of the south door of Repton church (SK 303 272).

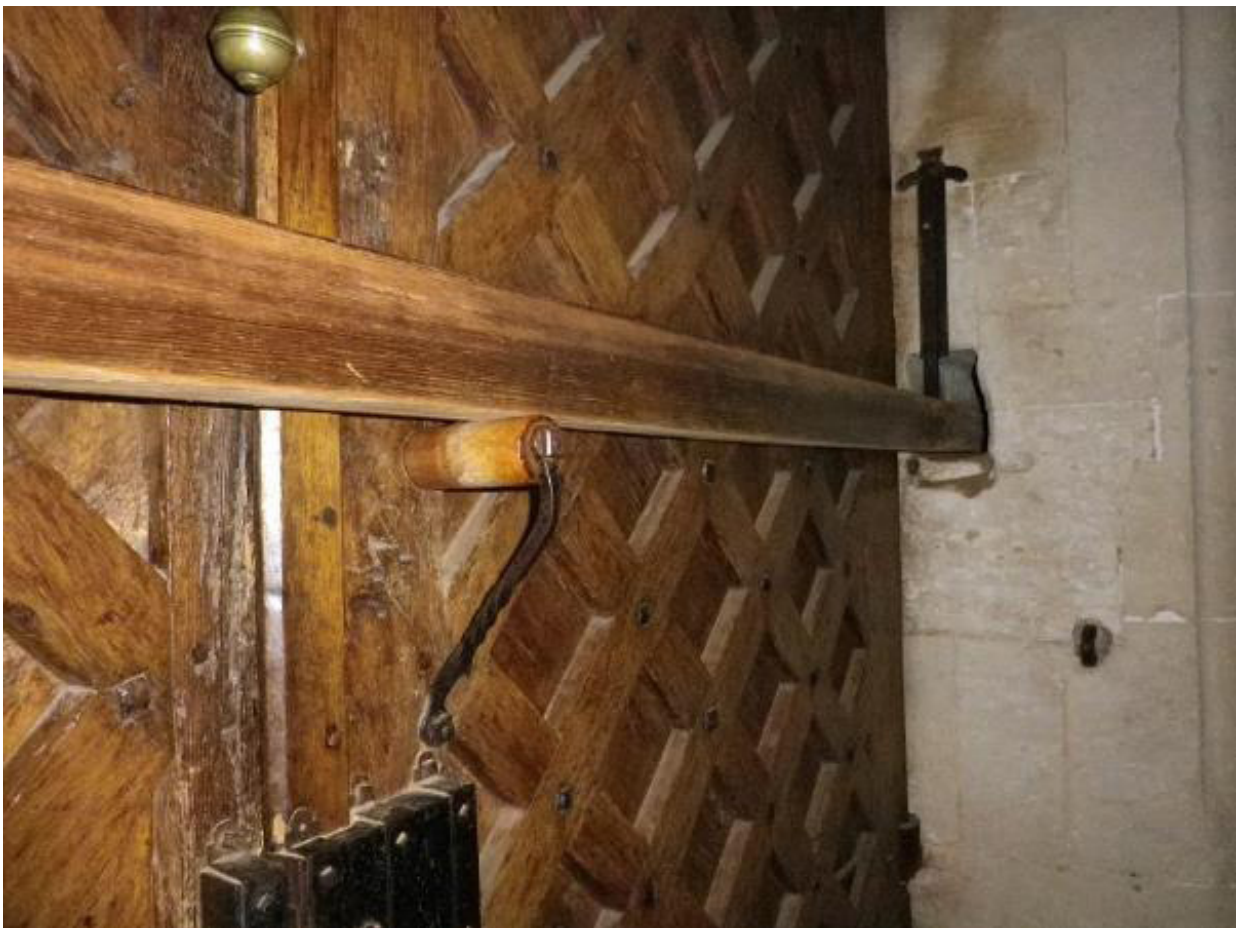
Figure 2.6. (Table 2.1). The central, west front door to Exeter Cathedral (SX 921 925), view north, with the bar lock in place. Note the pin to roll the weight of the bar on. The wooden roller appears to be a recent addition although the pin holding it may be original. Figures 2.6 to 2.9 kindly supplied by Diane A. Walker.

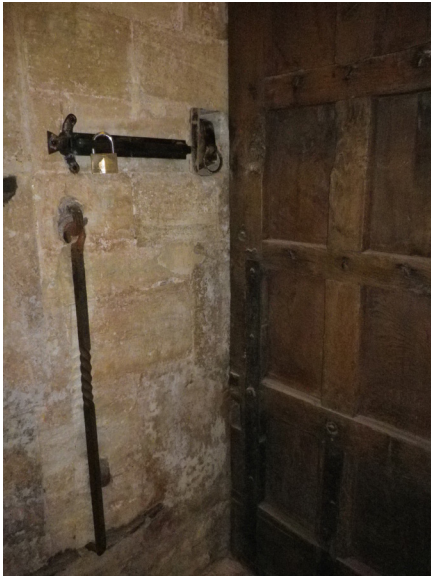
Figure 2.7. (Table 2.1). The two-leaf south door of the west front of Exeter Cathedral, view towards the south jamb (with the long hole). The iron bar hanging from the wall was designed to hook into a cup on the back of the door to help to hold the south leaf of the door closed.

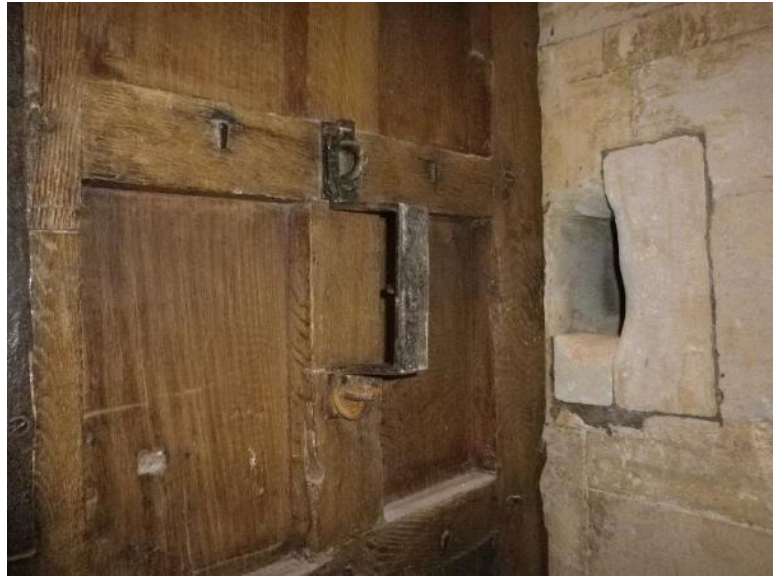
Figure 2.8. (Table 2.1). The north leaf of the same south door, this time viewed towards the north jamb from the inside. The iron bracket is to support the bar on the back of the door.

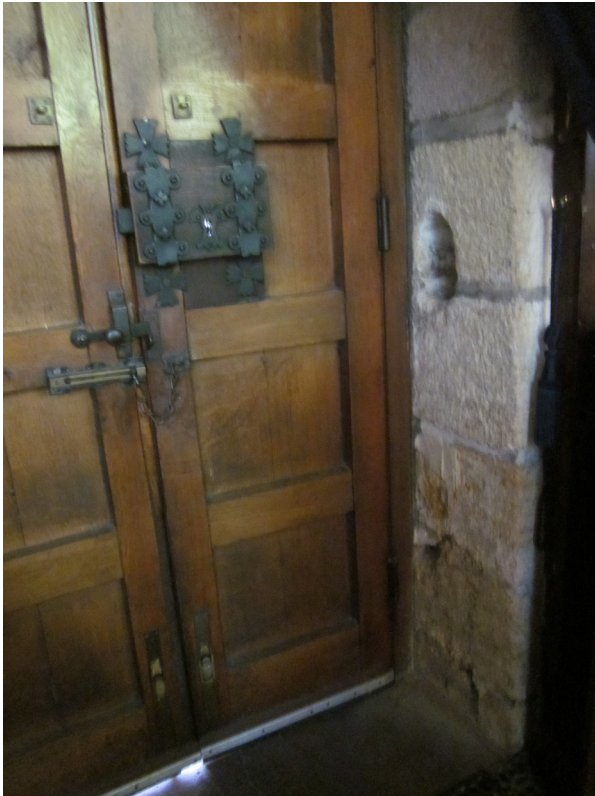
Figure 2.10. (Table 2.1). Haughton-le-Skerne church (NZ 307 158) reveals bar lock holes in both its south aisle and west tower doorways. The door jambs show their post-Norman bar lock holes to be deeper for the south aisle door, as shown, on its west side, and for the west tower door deeper in the north jamb.

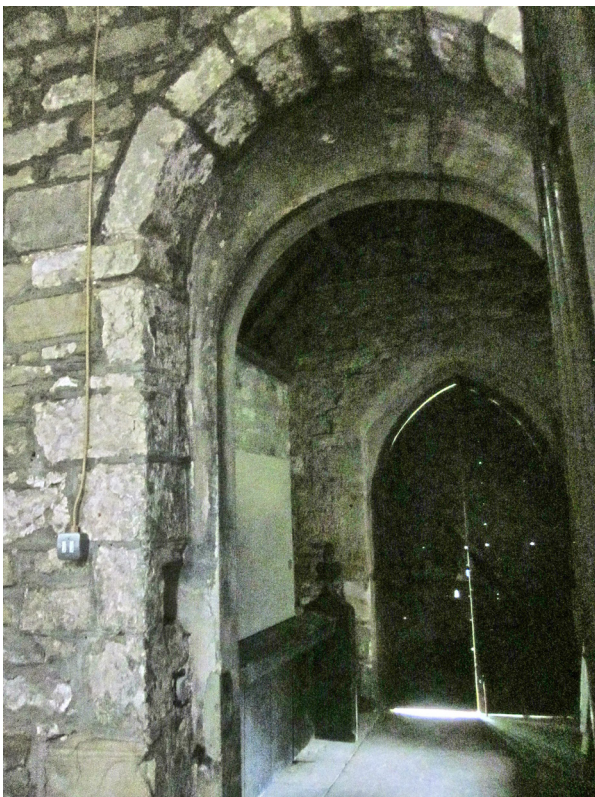
Figure 2.11. (Table 2.1). Pittington church (NZ 328 426) south nave doorway has a bar lock hole, about half a metre deep, on its east jamb.

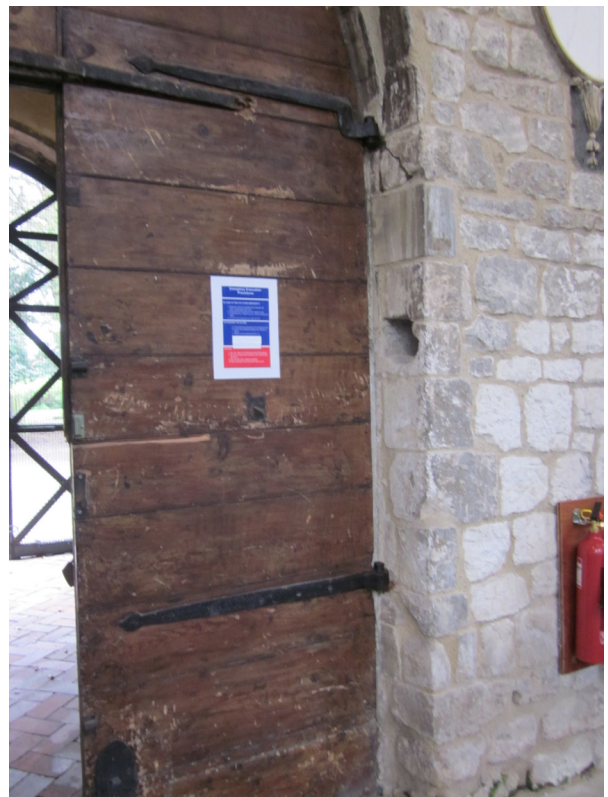
Figure 2.12. (Table 2.1). The bar lock hole in the west jamb of the south nave doorway at Barton-upon-Humber church (TA 035 219).

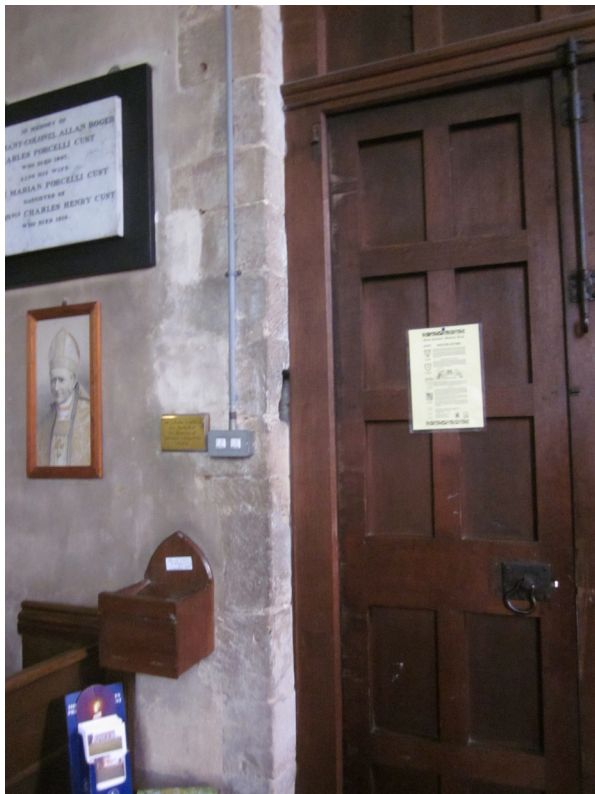
Figure 2.13

Figure 2.13. (Table 2.1). A deep bar lock hole is present on the east side of the south door of South Kyme church, Lincolnshire (TF 168 497). The original door has been replaced by a newer door.

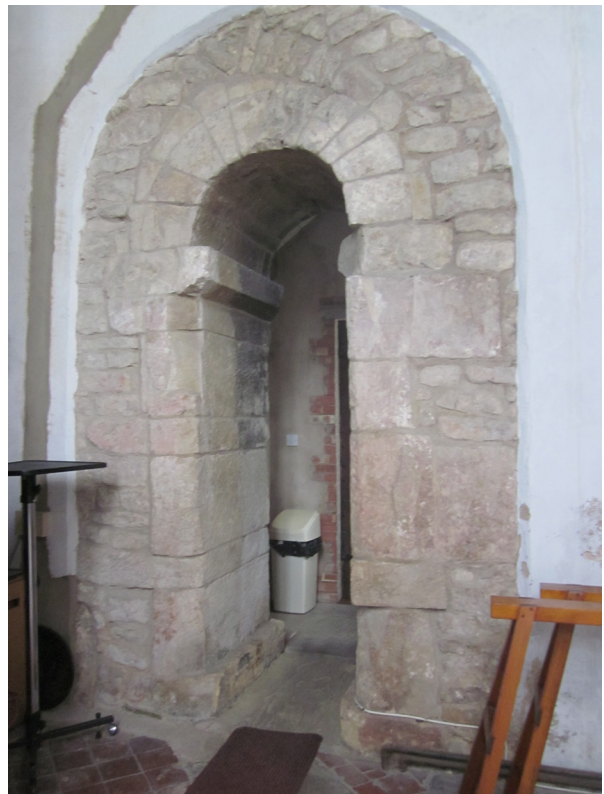
Figure 2.14

Figure 2.14. (Table 2.1). Stow (-in-Lindsey) church (SK 882 819), Lincolnshire, preserves many interesting early features. The bar lock holes do not photograph well, but this Anglo-Saxon doorway on the west wall in the north transept with its interesting cut backs is always worth further examination.

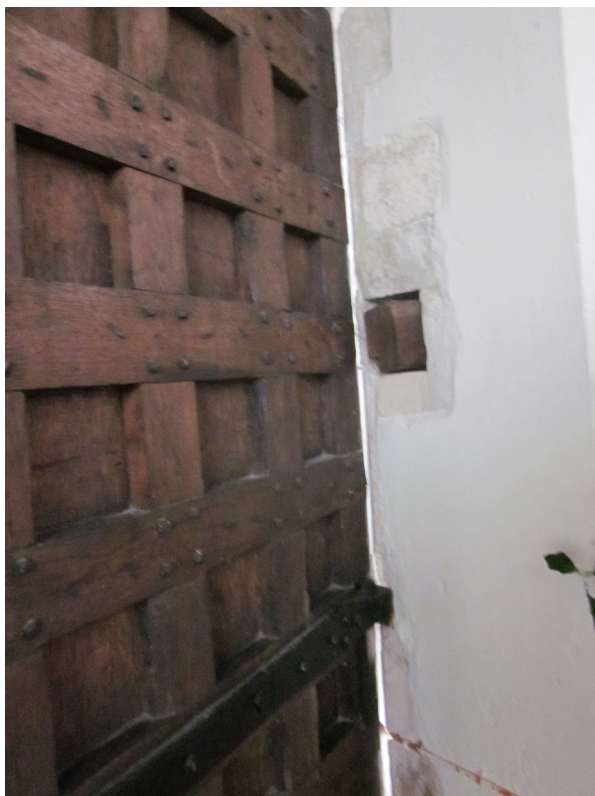
Figure 2.15

Figure 2.15. (Table 2.1). Acle church in Norfolk (TG 401 103) reveals a bar lock hole in its south nave doorway. The visible hole is in its west jamb. The door would appear to be more recent in age than the hole.

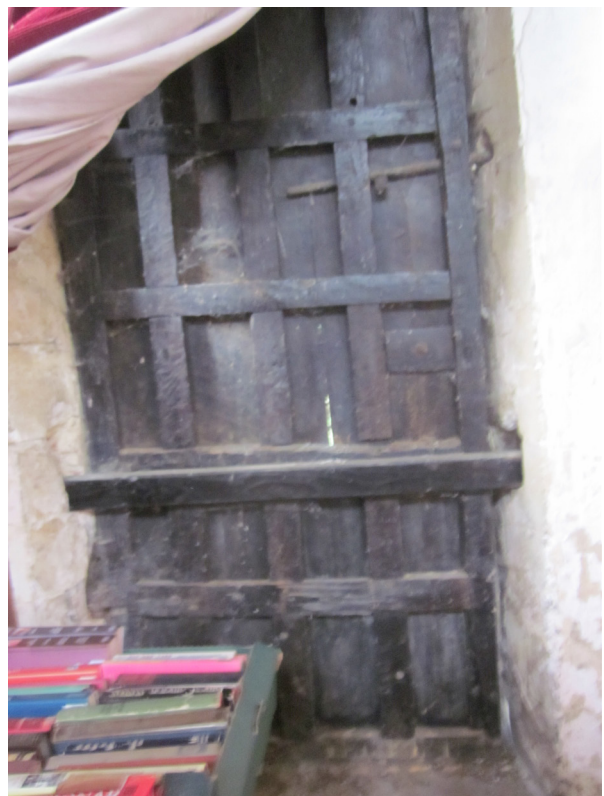
Figure 2.16

Figure 2.16. (Table 2.1). A relatively modern wooden bar is in place in this north nave aisle doorway at the church of St Andrew, Bedingham, Norfolk (TM 285 934). The door and the bar lock holes are of different ages with the worn holes the earlier. Note, a short iron bar is used additionally high on the door, using the bar lock principle to the east jamb.

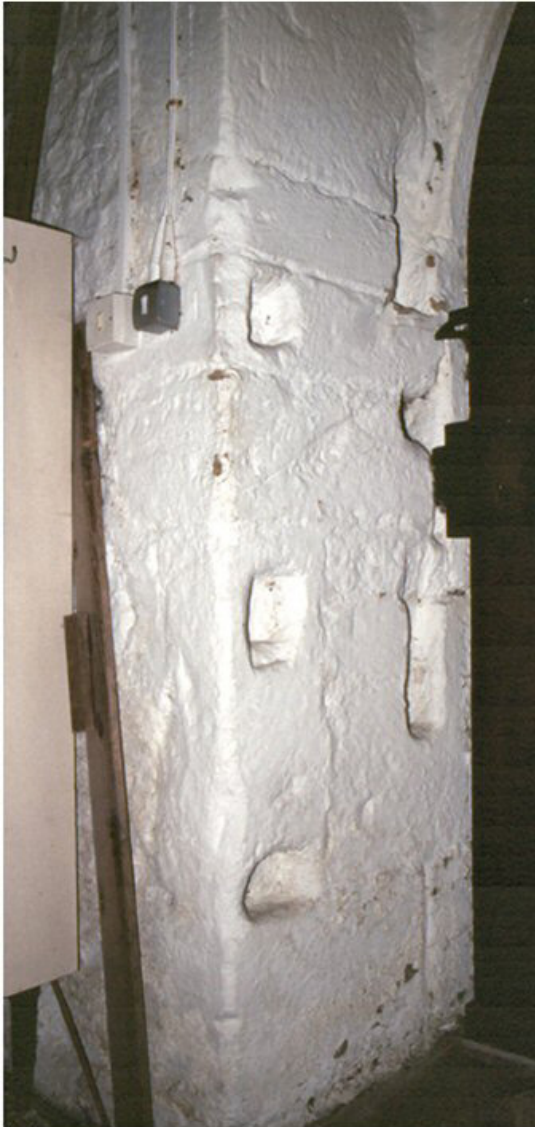
Figure 2.17. (Table 2.1). Dr Brooke kindly provided this photograph of the complex bar locks visible on the west door of Bywell, St Peter church, Northumberland (NZ 049 614). These would appear to relate to the bar provision for two adjoining doors: the farthest from the camera with the door rebate only visible over the top of the door, indicates that this door opened towards the viewer (the two lower bars would replace the requirement for the rebate to continue to the bottom of the door). The closure nearer to the camera appears not to have a rebate but the photograph fails to show the uppermost area of the door. The older parts of the church are described in Potter (2016, 26-7); the tower was built in the 13th C.

p. 188	Bywell church, St Peter, 14th C. west tower, west doorway with evidence of three draw bars (See <b>Figure 2.17</b> ).
p. 191	Newburn church, evidence of probably 14th C., blocked doorway mid-level tower to nave, draw bar on tower side.

The instance of the church of St Peter, Bywell (Figure 7.9 and Table 2.1, Figure 2.17), reveals typical interpretation difficulties (Brooke, 2000, 187-189). Brooke suggests the west tower in particular 'bears the typical hallmarks of a defensible refuge'. The church fails to display, however, any evidence of ever being defended. A few hundred metres to the north of St Peter, stands St Andrew's, and this church (Figure 7.10) provides barely any indication of being defended. If the locality had undergone a period of destruction or lack of security, its effects would be expected to be shown in both churches.

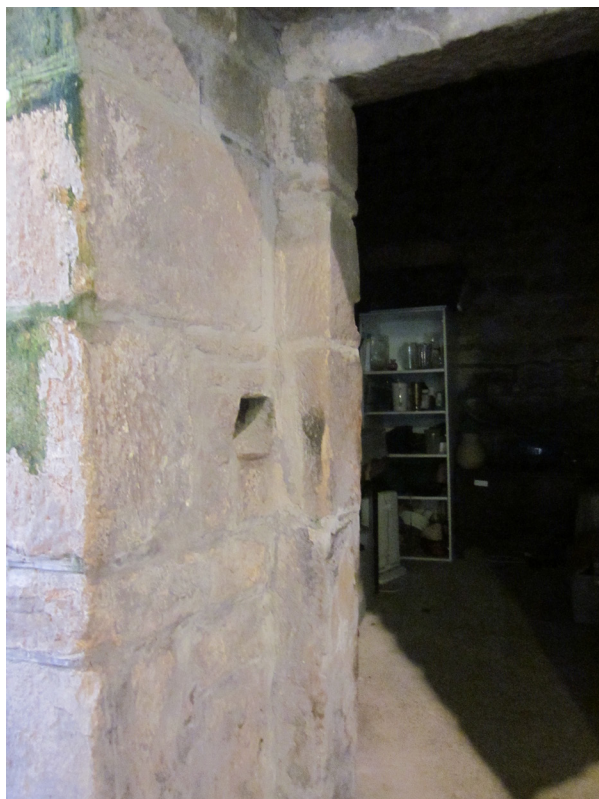
Figure 2.18. (Table 2.1). Edlingham church in Northumberland (NU 114 091) possesses a west nave doorway which now leads to the later (probably late 13th C) west tower. The bar lock hole on the south jamb is visible. It presumably pre-dates the tower and from the stonework of the doorway is likely to be of Anglo-Saxon age.

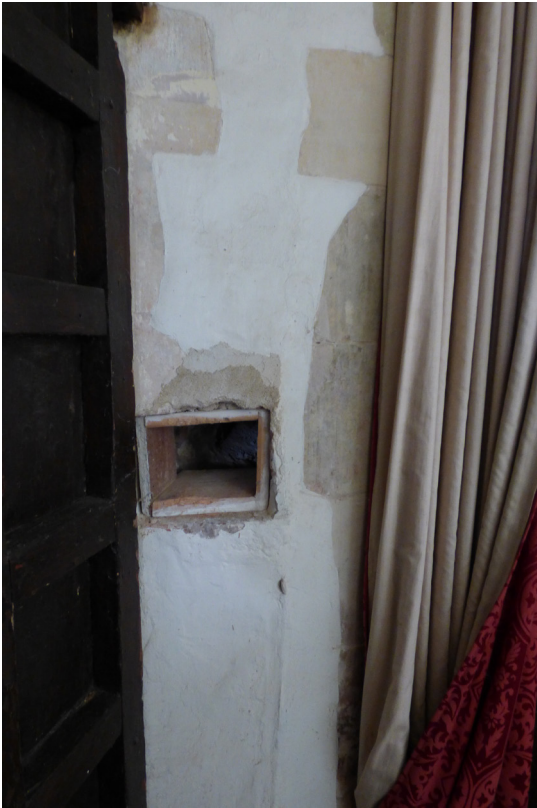
Figure 2.20. (Table 2.1). Old Newton church, and a view of the interior of the south nave doorway to show the bar lock holes. The doorway probably dates from the 13th-14th C.

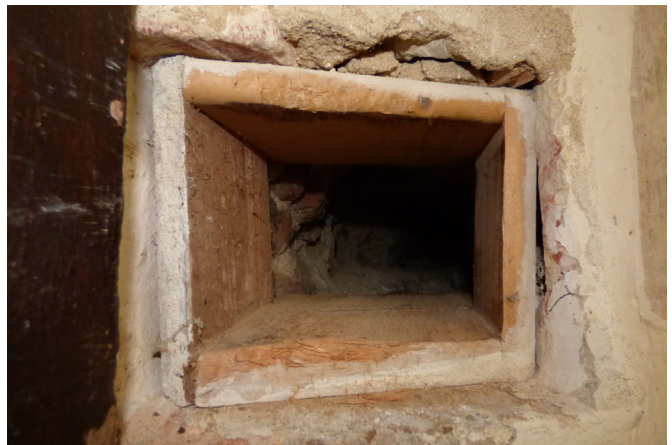
Figure 2.21. (Table 2.1). Old Newton church, detail of the west bar lock hole from the south nave doorway. The hole is lined with timber (as is the east hole) to permit easier movement of the bar. The lining was probably inserted about Victorian times.

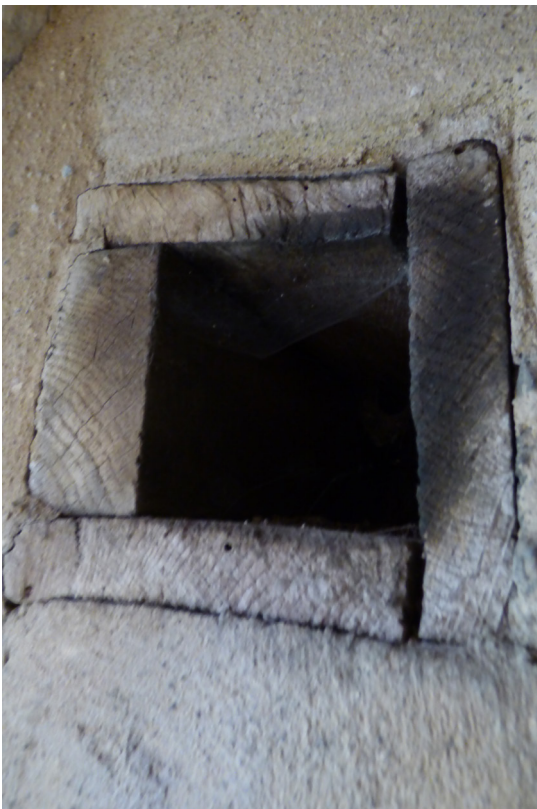
Figure 2.22. (Table 2.1). This figure was also kindly submitted by M.J. Renshaw and Dr V.R. Harding. It illustrates what the author has been advised is the only window in the upper storey of the chantry chapel (the ground floor was subsequently the vestry, and is now the parish office) to the north of the chancel of St Peter and St Mary church, Stowmarket, Suffolk (TM 049 247). The chapel probably dates to the 15th C., but the window (with leaded lights) was most likely modified in the 19th C.. Bar lock holes are evident either side of this window.

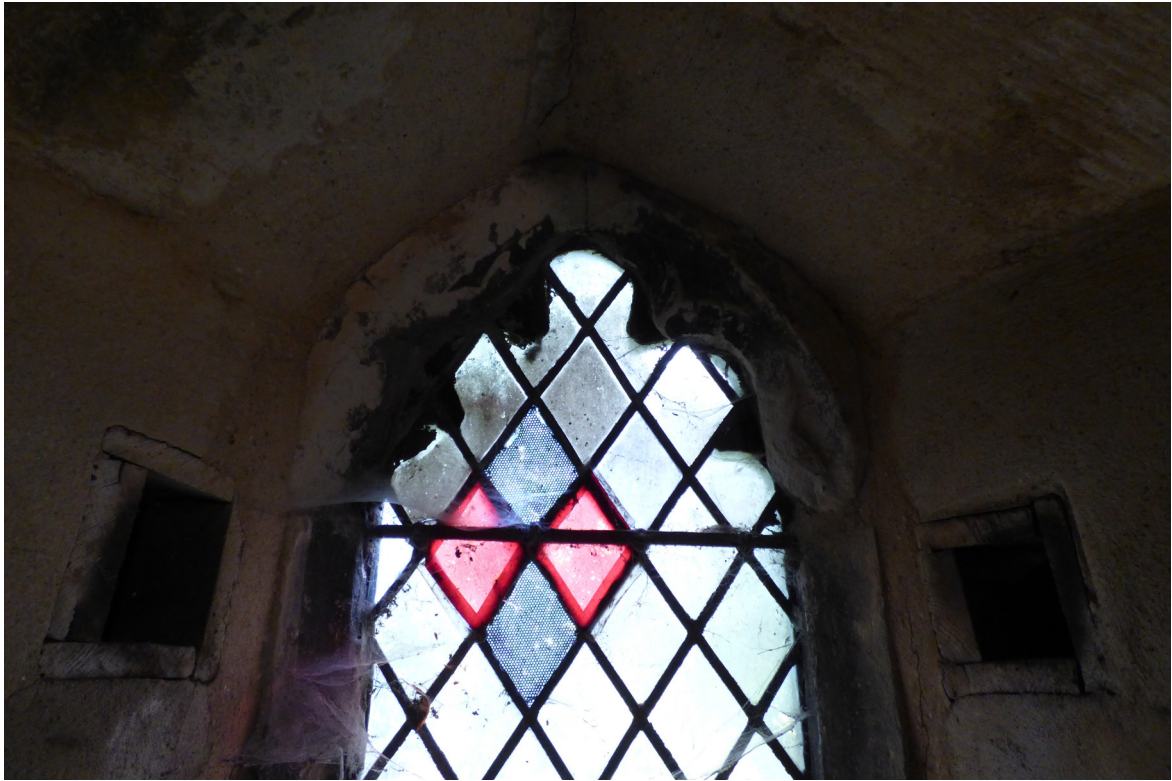
Figure 2.23

*Figure 2.23. (Table 2.1). The bar lock hole to the east of the window shown in Figure 2.22 can be seen to be lined with sawn planks. It has been suggested that the room may have once provided accommodation for the chantry priest. As to why the window should have been bar locked is uncertain but the room must at one time have been used to retain church valuables.*

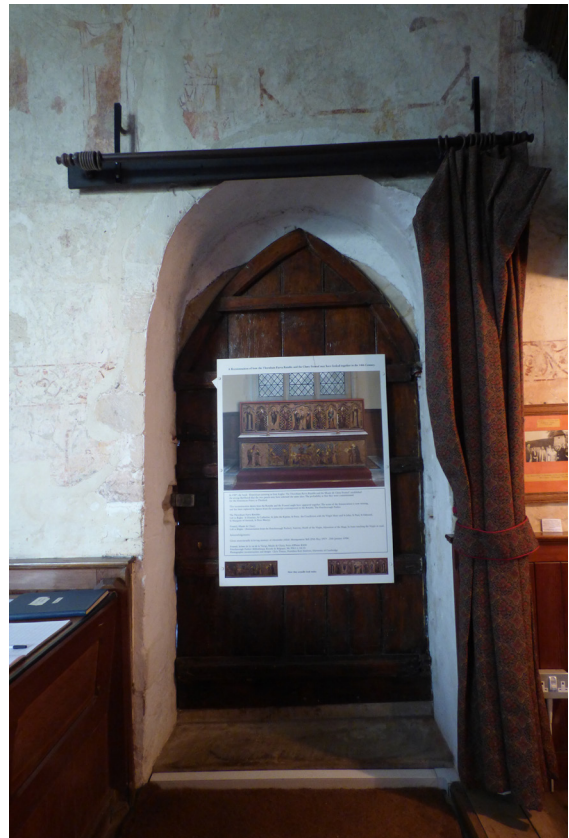
*Figure 2.26. (Table 2.1). The east side bar lock hole for Thornham Parva south nave door.*

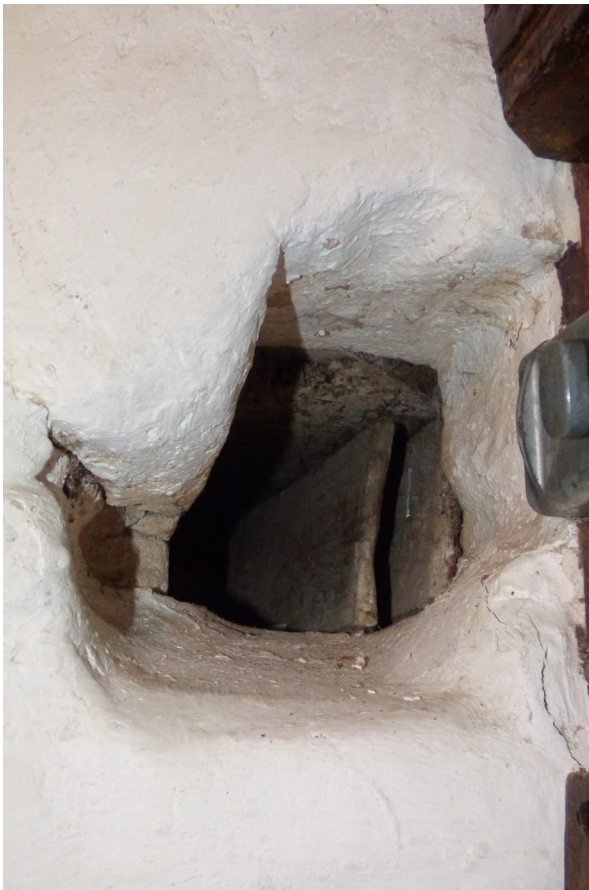
*Figure 2.27. (Table 2.1). The west side bar lock hole for Thornham Parva south nave door. The hole shows how it has been cut (probably through the earlier Norman walling) to accommodate the needs of a new bar lock and door (such as a change in door thickness or an adjustment to the door rebate).*

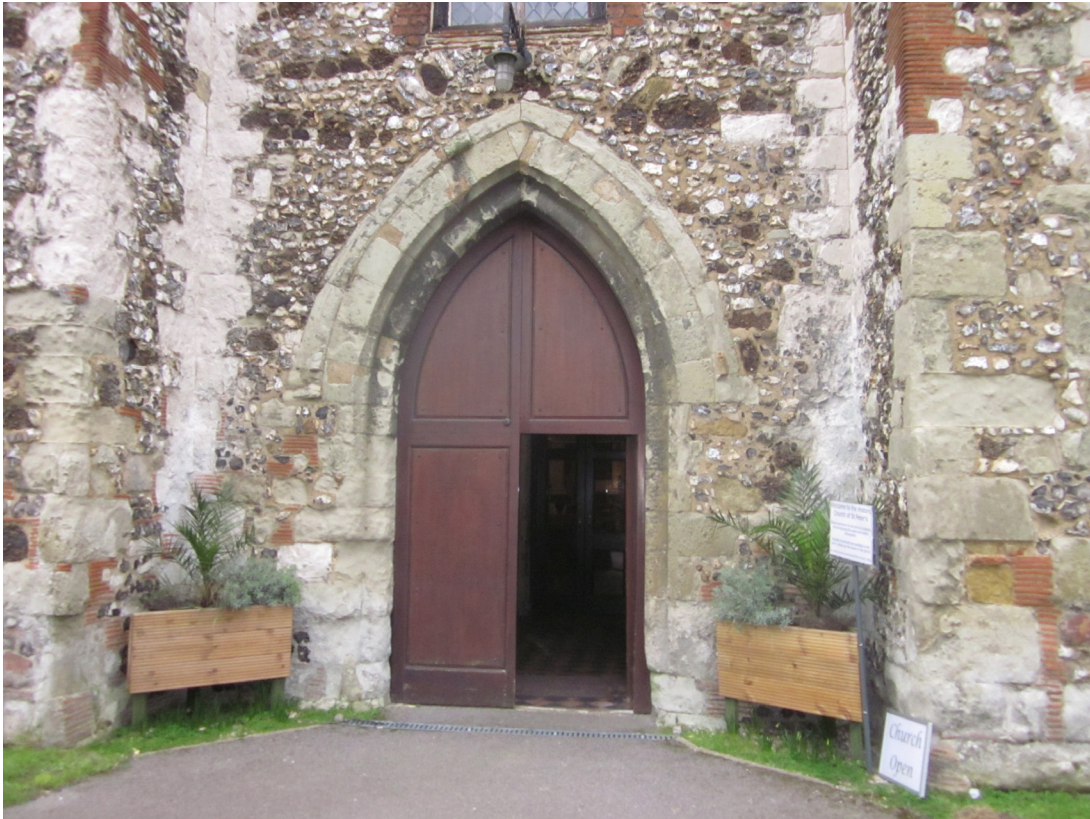
Figure 2.28

Figure 2.28. (Table 2.1). The lower part of the west tower at St Peter's church, Old Woking, Surrey (TQ 021 568) as seen from the west. Internal bar lock holes are deep (north side over a metre and into Chalk walls) and may date to an earlier structure (a porch rather than a tower) and a wider door.

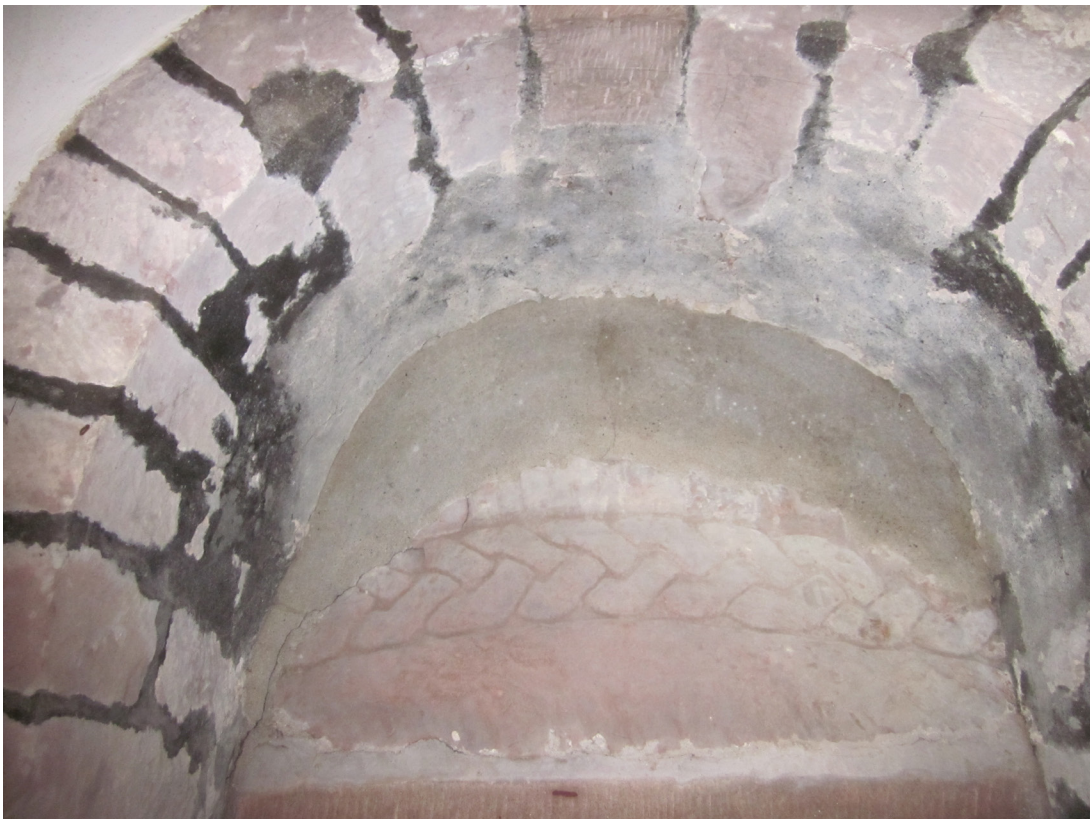
Figure 2.29

Figure 2.29. (Table 2.1). St Michael Bongate, Appleby, in Westmorland (NY 688 199), is now a private residence. Shown here is the internal view of the upper portion of the north nave doorway. Plait-work carving on the lintel stone is from an Anglo-Saxon hog-back. The door reveals bar lock holes at a lower level. The hole to take the east side of the bar is 1.32m deep which suggests that the doorway (now under a metre wide) was probably once wider.

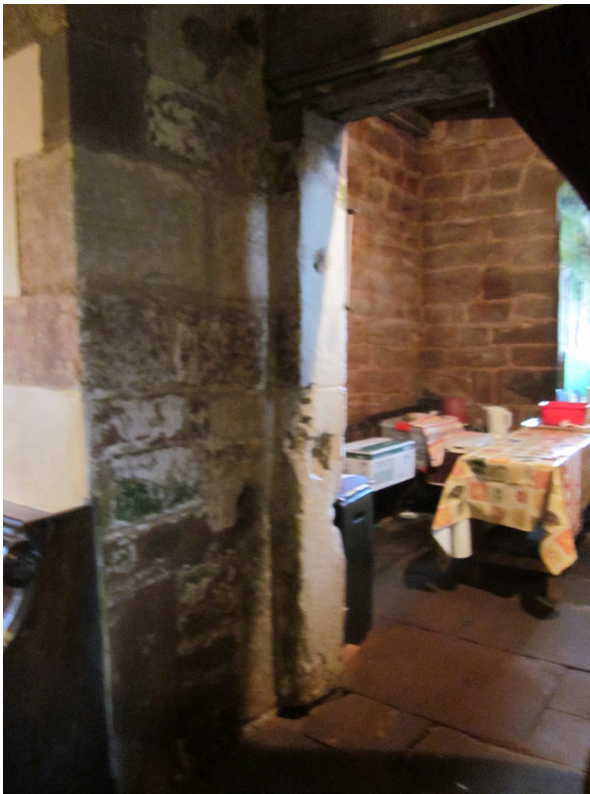
Figure 2.30. (Table 2.1). Long Marton church (NY 666 240), Westmorland, here exhibits the one time south bar lock hole for this west nave doorway, when at about table top height the bar lock hole was used to the east of the door's rebate. This hole proves to be about 1.2m deep and is presumed to be of Anglo-Saxon age. When the tower was built, about the early 12th C., the nave door probably became redundant.

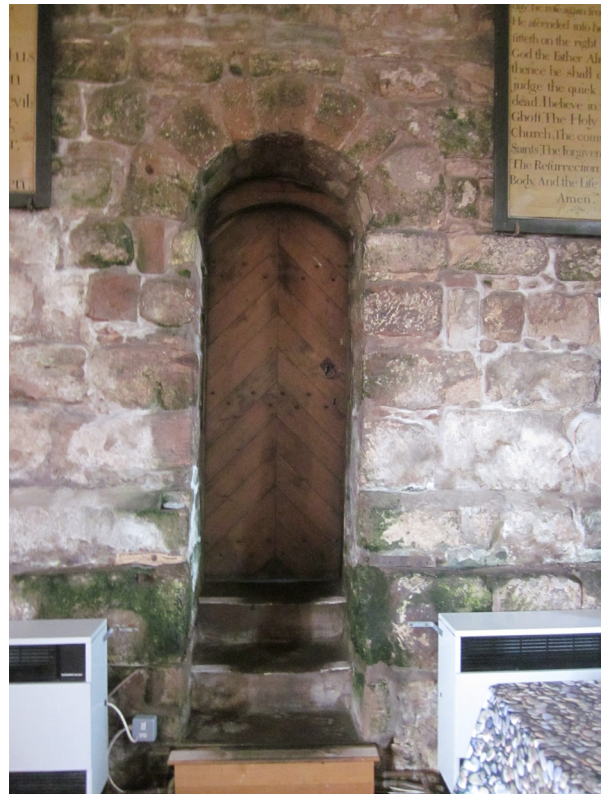
Figure 2.31. (Table 2.1). In the instance of Morland church (NY 598 225), rather than the west nave door, the locking system relates to the tower's east doorway. The tower door is reached by steps from the nave floor.

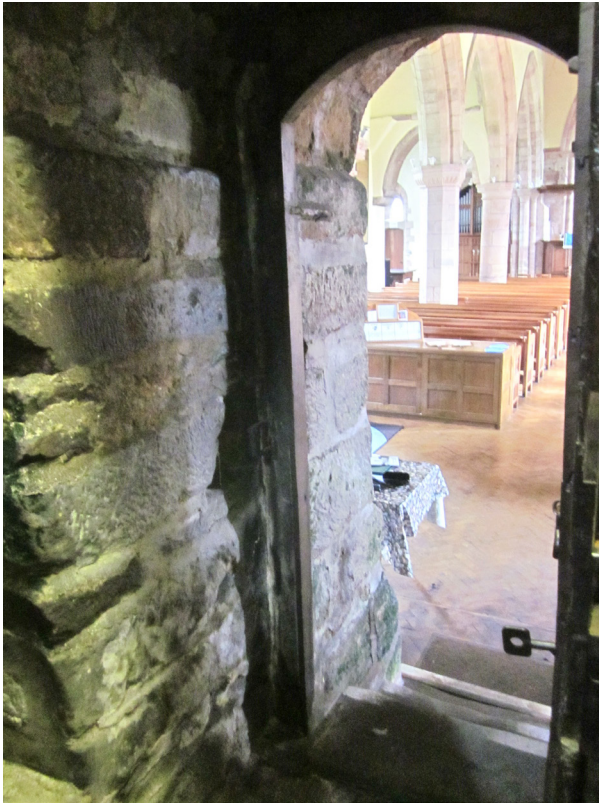
Figure 2.32

*Figure 2.32. (Table 2.1). From within the Morland church tower, a bar lock hole is here visible in the north jamb. This occurs inside, in turn, the door and its rebate. The tower was probably originally a separate building from the church.*

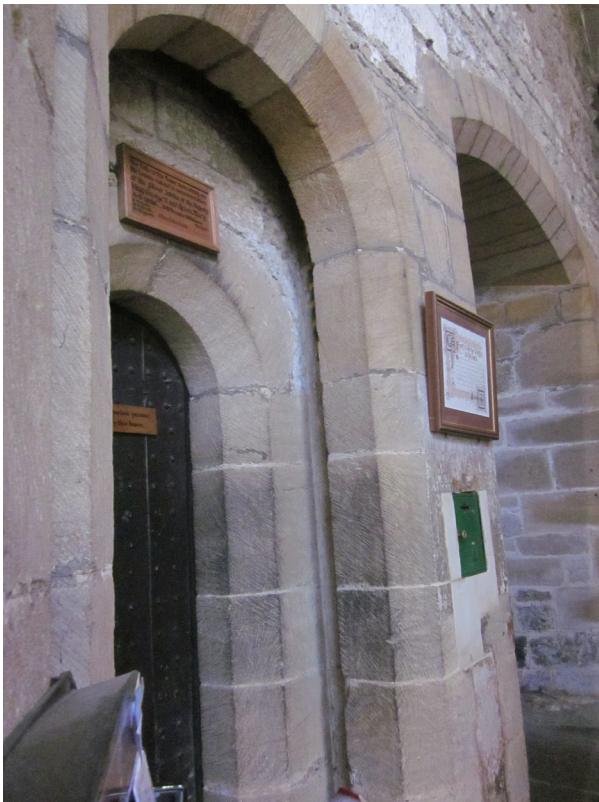
Figure 2.34

*Figure 2.34. (Table 2.1). The Bedale church doorway illustrated in Figure 2.33 proves to contain a portcullis within a groove in the doorway's structure (only discovered when the portcullis fell). The portcullis would have barred the access to the higher levels of the church.*

- d. Other features, such as the portcullis seen at Bedale church, Yorkshire (see Figure 2.34), designed to prevent unwanted communication. These are rare in churches but common in castles.

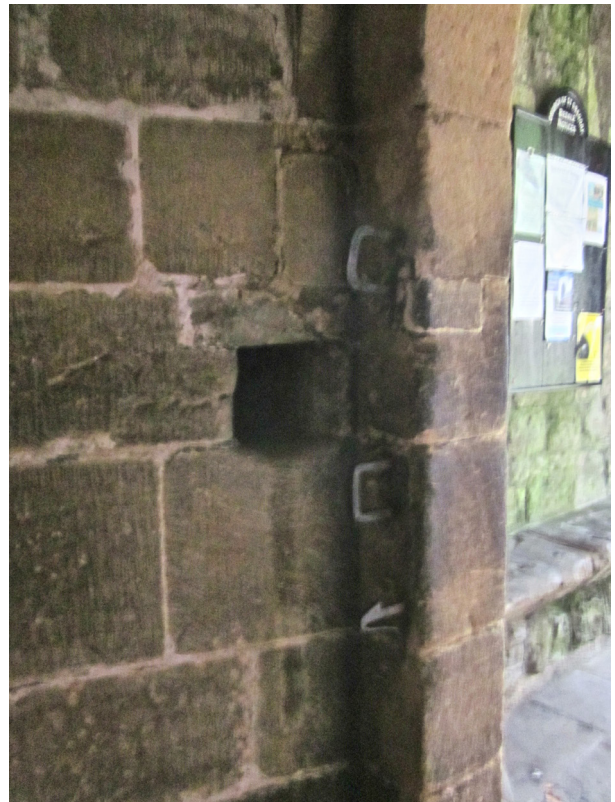
Figure 2.35

*Figure 2.35. (Table 2.1). The doorway between the porch and the tower at Bedale church provided further protection. On the east jamb of the doorway the presence of a bar lock hole is revealed. The protective structures all appear to relate to a period of around the first quarter of the 14th C.*
