# Bar Locks and Early Church Security in the British Isles

John F. Potter

Access Archaeology

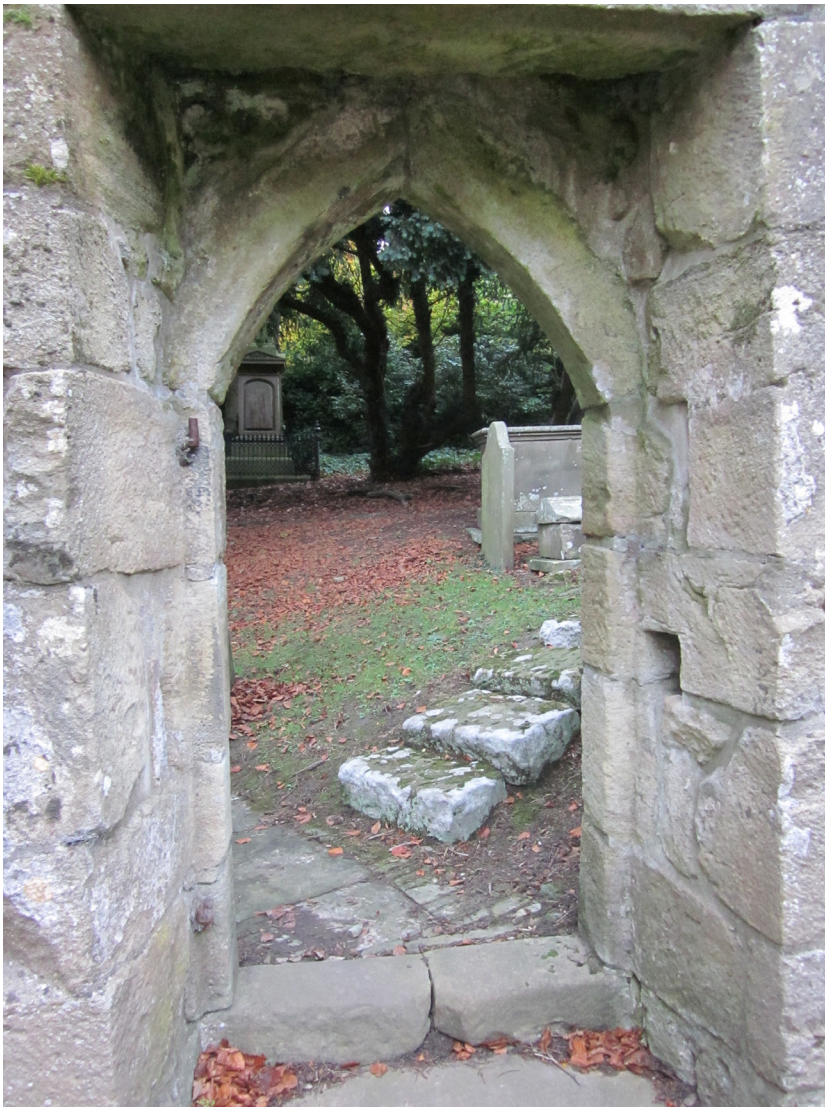
*Figure 2.36. (Table 2.1). The disused church at Pateley Bridge, in Yorkshire (SE 164 656) retains the bar lock holes for three doorways. Shown here is the north doorway, with the bar lock hole in its east jamb.*

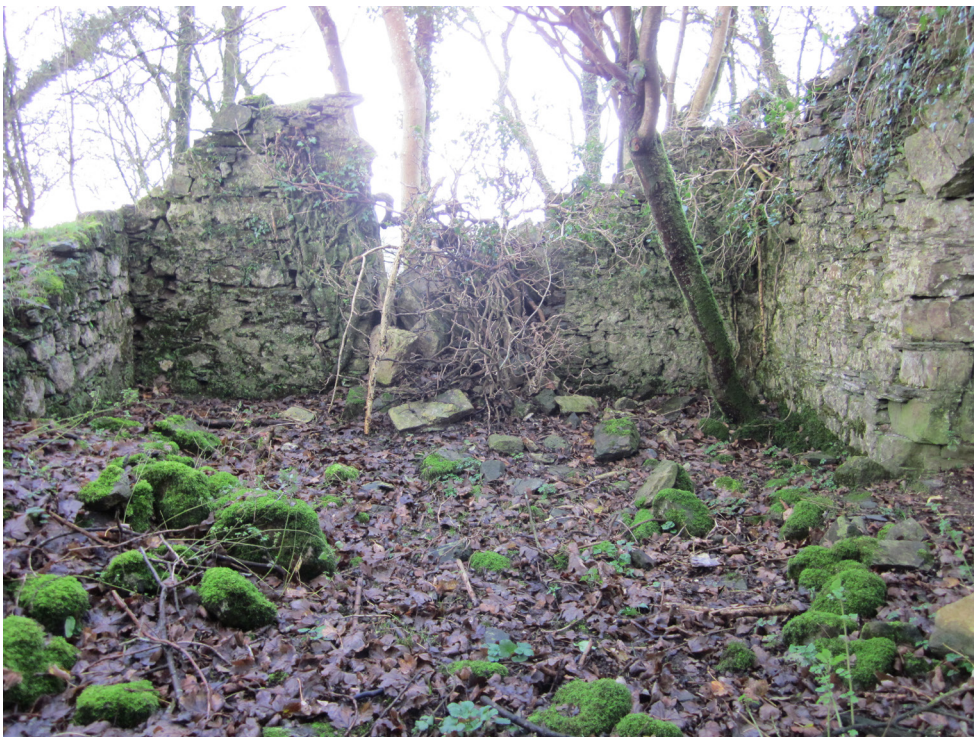
Figure 4.2. (Table 4.1). Capel Bettws is here viewed to show the interior of the nave and the position of the west doorway. Over the last few years the wall surrounding the west door has collapsed and the draw bar holes are no longer visible.

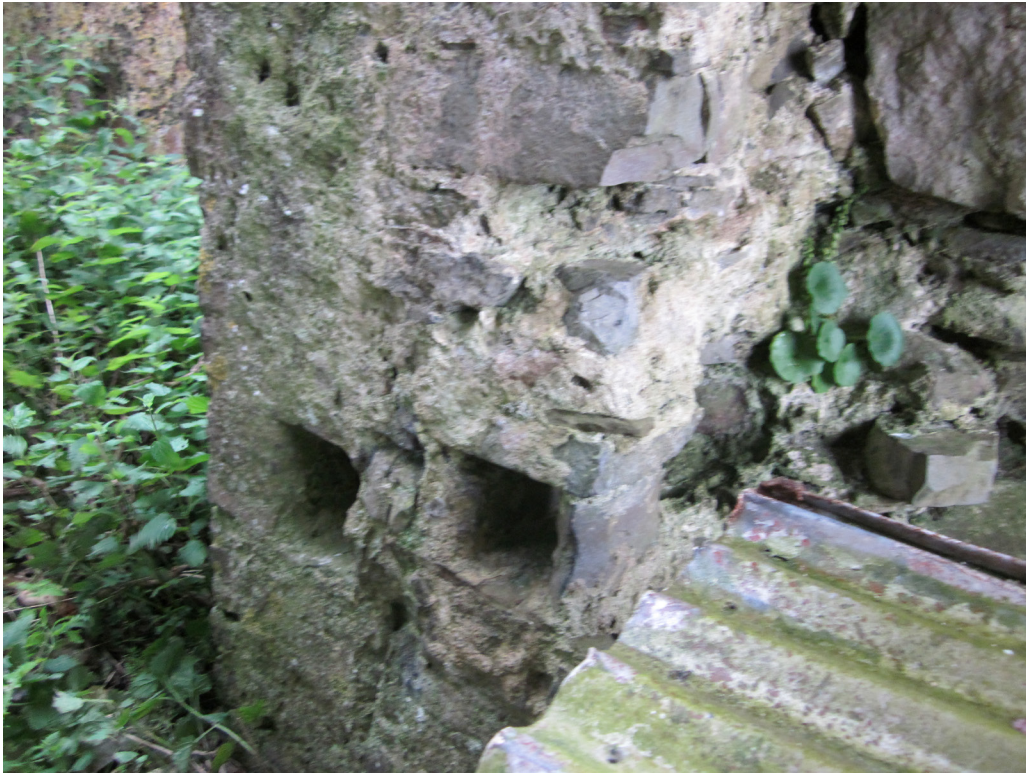
Figure 4.5. (Table 4.1). From within Capel Dyddgen tower the bar lock holes of the south jamb of both the one time west nave door and the tower's eastern door (the nearer) may be seen. The relationship reveals that the chapel originally terminated at its west door, but with the addition of the tower that was to become the secure stronghold by placing a further bar locked doorway at the tower's eastern entrance.

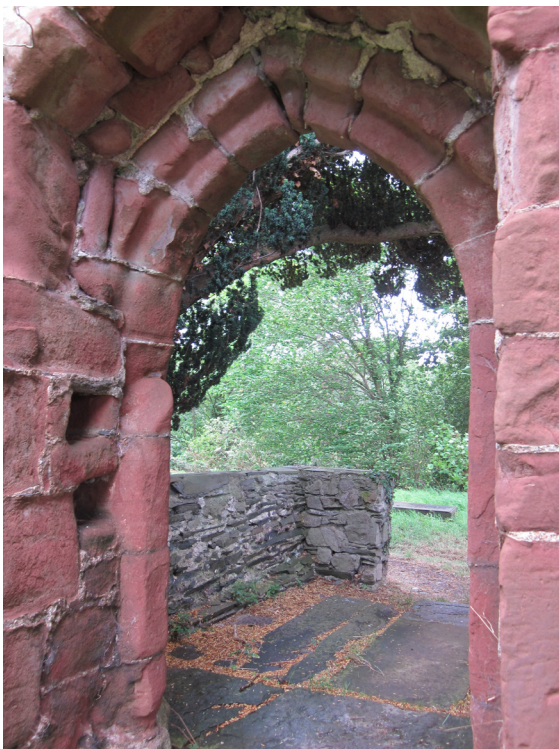
*Figure 4.8*

Figure 4.8. (Table 4.1). The south doorway to the extended Llanbedr Dyffryn Clwyd church is built of local red Triassic sandstone, in a position just west of the south wall's junction with the 'Denbighshire Grits'. Two bar lock holes are shown in the east jamb of the south door, the upper one probably succeeding the lower in its use (the sandstone is relatively soft).

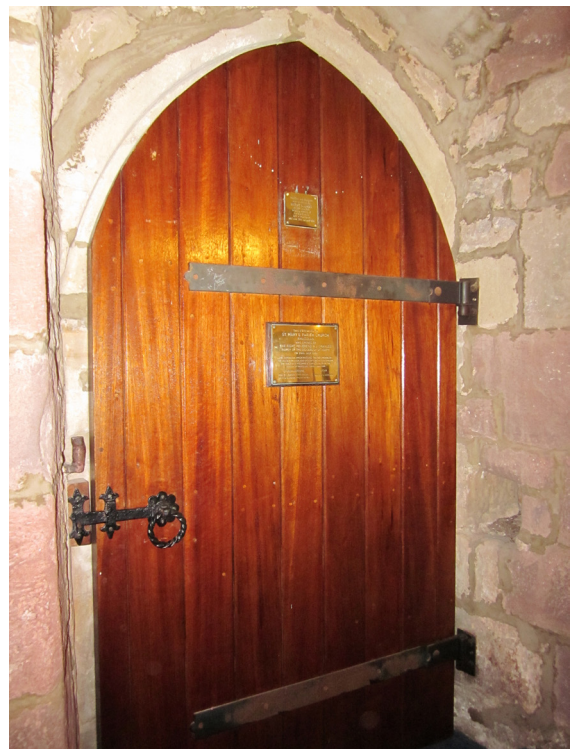
*Figure 4.9*

Figure 4.9. (Table 4.1). The church of St Mary, Rhuddlan, Denbighshire (SJ 021 781) is double-aisled. The north aisle was regarded as having been constructed in the 15th C., but building work in 1981 uncovered a doorway, probably of 13th C. date. The door concerned possesses bar lock holes which once secured this doorway, these occurring mid-way up each jamb.

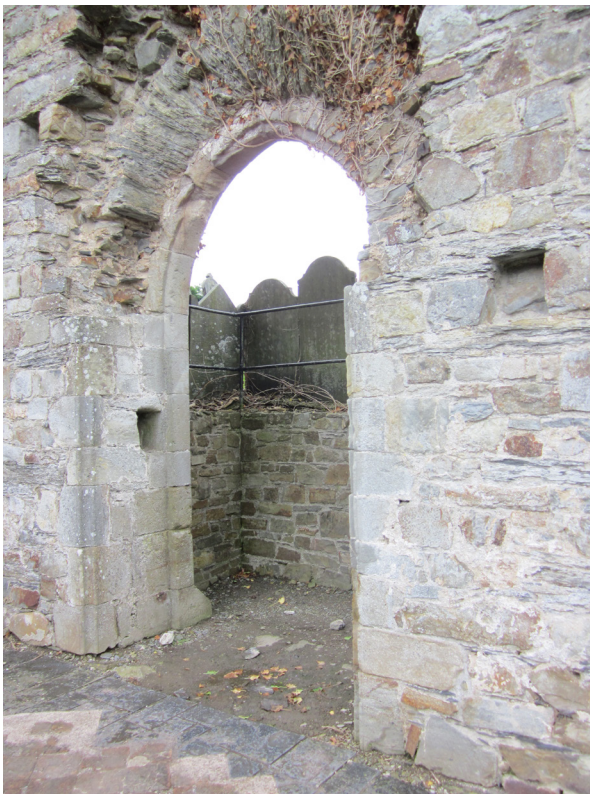
Figure 4.10. (Table 4.1). The Benedictine abbey church of St Dogmael, Pembrokeshire (SN 164 458) is also a ruin. This doorway is preserved towards the western end of the northern wall of the nave and is here viewed from the inside to show the west jamb and a bar lock hole.

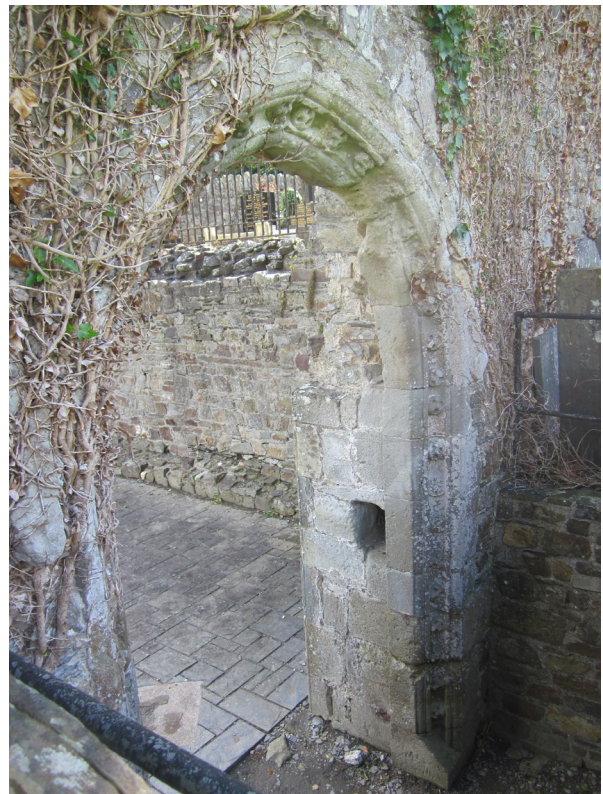
Figure 4.11. (Table 4.1). This view of the St Dogmael nave north door shows the appearance of the same bar lock hole from the exterior.

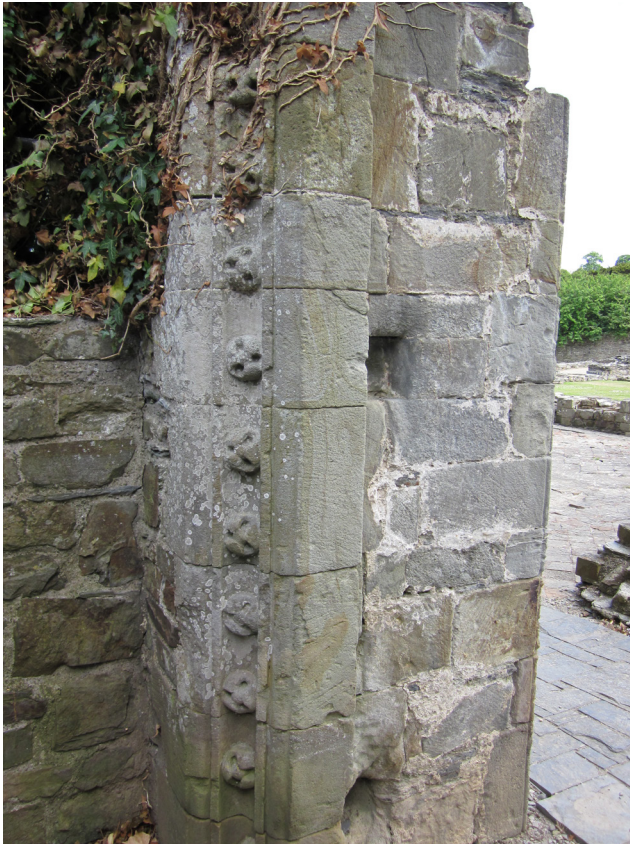
Figure 4.12. (Table 4.1). The same north nave door at St Dogmael church viewed to show the east jamb from the exterior. The external ball-flower ornament has been described as of late 13th C. date. A worn lower possible bar lock hole is visible towards the base of the jamb.

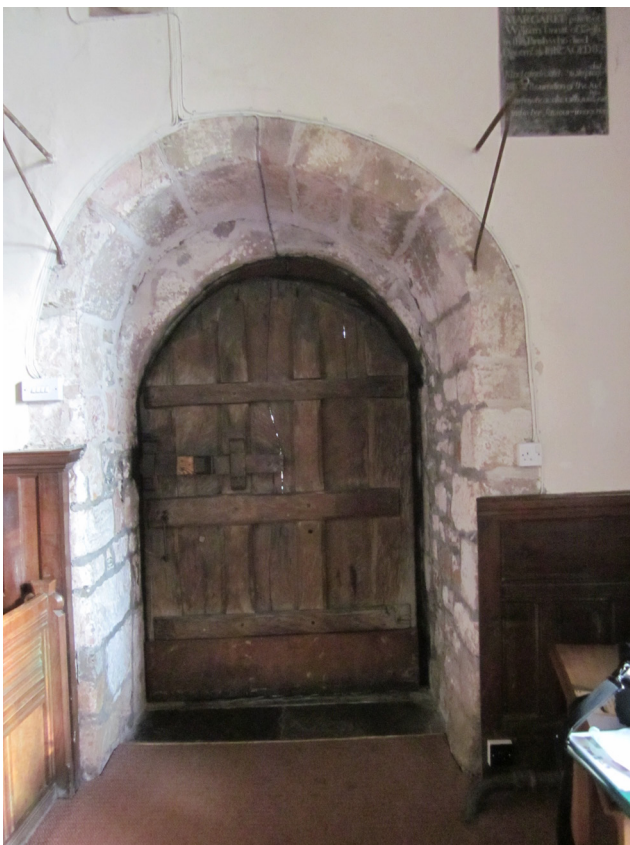
Figure 4.13. (Table 2.1). In Montgomery, the church of Llansantffraid-ym-Mechain (SJ 221 204) provides an example of a bar lock using one side of the doorway only. The bar operates into the east jamb of the south door of the nave, with the door hinged on the west. This bar lock remains in use and is poorly visible above the mid-door horizontal support. Examples of half door bar locks have been rarely observed elsewhere in these studies. Although difficult to date none of these half bar locks appear unduly old.

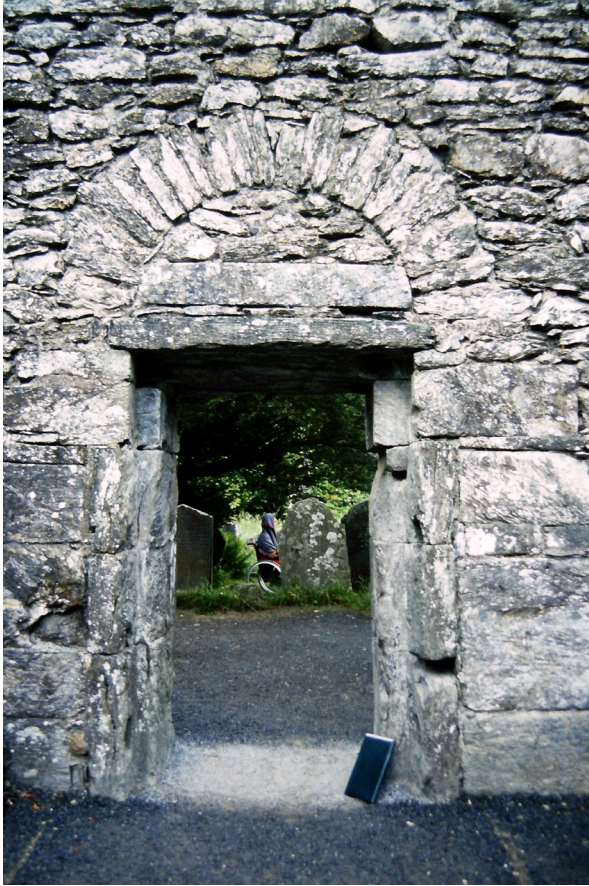
Figure 5.2. The inside of the west doorway to Glendalough Cathedral (T 123 968). The stonework is laid to typical Anglo-Saxon (Patterned) style with the exception of the doorway jambs which have been cut into and modified to provide a setting for a later door (if a date, has to be suggested in the 13th -14th C.).

However, Ó Carragáin (2010, 98, Figure 102) illustrates the interior of the west doorway to Glendalough Cathedral and draws attention to three bar lock holes on the south jamb. He writes '*... when the church was rebuilt the walls were on each jamb made considerably thicker, and as a result the draw bar holes were blocked and became redundant.*'. In July 2006, the present author photographed the same doorway from both the east (that is the interior, Figure 5.2) and the west (Figure 5.3) and holes would appear to have been blocked at that time. For significantly different interpretations as to the age of the various structures at Glendalough see Potter (2009c, 113-122).

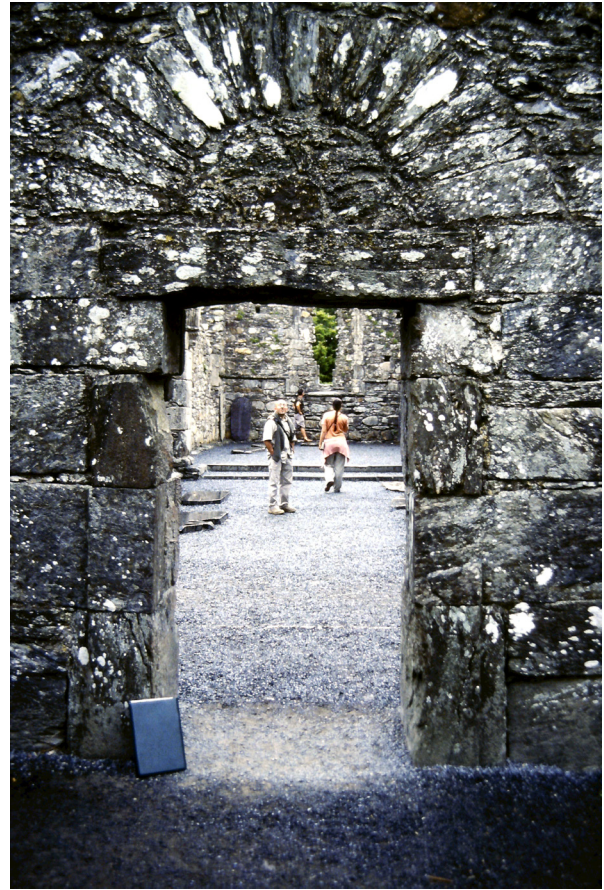
Figure 5.3. The outside of the west doorway to Glendalough Cathedral seen in Figure 5.2. The stonework is clearly to 'Patterned' style (Folder 310mm long).

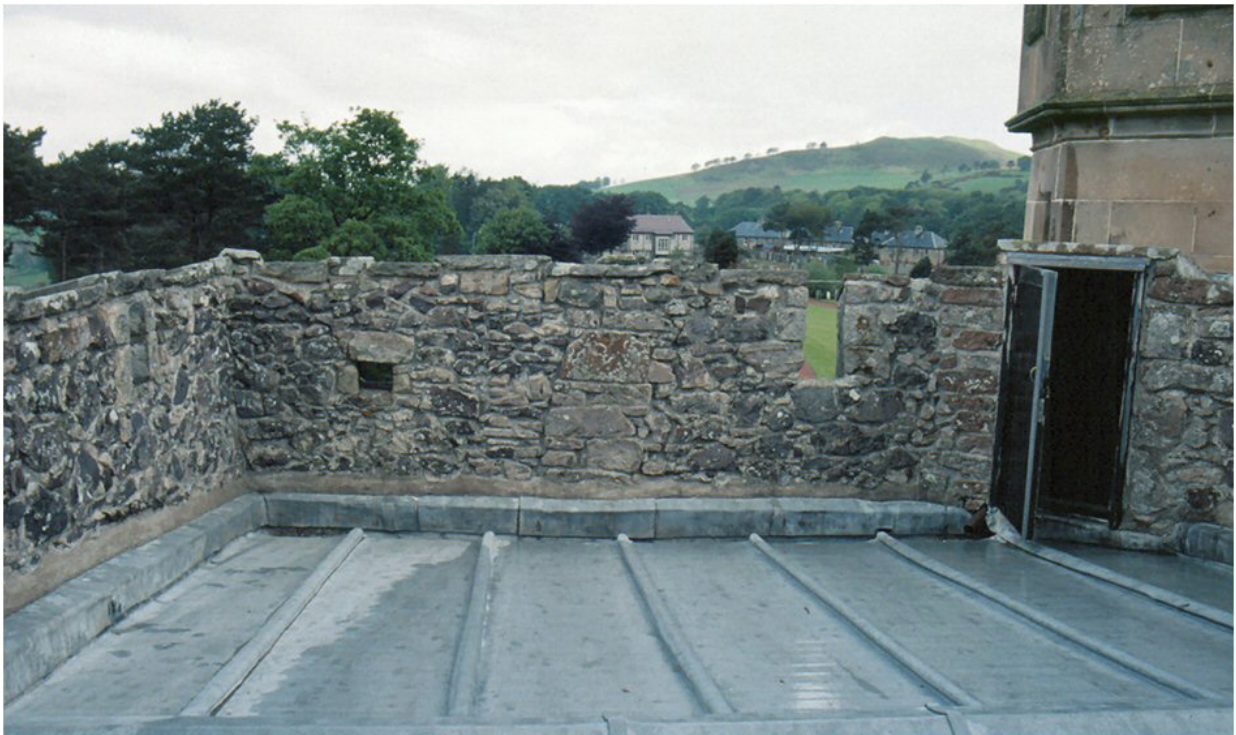
*Figure 7.3. This figure is again from Dr Brooke; it illustrates the tower parapet at Biggar church, south Lanarkshire. The parapet was clearly hurriedly built (following difficult times related to the restoration of the monarchy {1660-90} and a requirement for defensibility).*

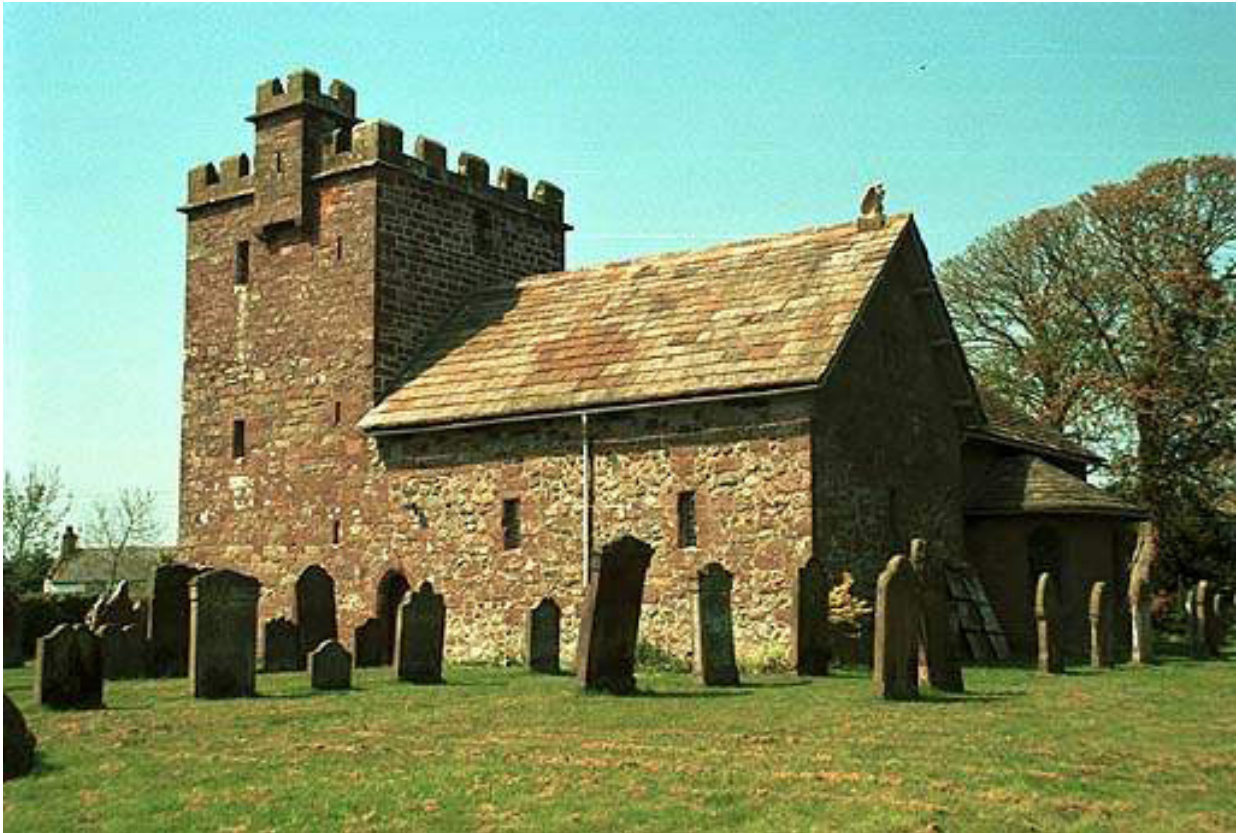
*Figure 7.4. Newton Arlosh church in Cumberland (NY 198 553) has monastic origins, and the tower at height, as kindly displayed here by Dr Brooke, carries a garderobe.*

- b. Garderobes. The present author has never seen garderobes in association with the very many churches he has viewed. They are, of course, a feature of castles and less commonly of monastic buildings. Dr Brooke advised that the church at Newton Arlosh, in Cumberland, with monastic origins has a garderobe and he kindly provided the figure (see Figure 7.4 and Harrison, 2004, 68-69).

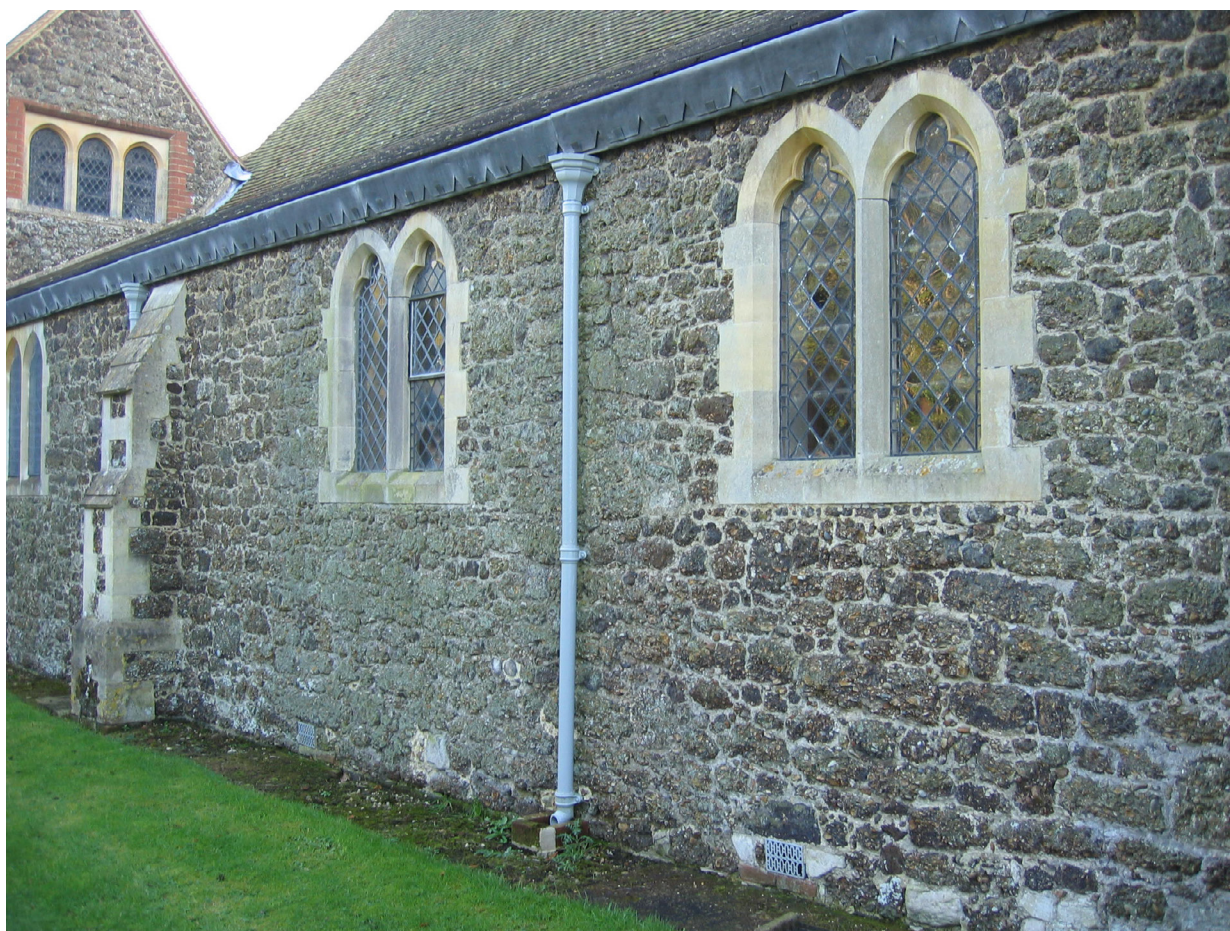
Figure 7.5. The church of St Michael, Heckfield, Hampshire (SU 723 605) has its Victorian nave walls built in ferruginously-cemented gravel. When the Anglo-Saxon walls were knocked down in 1876, their strength was such that the wall material was reused.

Wall thicknesses in early churches certainly vary. It might be thought that walls built particularly stoutly would have had defensibility in mind, but in fact much of the variety relates to the styles of building. Anglo-Saxon walls tend to be relatively thin, 'seldom as much as 3 ft' (0.914m.) 'in thickness' and 'more often nearer to 2ft 6in' (0.762m.), (Brown, 1925, 23; citation from Taylor and Taylor, 1965, 12; Taylor, 1978, 959; Potter, 2015, 22-23). Their walls remain, where still standing, of considerable strength. The church of St Michael, Heckfield (SU 723 605) in North Hampshire retains walls which were once constructed wholly of ferruginously-cemented gravel. These were situated to the north side and to the south side of the nave and each wall was little more than 0.20m (or 8in) thick. Fortunately, a churchwarden's account book of 1876 (Potter, 2001, 9-10; 2003a) described in some detail the manner in which ('very old') wall material of ferruginously-cemented gravel had been demolished to build new walls illustrating Victorian characteristics (Figure 7.5).

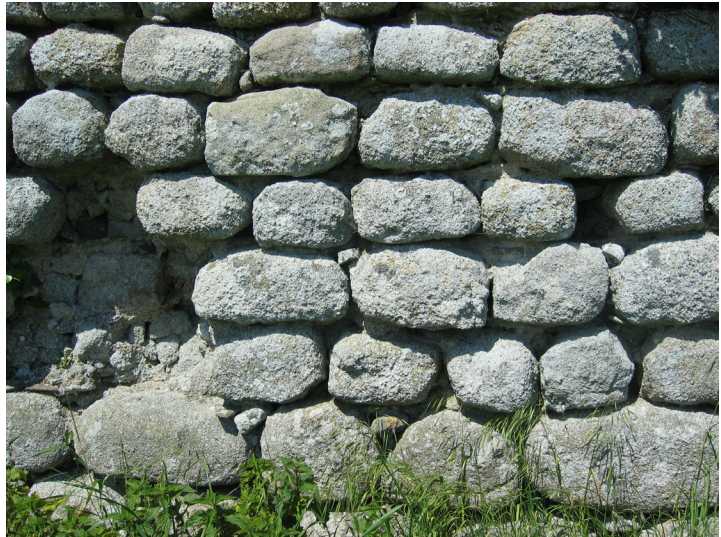
*Figure 7.6. The Norman walls of the ruined Agha church, Carlow (S 730 654) in Ireland. The outer walls consist unusually of well-fitted boulders of hammered granite but their interior is only of rubble of limited strength.*

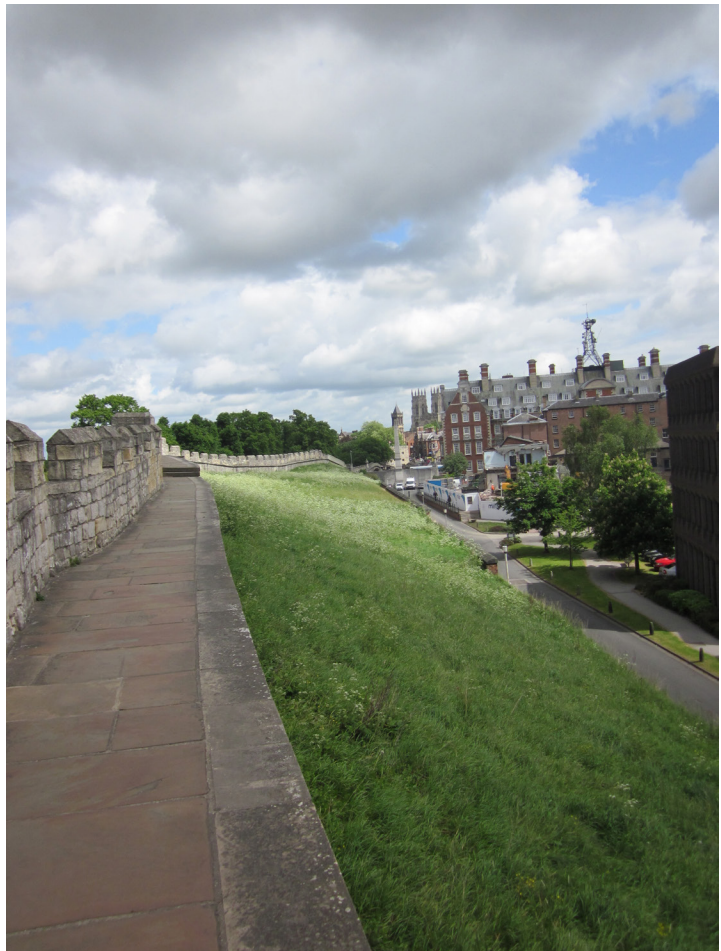
*Figure 7.7. View north, of the rampired walls, City of York.*

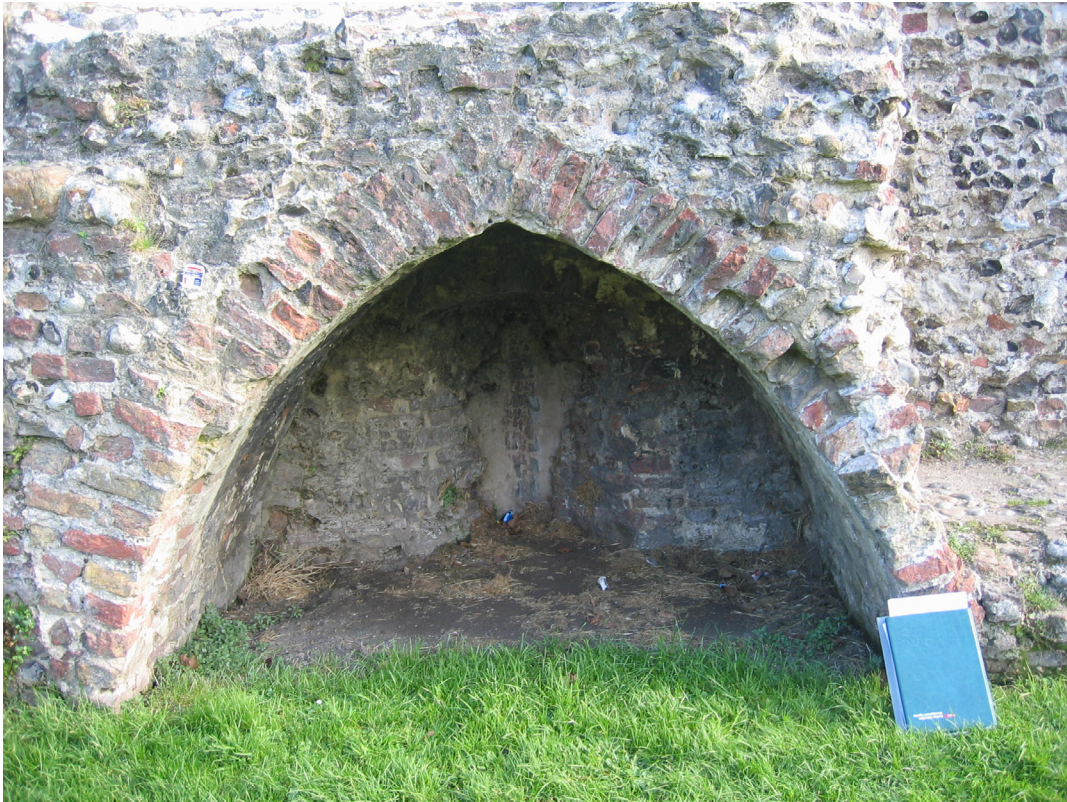
*Figure 7.8*

*Figure 7.8. With the removal of rampires as shown here at Great Yarmouth, some defensive systems, as gun emplacements and arrow slits were retained in the walls.*

Other factors more effectively modified the strengths of walls; the skills of the masons erecting the walls varied, but in particular the masons' choice of stones was critical. Different rocks vary enormously in their ability to offer protection against both random and wilful damage. For most walls, therefore, it is difficult to assess their quality or ability to defend ecclesiastical buildings. The situation can differ, however, where, as with more extensive town walls, new techniques in warfare may be employed. At much the same time as other cities, the walls of York were provided with rampires (Figure 7.7). The walls of Great Yarmouth were studied in detail by the author (Potter, 2008a, Table 1.1). There, historically, initial building commenced in the late 13th C. with a murage grant helping to create the early walls of both bricks and flints. The first rampiring (building of earthen ramps on the lower inside of the walls of the City to protect their collapse by gunfire) commenced at Great Yarmouth in 1544. Both wall arrow slits and gun ports were built into the lower levels of the rampired wall (Figure 7.8).

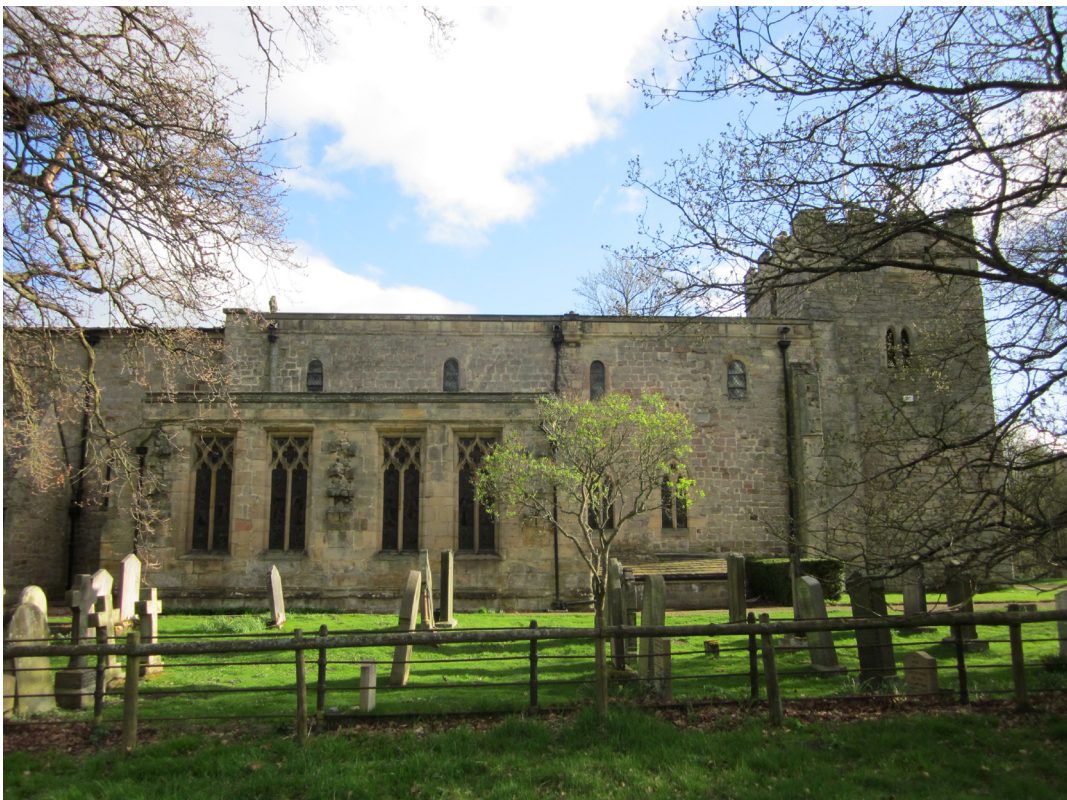
*Figure 7.9*

*Figure 7.9. The church of Bywell, St Peter (NZ 049 614), see also Figure 2.17, stands by the north bank of the River Tyne. Three of the four of the round-headed windows on the north side of the higher levels of the nave are of Anglo-Saxon build. Brooke (2000, 187) dated the tower to the 14th C. and indicated the presence (his text Figure 99) to a set of 'draw-bar' slots in the west entrance. A view down into the nave was once served by a small lancet, now blocked. He concluded that the tower was a 'defensible' refuge but doubts must remain as to whether the church was ever defended*

The instance of the church of St Peter, Bywell (Figure 7.9 and Table 2.1, Figure 2.17), reveals typical interpretation difficulties (Brooke, 2000, 187-189). Brooke suggests the west tower in particular 'bears the typical hallmarks of a defensible refuge'. The church fails to display, however, any evidence of ever being defended. A few hundred metres to the north of St Peter, stands St Andrew's, and this church (Figure 7.10) provides barely any indication of being defended. If the locality had undergone a period of destruction or lack of security, its effects would be expected to be shown in both churches.

-	Traces of once higher roof lines to nave and chancel
Modern, rebuilt	High level door tower/nave, in Anglo-Saxon style. Keyhole window south tower wall <b>See Figure 8.22</b>
Probably 14 <sup>th</sup> - early 15th C	Roof of thatch <b>See Figure 2.15</b>
12th - 13th C	<b>See Figure 2.16</b>
Probably 16th C	Three Anglo-Saxon windows above the north arcade (not that rebuilt to the west) <b>See Figures 2.17, 7.9 and Brooke (2000, 187-8)</b>

Bywell, St Peter* See Figure 7.9	Northumberland	NZ 049 614	Three windows above the north arcade (not that rebuilt to west)	Anglo-Saxon

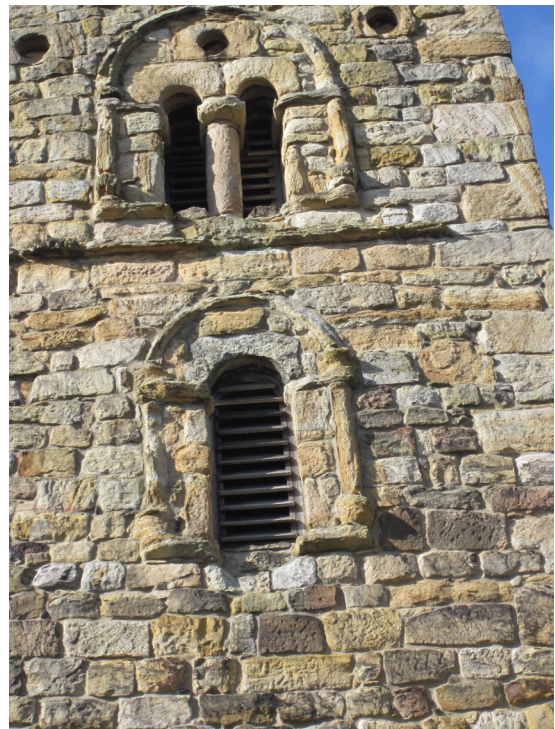
*Figure 7.10. St Andrew's church, Bywell (NZ 048 615), see Tables 1.3 and 2.1, retains its Anglo-Saxon tower (Potter, 2016, 22-26) and characteristics which include a south facing belfry outlined in strip work and a doorway opening into space. Brooke (2000, 187) suggested that the south doorway may have been secured by two draw-bars, now plastered over and not seen by the present author.*

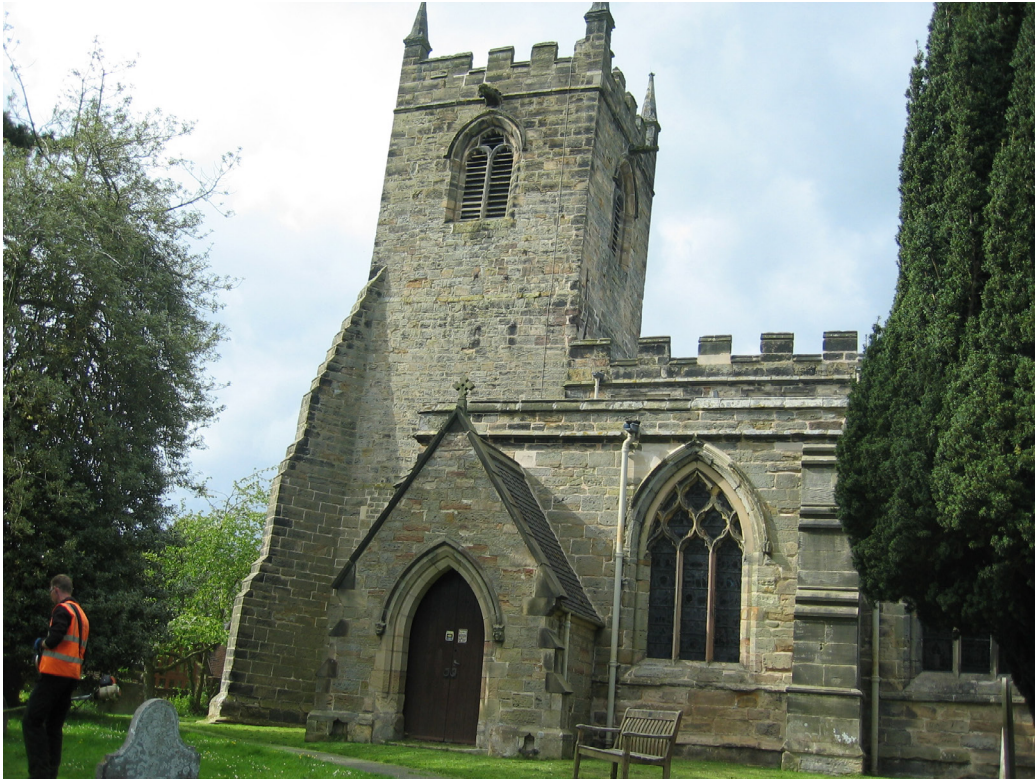
Figure 8.1. (Table 8.1). Aston by Trent church, Derbyshire (SK 414 294), and its tower viewed from the south-east.

-	Blocked 14th C or later arch above tower arch. Possible knife sharpening exterior south wall on buttress <b>See Figures 8.1, 8.2</b>
Possibly 15th C	Higher level passage way above chancel arch (Anglo-Saxon) <b>See Figures 2.5, 8.3</b>
Mid 14th C Brewer's Door, late 14th C	<b>See Figures 2.6 to 2.9</b>
Late 13th- early 14th C	Both holes infilled

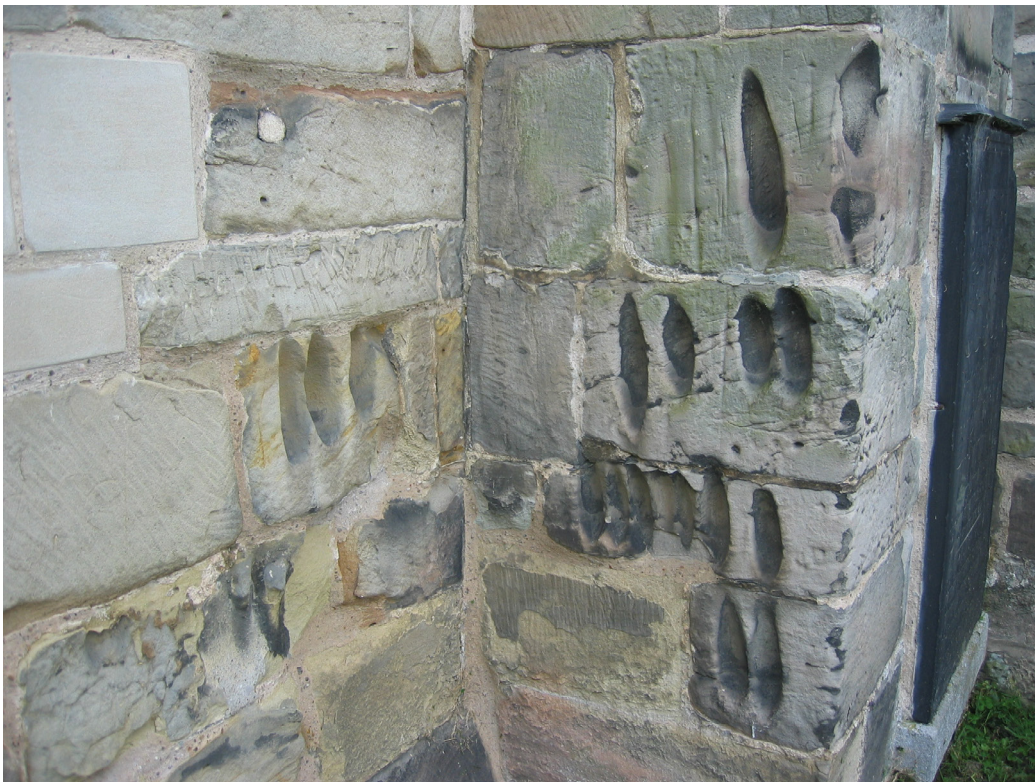
Figure 8.2. (Table 8.1). On this Aston by Trent buttress, at the join of the nave south wall and the chancel, the stonework has been used for possible sharpening.

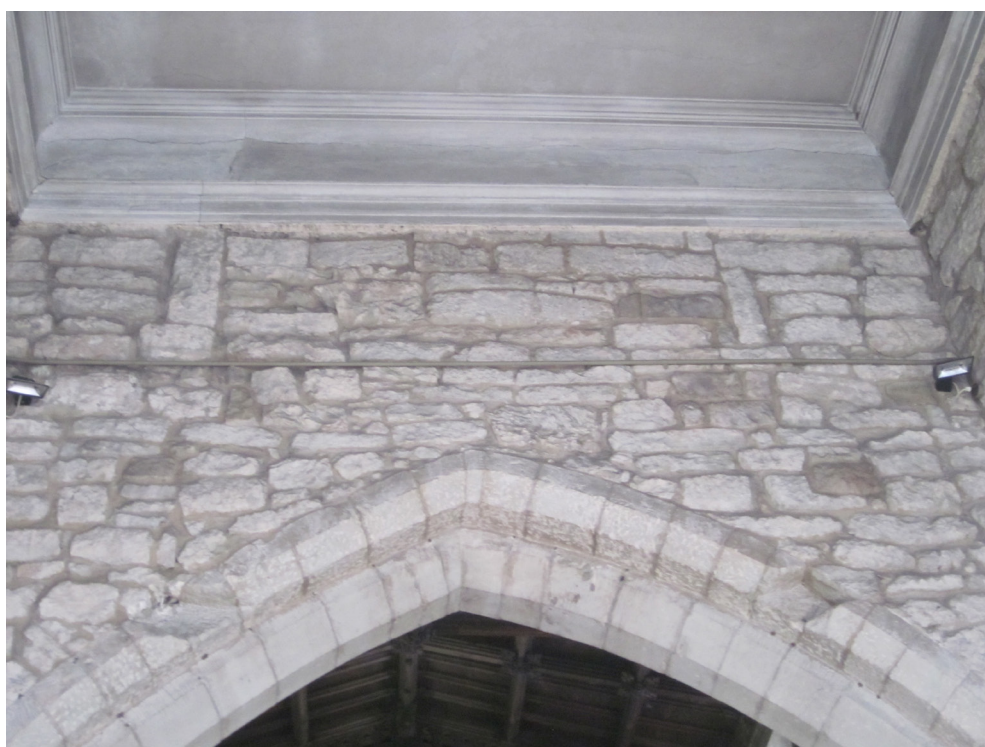
*Figure 8.3. (Table 8.1). The chancel arch at Repton church (SK 303 272) when viewed from the east shows traces centrally of a higher, Anglo-Saxon blocked smaller arch.*

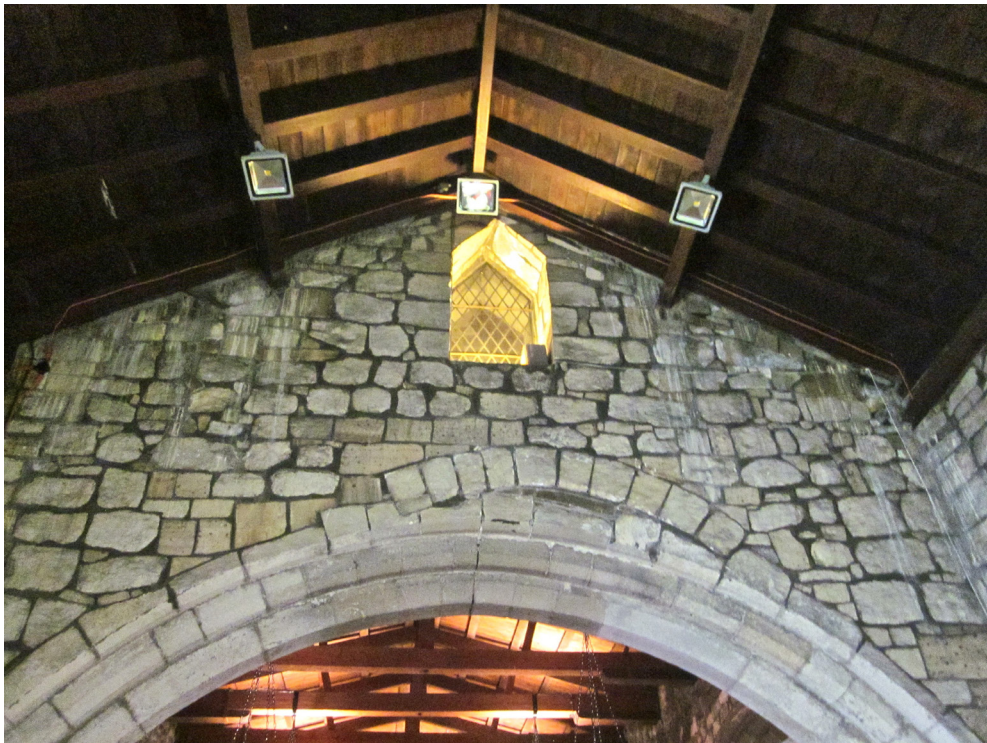
Figure 8.4. (Table 8.1). Hart church, Durham (NZ 470 357) showing the Norman chancel arch and, as seen from the chancel, above it traces of an earlier chancel arch and a triangular doorway. The triangular doorway typifies Anglo-Saxon work, but this doorway has been rebuilt, for all jamb stones are laid BH.

-	North jamb of west nave doorway used as whetstone
-	Triangular doorway above chancel arch probably modified in Norman times. Chamfered lancets probably 13th - 14th C <b>See Figure 8.4</b>
Both similar Post-Norman-pre 14thC	Aisle door west hole deep <b>See Figure 2.10</b>

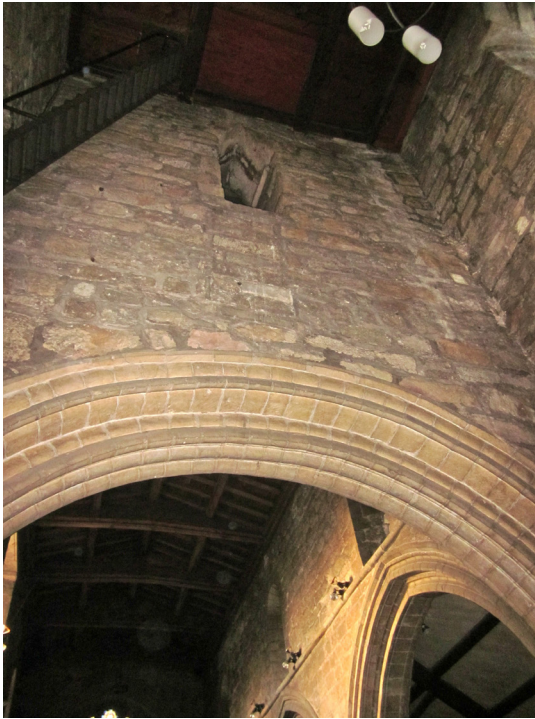
Figure 8.5

Figure 8.5. (Table 8.1). Norton church (NZ 442 221), in Anglo-Saxon style, has the lowest walls of its square tower broader than the adjoining adjuncts, so that all four quoins of the tower are visible. The areas above all four arms of the church (nave, chancel, and both transepts) were it appears accessible from the higher floors of the tower by means of triangular headed doorways. In this view the high doorway over the arch to the nave may be seen from the tower.

-	Triangular doorways (four) from tower at high level (Anglo-Saxon). Also tower windows <b>See Figures 8.5, 8.6</b>
-	Above tower arch doorway (probably 1350). Windows cut by Norman arcade (intimates pre c.1180) <b>See Figures 2.11, 8.7</b>

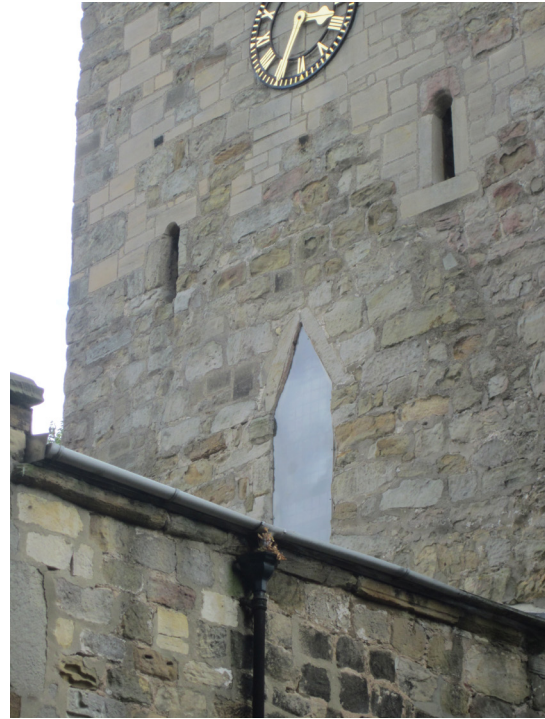
Figure 8.6

Figure 8.6. (Table 8.1). A second of the tower doorways at Norton church can be seen in this picture, where on the north side of the tower a triangular doorway once provided access to the floor over the north transept. The trace of the early transept roof can be seen on the tower's north face.

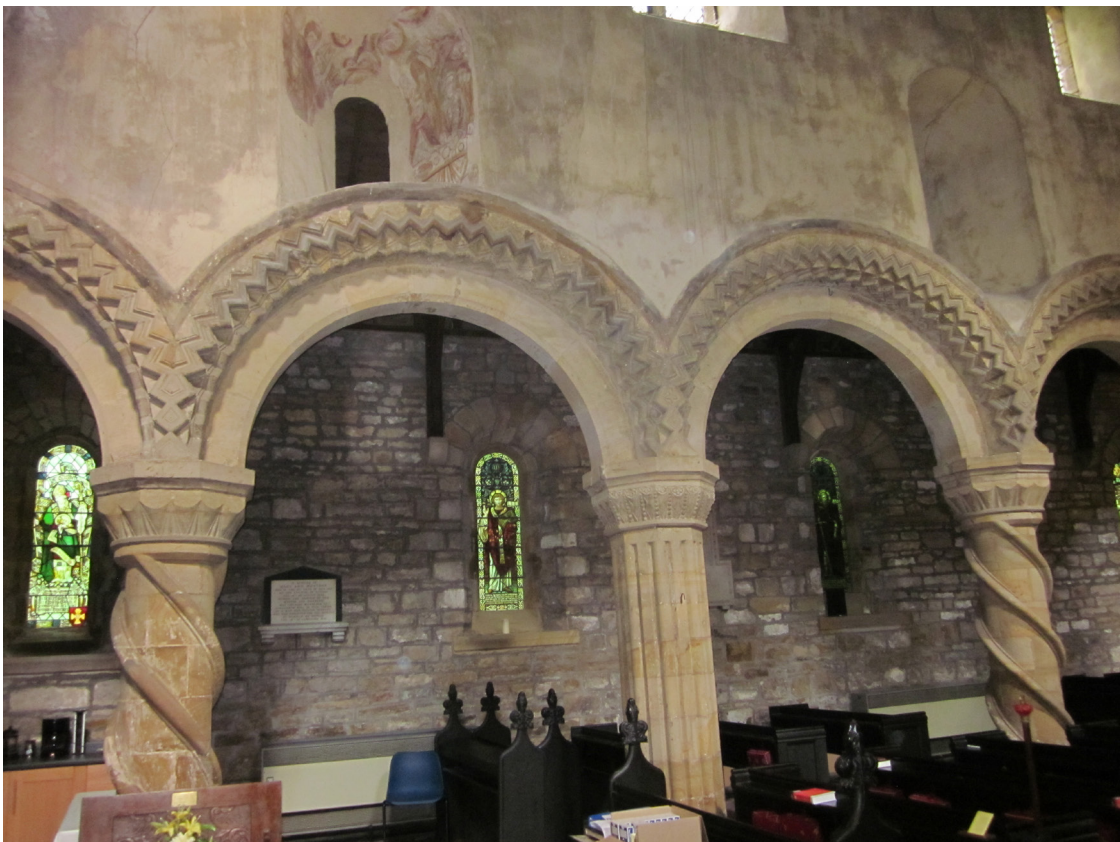
Figure 8.7. (Table 8.1). St Laurence church, Pittington (NZ 328 436) here displays one of its archaeological attractions. This elaborate Norman north arcade is thought to date from about 1180. The arcade cuts earlier windows which retain paintings probably of 12th C. date

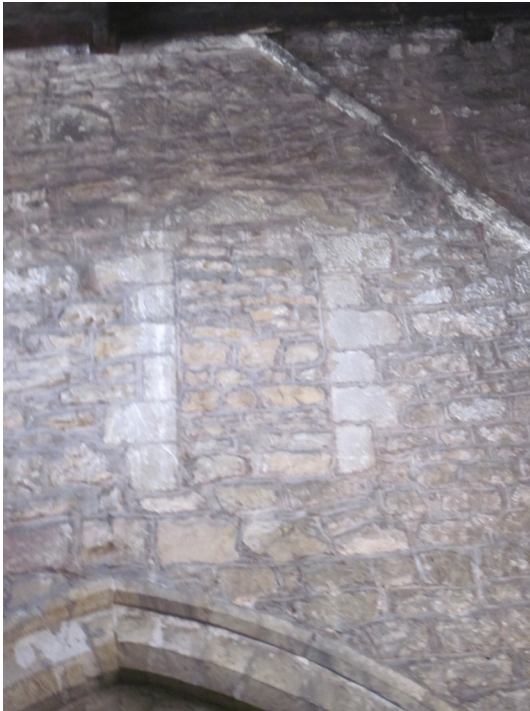
Figure 8.8. (Table 8.1). Above the tower arch at Staindrop church, Durham (NZ 131 206) an off-centre, high level doorway, now blocked, once connected to a higher level in the nave.

-	High level doors in tower and above tower arch (possibly 13th C.). Monosplay window above Norman south nave wall <b>See Figure 8.8</b>
-	Civil War (1643) musket shot holes in south nave door <b>See Figure 8.9</b>

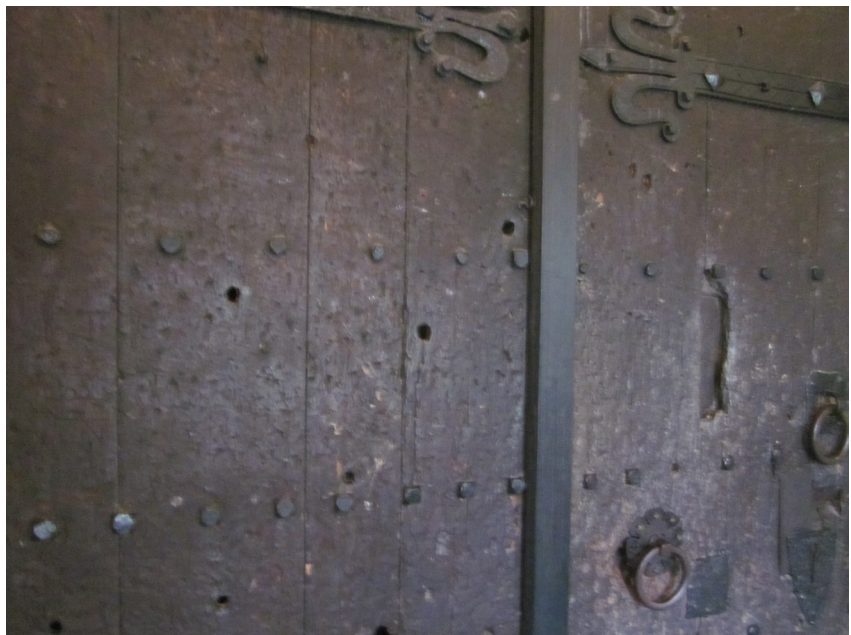
Figure 8.9. (Table 8.1). Alton church, in Hampshire (SU 717 396), where local aspects of the Civil War, in 1643, left musket shot holes on the outside of the south nave door. The door has subsequently been thickened on the inner surface.

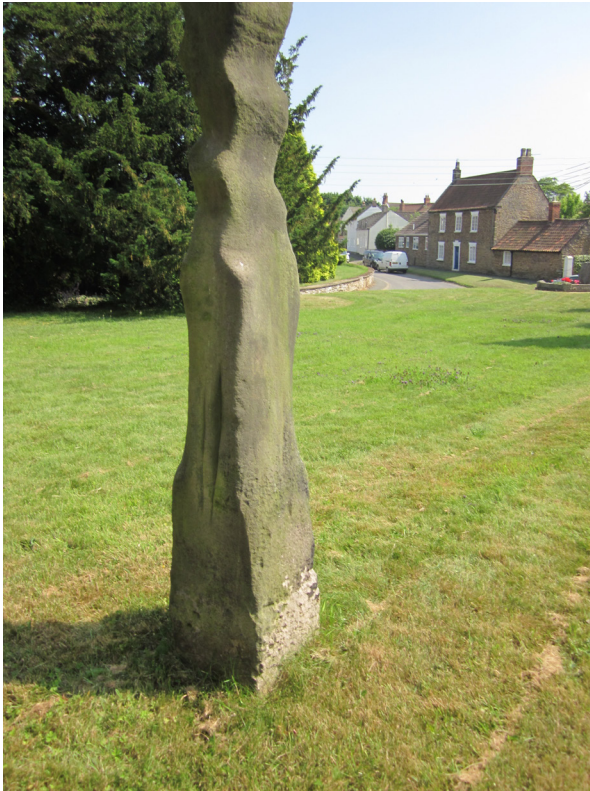
*Figure 8.10*

*Figure 8.10. (Table 8.1). In Lincolnshire, at Alkborough (SE 882 219), the village cross has clearly been much used as the village whetstone.*

-	Village Cross served as whetstone <b>See Figure 8.10</b>
-	High level window over tower arch, and Anglo-Saxon south nave wall
Post Norman – mid 13th C	Anglo-Saxon high level doors tower, and whetstone use of north jamb west tower door <b>See Figures 2.12, 8.11, 8.12, 8.13</b>
