# Bar Locks and Early Church Security in the British Isles

John F. Potter

Access Archaeology

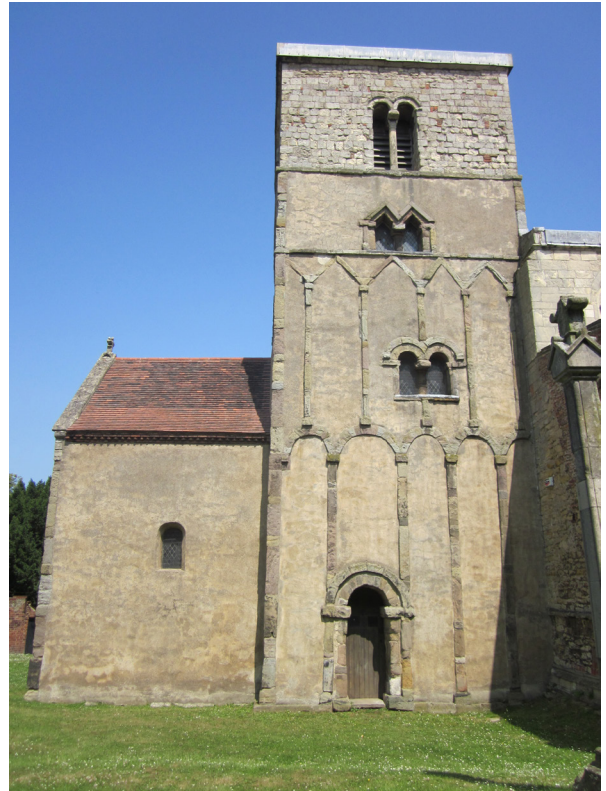
*Figure 8.11*

*Figure 8.11. (Table 8.1). The south face of both the Anglo-Saxon tower and western annexe at Barton-upon-Humber church (TA 035 219), Lincolnshire.*

-	Village Cross served as whetstone <b>See Figure 8.10</b>
-	High level window over tower arch, and Anglo-Saxon south nave wall
Post Norman – mid 13th C	Anglo-Saxon high level doors tower, and whetstone use of north jamb west tower door <b>See Figures 2.12, 8.11, 8.12, 8.13</b>

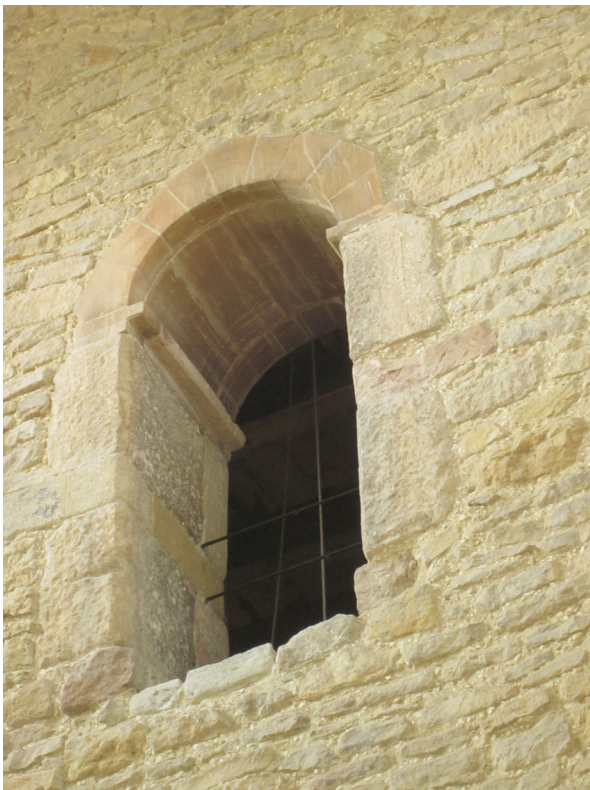
*Figure 8.12*

*Figure 8.12. (Table 8.1). On the east face of the tower, and above the tower arch, at Barton-upon-Humber church this Anglo-Saxon doorway clearly reveals its patterned stonework.*

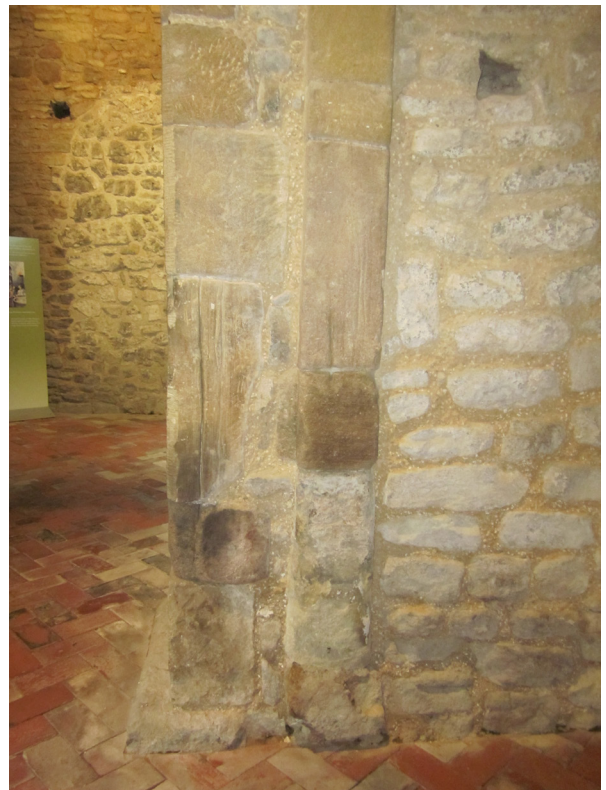
*Figure 8.13*

*Figure 8.13. (Table 8.1) The lowest stones in the northern jamb of this doorway at Barton-on-Humber church, Lincolnshire (TA 035 219) have been used as whetstones, probably for sharpening swords (note vertical cuts). The church is fully described in Potter (2015, 144-153).*

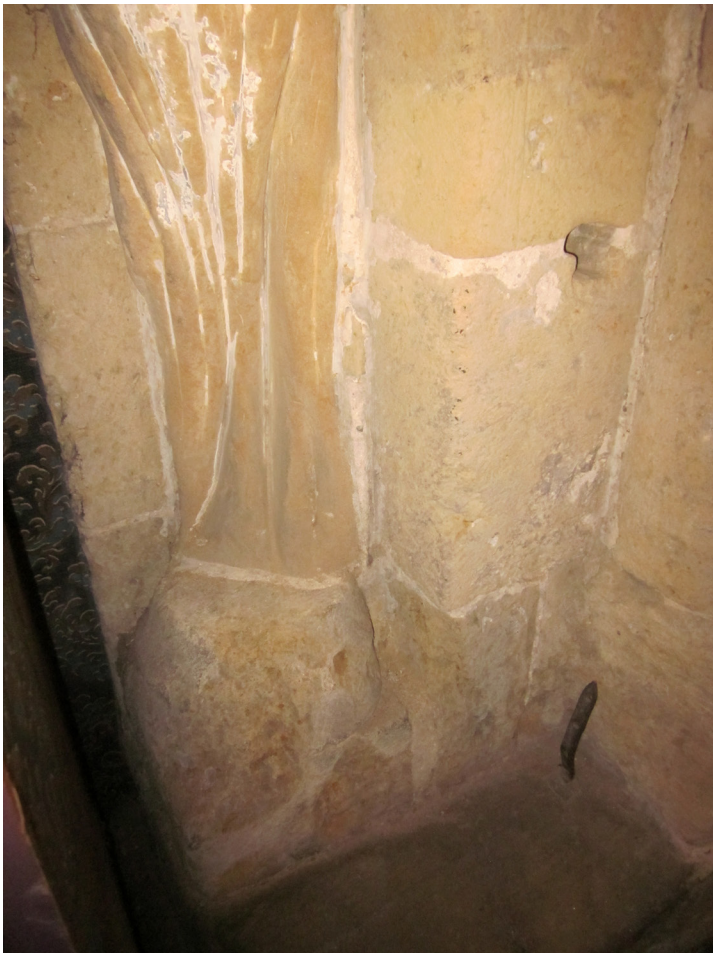
*Figure 8.14. (Table 8.1). In Broughton church tower, Lincolnshire (SE 960 086) one arch jamb reveals its past use as a whetstone, from the height of the wear possibly for sharpening arrows.*

-	Both low west tower and west tower staircase show Anglo-Saxon features as slit windows, and use as whetstones <b>See Figure 8.14</b>
-	East wall tower once had door to high nave, tower narrow windows

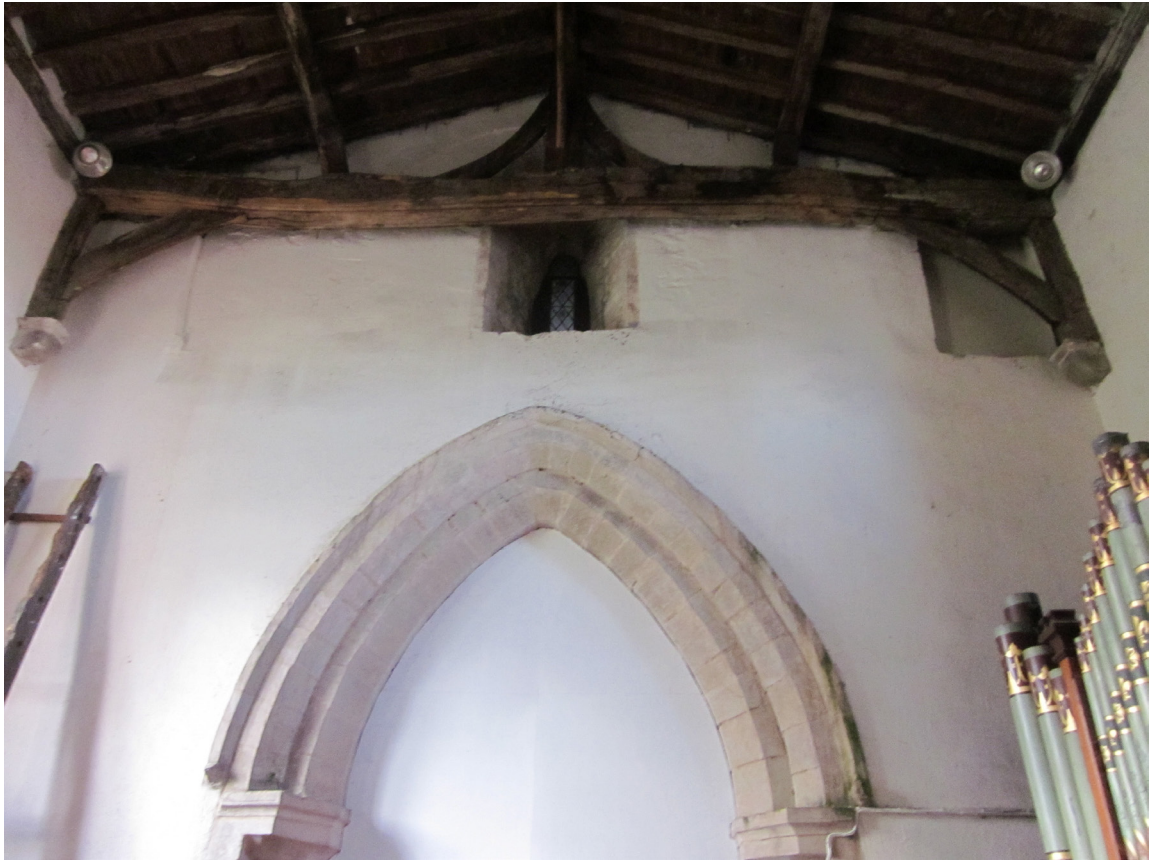
Figure 8.15

Figure 8.15. (Table 8.1). The church of St James, Castle Bytham (SK 988 183) possesses high level windows/doors, these on the west wall of the nave.

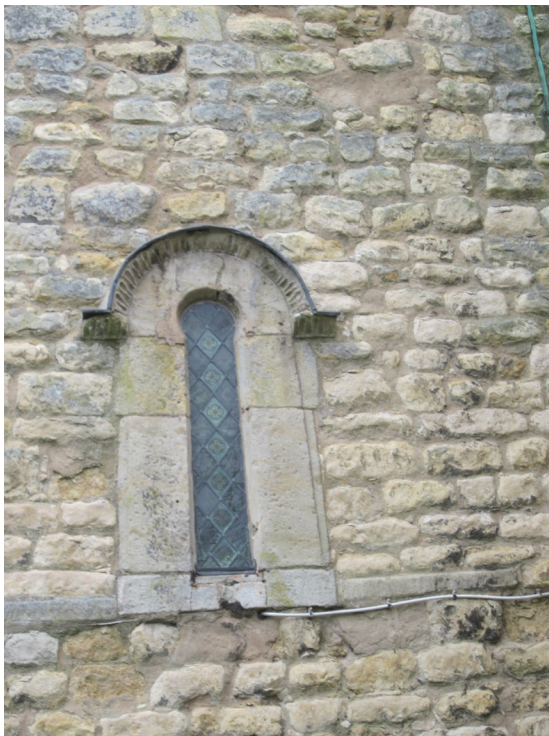
Figure 8.16

Figure 8.16. (Table 8.1). This keyhole window is preserved at a relatively low level on the south wall of the tower of Coleby church, Lincolnshire (SK 975 606). The cut back visible and stonework indicate the window to be of Anglo-Saxon age.

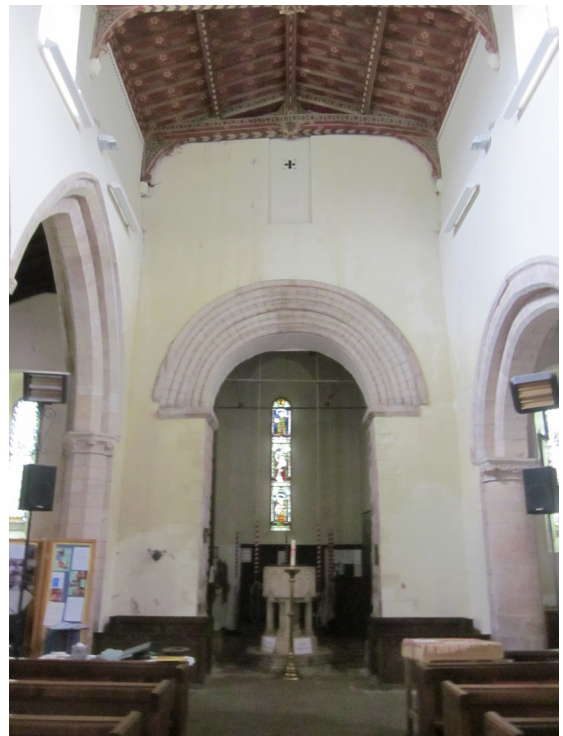
Figure 8.17

Figure 8.17. (Table 8.1). The tower arch at Corringham church, Lincolnshire (SK 872 917), seen from the nave, shows above it a blocked doorway at first floor level.

-	Infilled high level door above tower arch <b>See Figure 8.17</b>

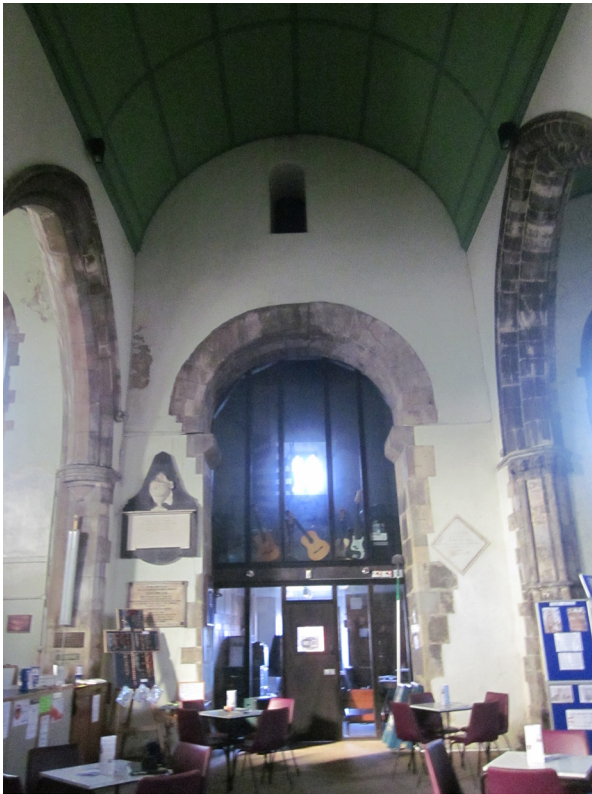
Figure 8.18. (Table 8.1). St Mary-le-Wigford church, Lincoln (SK 974 708) carries a high level doorway above its Tower arch. When this doorway was unblocked the jambs were said to convey an Anglo-Saxon age.

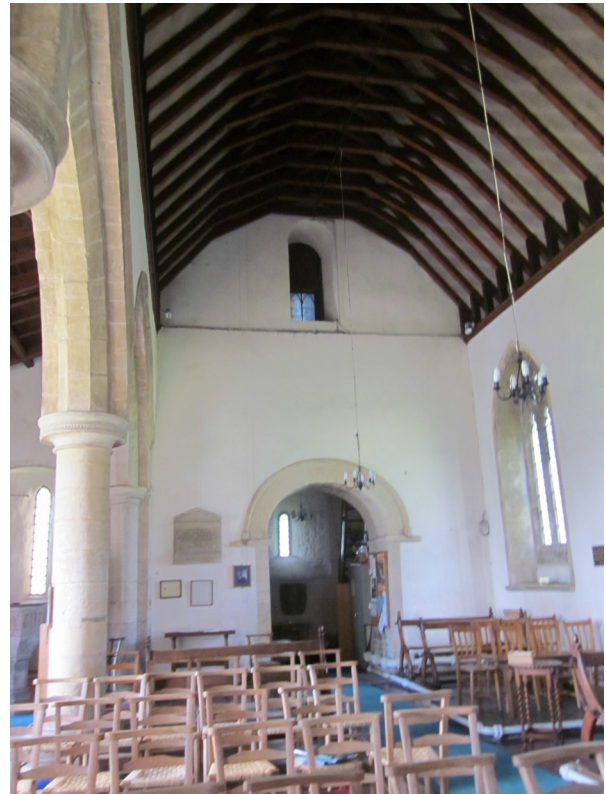
Figure 8.19. (Table 8.1). Little Bytham church (TF 013 180) showing the tower arch as seen from the nave. Unfortunately, all stone detail relating to the high level doorway is covered in plaster.

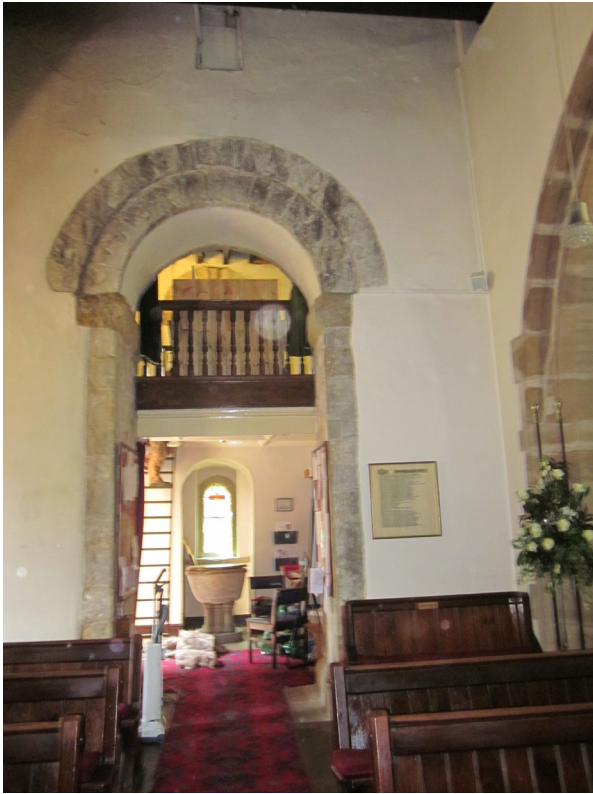
Figure 8.20

Figure 8.20. (Table 8.1). St Giles church, Scartho in Lincolnshire (TA 267 063) is yet another church in the county to carry a high level doorway above its tower arch.

-	Altered tower/nave high doorway. Tower west face repaired keyhole (?Anglo-Saxon)
-	Tower/nave high doorway (?13th C.). Tower modified small windows <b>See Figure 8.20</b>
East deep (over a metre) jamb hole only	Southern part of former Augustinian priory founded before 1169 <b>See Figure 2.13</b>
Bar lock holes 0.12 to 0.15m deep to both west and east	North and south transepts display Anglo-Saxon and Norman style windows (some modernised) <b>See Figure 2.14</b>

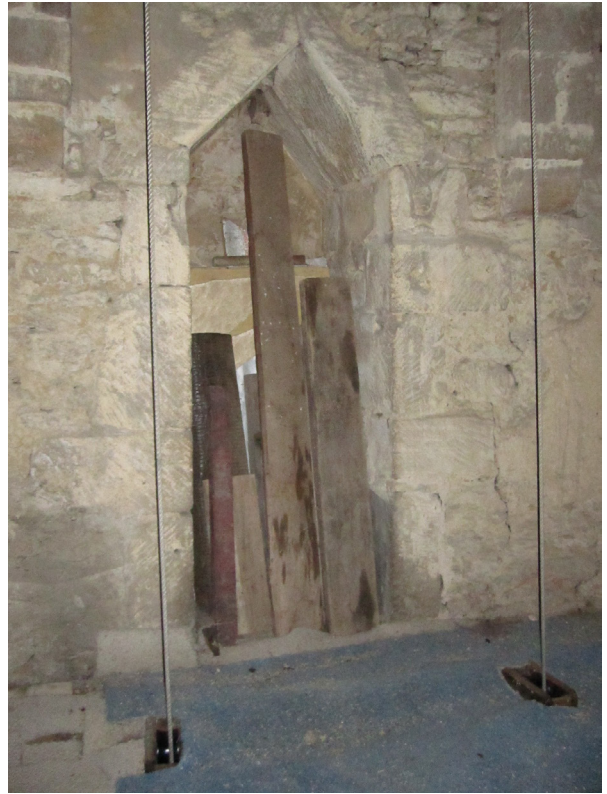
Figure 8.21

Figure 8.21. (Table 8.1). Thurlby church (TF 105 167), like others in Lincolnshire, has a doorway above its tower arch. The doorway in this instance is with a triangular head and likely to be Anglo-Saxon. Paul Ratcliffe, a local resident had permission to visit the higher levels of the tower and he kindly took this photograph (the doorway viewed from inside the tower). Unfortunately, no stonework orientations could be read.

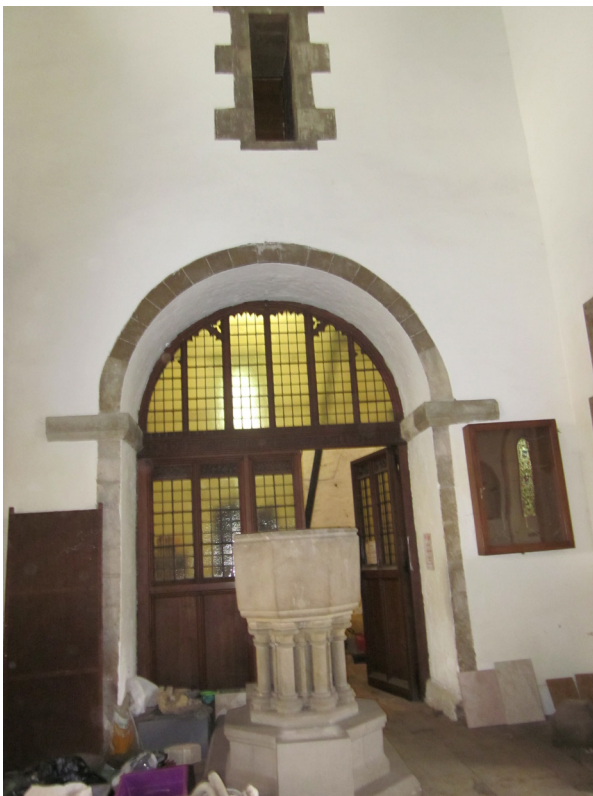
Figure 8.22

Figure 8.22. (Table 8.1). Much of Winterton church (SE 928 126) has been modernised. The doorway above the tower arch probably in 1904 when it was stated it was modelled on the earlier doorway replaced. The 'long and short' stones in the part of the doorway visible suggesting an earlier Anglo-Saxon style.

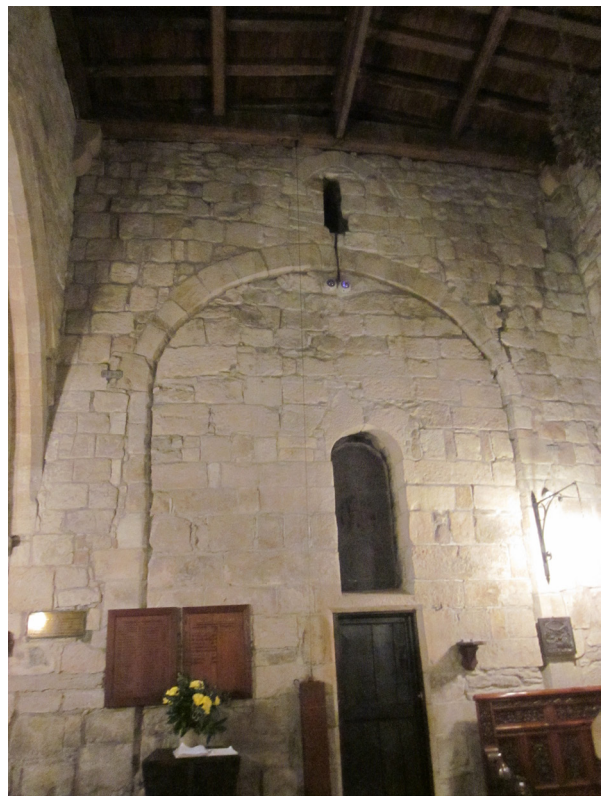
Figure 8.23

Figure 8.23. (Table 8.1). Hartburn church in Northumberland (NZ 090 161) has a blocked tower arch, seen here as from the nave, to presumably give the tower security. But to maintain limited tower access, two doorways have been opened in the blocking on a line central to the church. The earlier and higher, of these doorways is thought to have been used by means of a removable ladder to maintain security, the lower doorway is relatively modern. Higher in this wall there is a window and above it (not visible) a further blocked doorway.

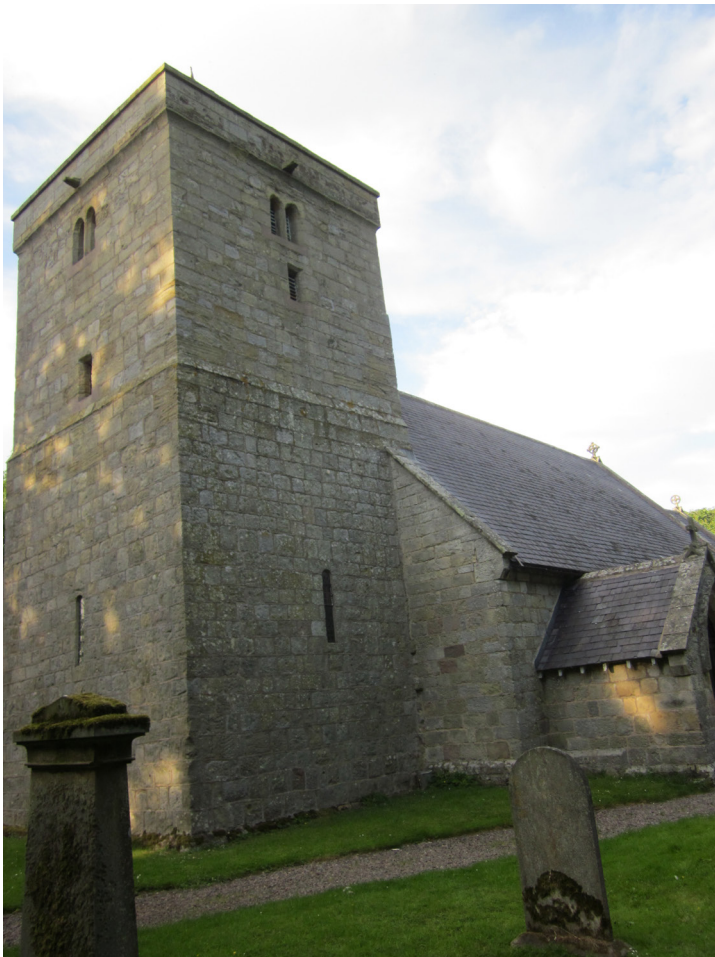
Figure 8.24. (Table 8.1). Ingram church, Northumberland (NU 019 163). Brooke (2000, 94-95) noted that the tower was restored in the 19th C. although the openings were in size minimal; but that the original Norman tower arch remained and the various records for the 16th C detailed Scottish raids.

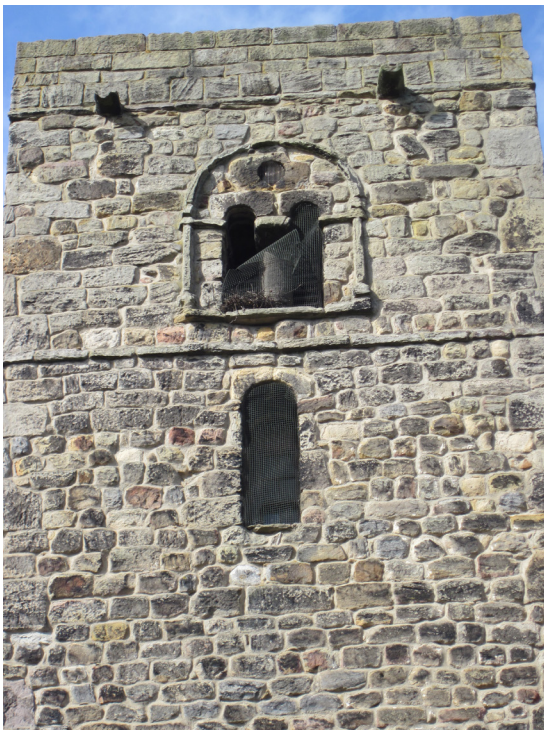
*Figure 8.26*

Figure 8.26. (Table 8.1). Ovingham church in Northumberland (NZ 085 637), showing the upper south face of the tower. The stonework of the double belfry window (all stones BVFIA or BH) indicates it is of a Patterned, Anglo-Saxon build. Below the belfry there is a doorway which opens into space; clearly not an indication of increasing church security. Other Anglo-Saxon similar doorways are known elsewhere as at Earl's Barton in Northamptonshire and St Andrew, Bywell, always on the tower south wall, their purpose is as of yet unknown.

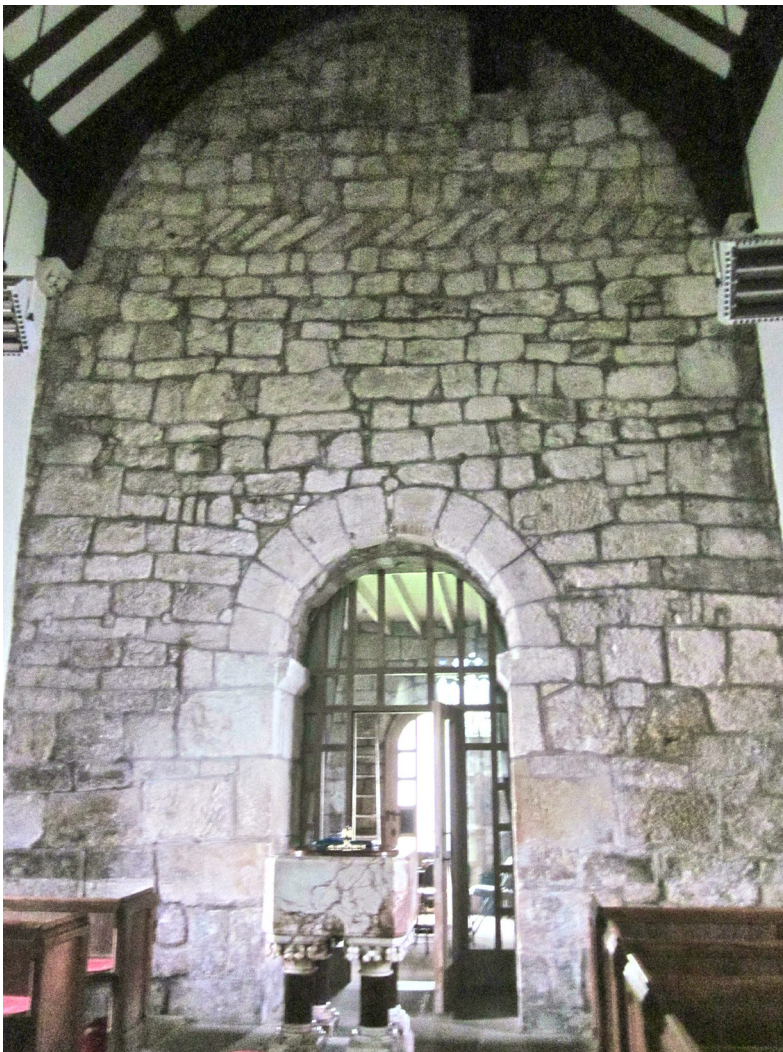
Figure 8.28. (Table 8.1). At Hovingham church, in Yorkshire (SE 666 757) the tower arch has apparently been created by cutting straight through the west nave wall, quite possibly by enlarging a smaller earlier arch. Viewed here from the nave, high above the arch, a doorway exists somewhat north of the central line of the church of the church. This doorway must have once permitted communication between the tower and the nave.

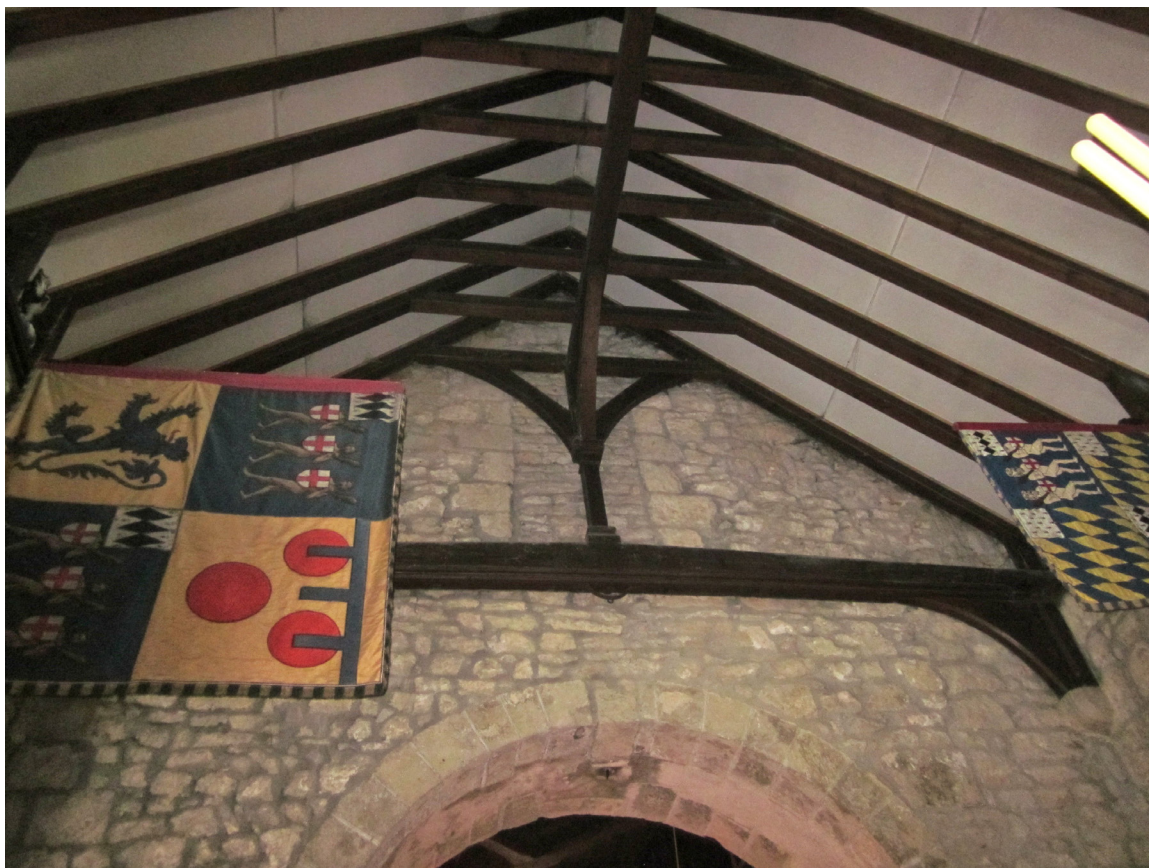
Figure 8.29. (Table 8.1). Viewed from the nave and seen high above the tower arch, a blocked early doorway may be seen at Kirby Underdale church (SE 808 585). The jamb stones from their setting suggest that the doorway may be Anglo-Saxon.

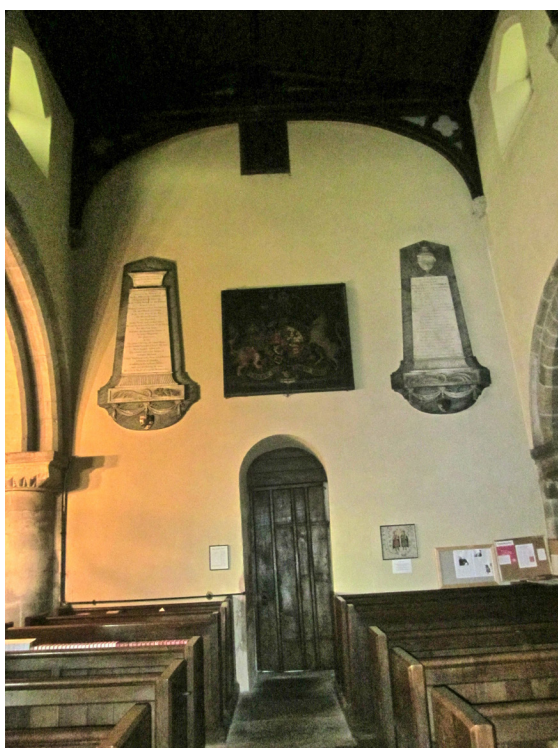
Figure 8.30. (Table 8.1). Viewed from the east the western wall of the interior of Stonegrave church (SE 655 778) is evident. The nave west door (now the tower arch), with higher, the lower portion of a doorway from the tower to a chamber over the present nave, are visible.

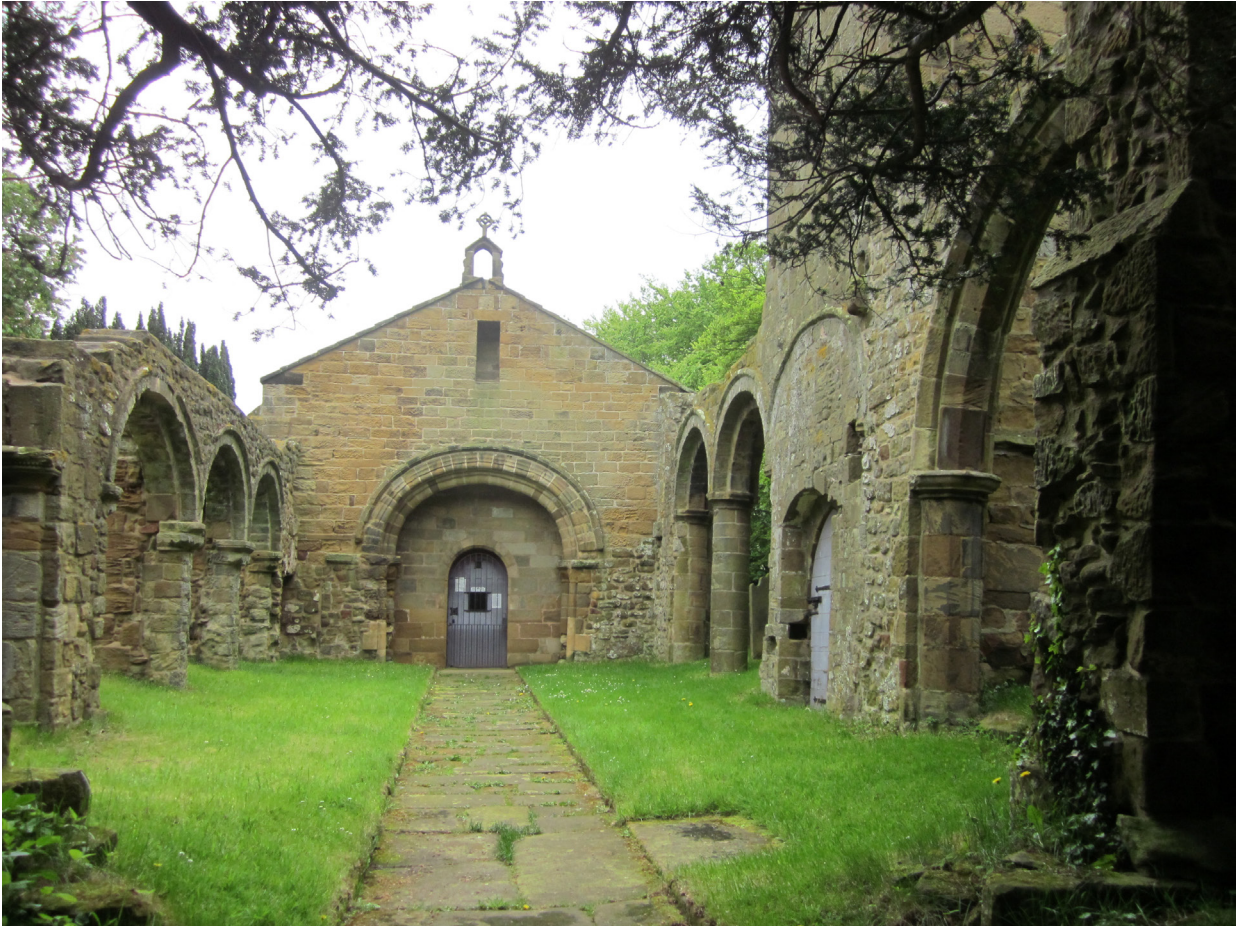
*Figure 8.31. (Table 8.1). The Holy Cross church, Whorlton-in-Cleveland (SE 484 025) here displays the west side of its blocked Norman chancel arch, and higher, a later doorway. To the south of the arch the low walling, over a small area, is constructed of boulders, a possible intimation of an earlier age.*

Anglo-Saxon (No proof of full circulation for persons)	Window above tower arch, also in blocked state high south nave wall and porch ( <i>porticus</i> )
Possibly bar locks date from 13th C	a) Bar holes now shallow b) The east bar hole the deepest c) East bar hole deep <b>See Figure 2.36</b>
About 1300 Early English	East bar lock hole present, west cement filled. Nave west end two lancet windows
Possibly 11th C Ground floor earliest possibly 11th C	High level blocked door above tower arch. Tower early windows, some double splayed
Probably Norman. 12th C.	Door over west nave door from tower. Small window second stage tower <b>See Figure 8.30</b>
Norman	High level doorway above tower arch
Possibly 14th C	Ruin. Blocked doorway over chancel arch (for communication) <b>See Figure 8.31</b>

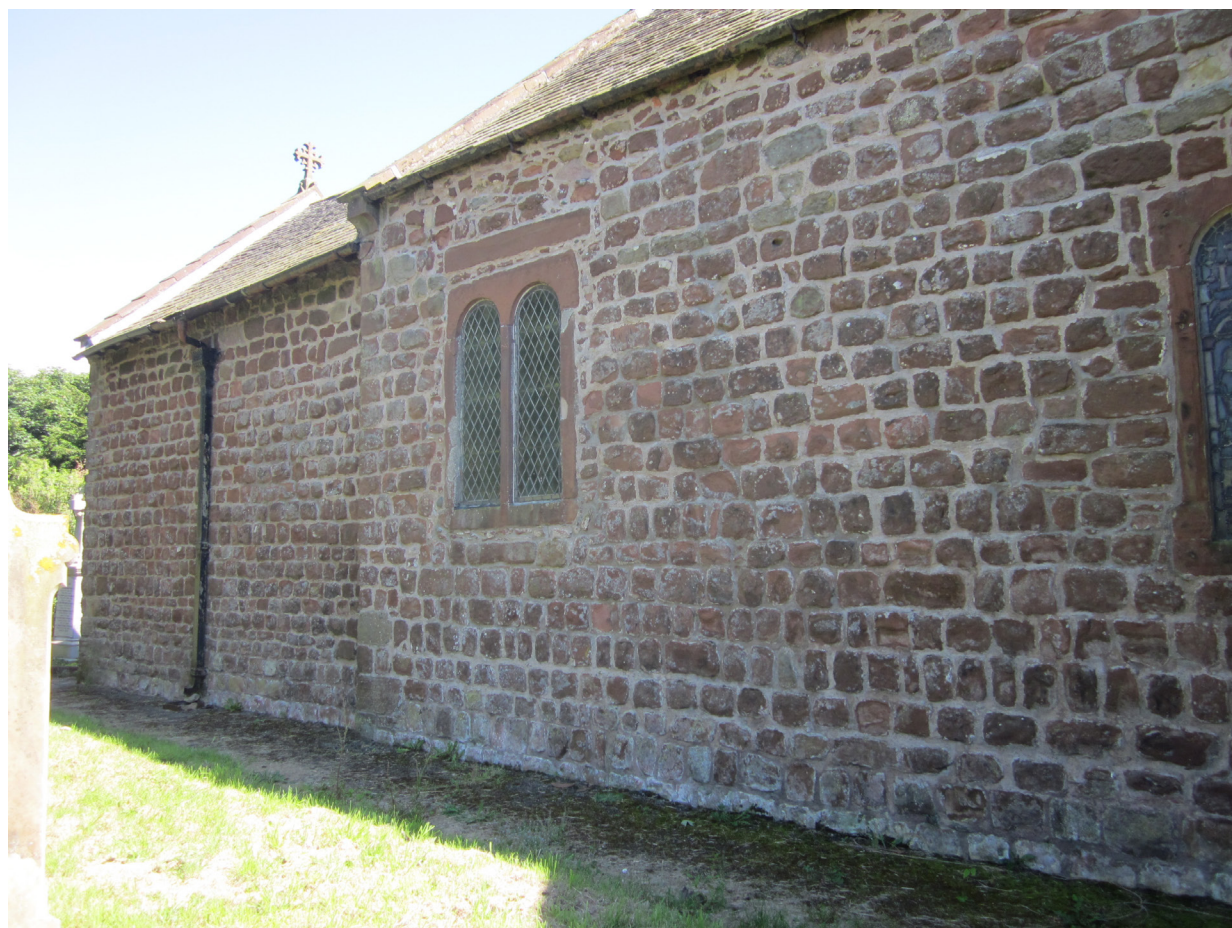
Figure 8.32. (Table 8.2). Cross Canonby church, Cumberland (NY 069 390). Brooke (2000, 296) commented 'there are very few windows earlier than the 17th or 18th centuries' and 'there are no obvious defensible features'. The north wall of the nave and chancel are shown (constructed of Roman squared stones), the windows illustrated are late additions to the walls (note the irregular relationship with the wall stones).

Ecclesiastical Site	County	Grid Reference	Narrow Windows	Any Specific details
Cross Canonby* See Figure 8.32	Cumberland	NY 069 390	Narrow window south chancel wall, 2.15m above cill	Modified, possibly Norman originally
Kirkhampton	Cumberland	NY 305 564	Narrow window south chancel wall	Rebuilt, now includes only one Anglo-Saxon stone
Croxdale Chapel	Durham	NZ 274 399	Nave north wall	13th C. lancet
Escomb See Figure 8.33	Durham	NZ 189 302	Nave north wall	13th C. lancet
Jarrow See Figure 8.34	Durham	NZ 339 653	South chancel wall	Three Anglo-Saxon windows
Monkwearmouth	Durham	NZ 402 577	Small, west and south facing windows	Uncertain
Seaham	Durham	NZ 422 505	Small nave windows	Three windows Anglo-Saxon
Barholm	Lincolnshire	TF 090 110	Nave south wall	?Anglo-Saxon
Clee	Lincolnshire	TA 290 084	Tower has west 'keyhole' window	Modified
Greetwell	Lincolnshire	TF 013 715	South wall nave	Uncertain
Hainton See Figure 8.35	Lincolnshire	TF 180 144	Tower south side has keyhole window	Probably Anglo-Saxon

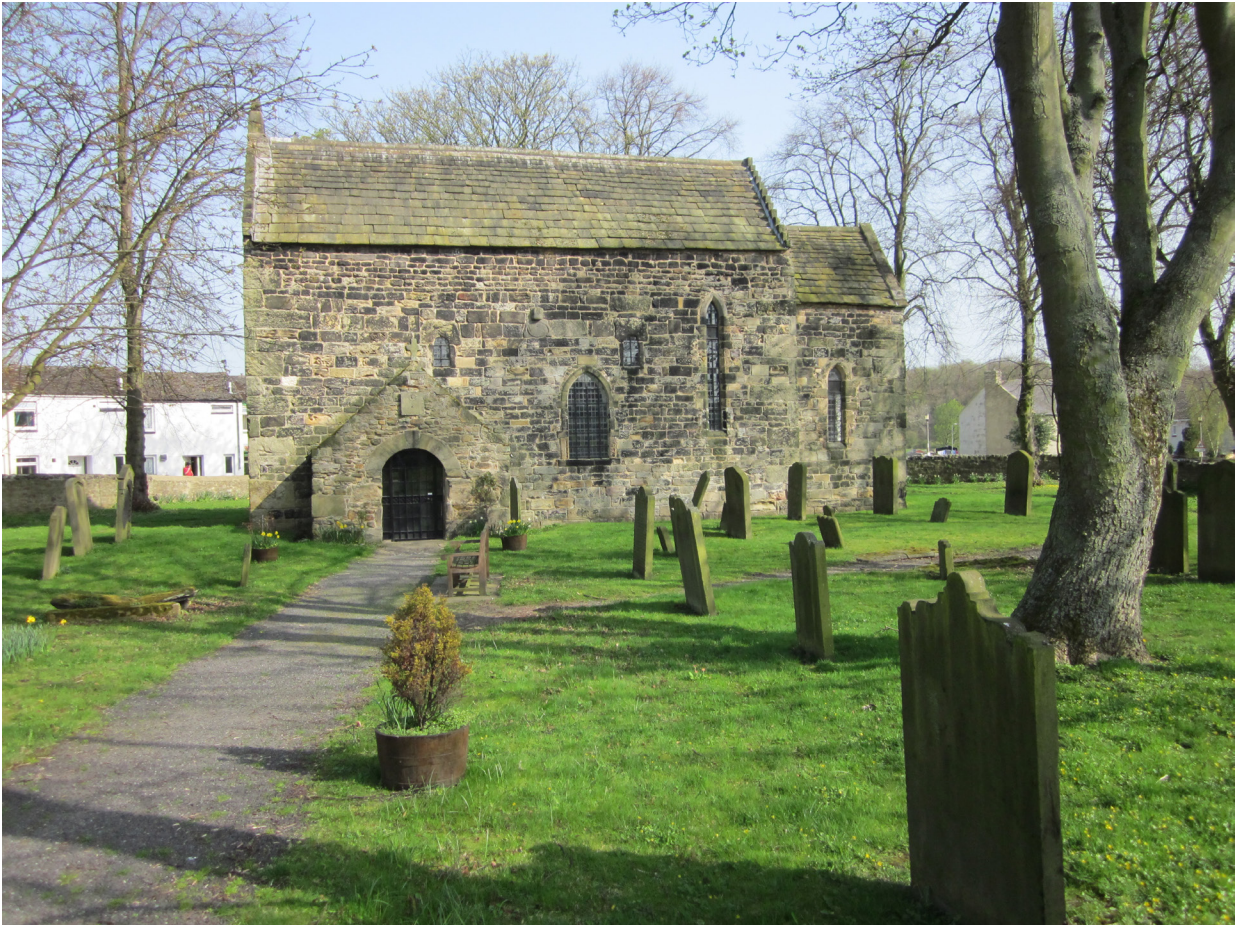
*Figure 8.33. (Table 8.2). Escomb church, Durham (NZ 189 302). Escomb church is renowned for features of its preservation, for windows, doors and quoins all retain evidence of the distinctive Patterned style of stonework. Nearly all elements of the stonework of the church reflect 'The Escomb Style' surely confirming no elements of past disturbance or destruction.*

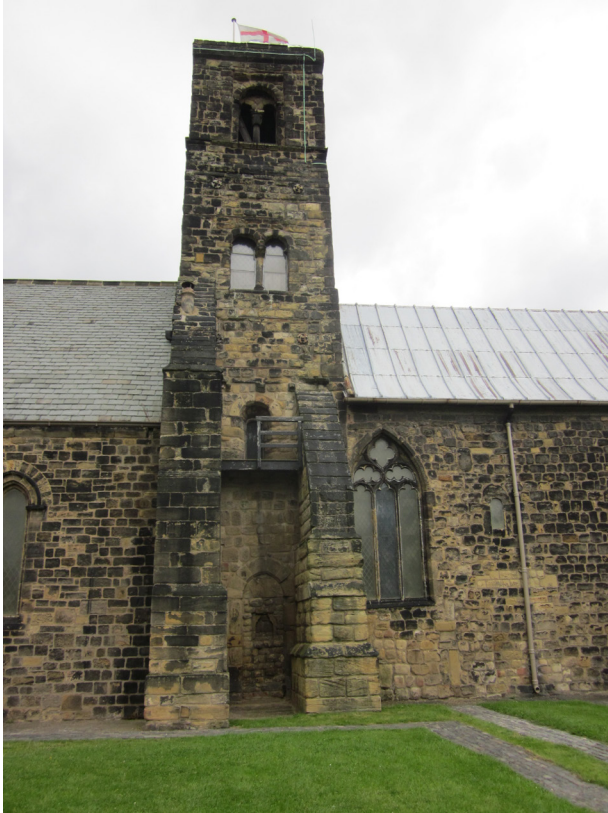
Figure 8.34. (Table 8.2). Jarrow church, Durham (NZ 339 653). In many respects Jarrow church having been in use for a millennium or more years is complex to interpret. The south wall has elements of various doorways which remain visible. The three monosplay Anglo-Saxon windows in the south chancel walls each have BVFIA and BH stones creating the window jambs. Several years ago the present author commenced an analysis of the Patterned wall masonry that occurred patchily on the south chancel wall, in which Face Bedded stones were common (Potter, 2015, 98). This analysis was not completed.

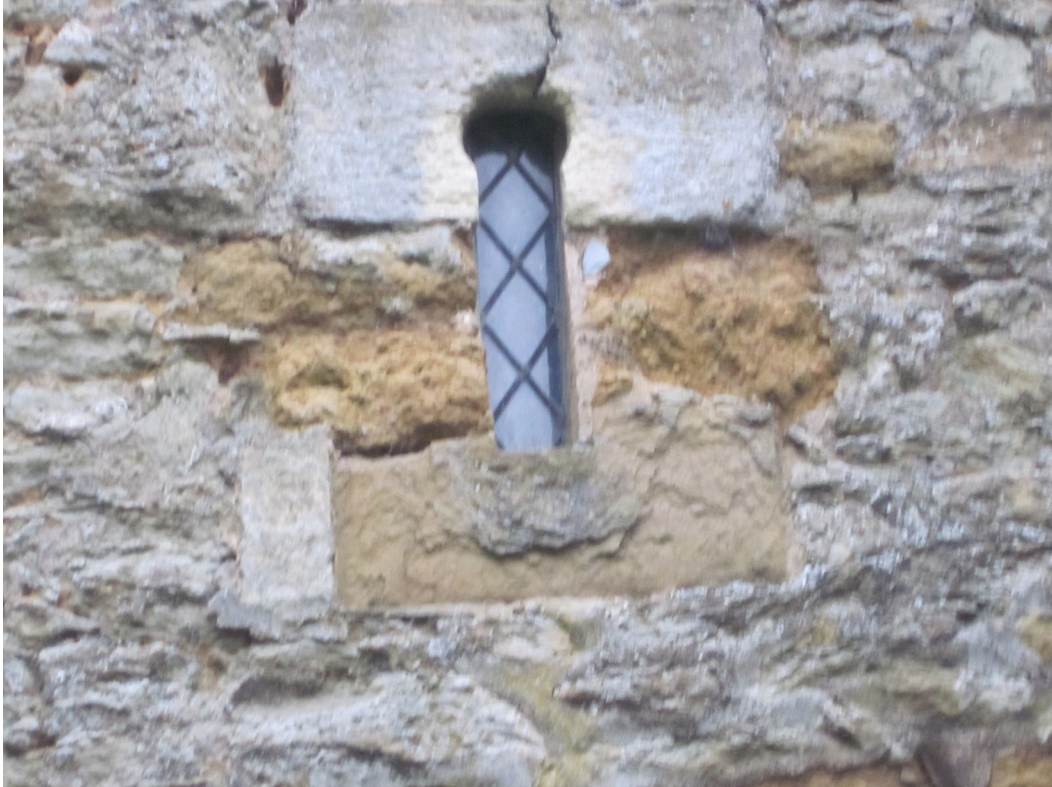
Figure 8.35. (Table 8.2) A keyhole window in the south wall of the tower of Hainton church, Lincolnshire (TF 180 844), fully described in Potter (2015, 200-205).

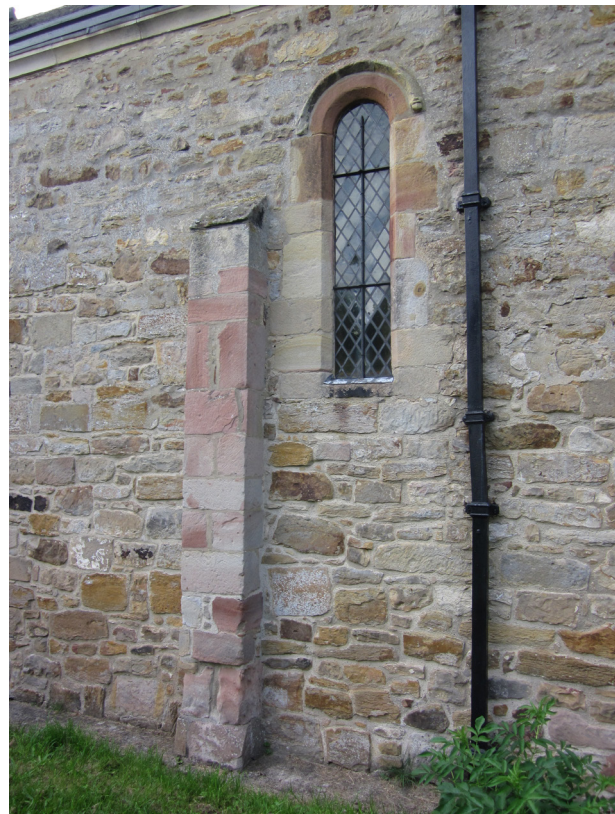
Figure 8.37. (Table 8.2). Easby church, Yorkshire (NZ 185 003). This Norman style window in low in the south wall of the chancel has clearly been extensively repaired. The shallow buttress is also an additional feature.

Bulmer	Yorkshire	SE 699 676	Narrow monosplay windows in nave	Probably 11th C
Easby <b>See Figure 8.37</b>	Yorkshire	NZ 185 003	Chancel, south wall window	Repaired Norman
Hackness	Yorkshire	SE 969 905	Vestiges of windows above south arcade arches	Probably Anglo-Saxon
Hauxwell	Yorkshire	SE 166 932	Part of window, west end of south nave wall	Late 11th C.
Hornby	Yorkshire	SE 222 937	Tower second stage, south wall	12th C.
Lastingham <b>See Figure 8.38</b>	Yorkshire	SE 728 904	Crypt and apse area	Modified Norman

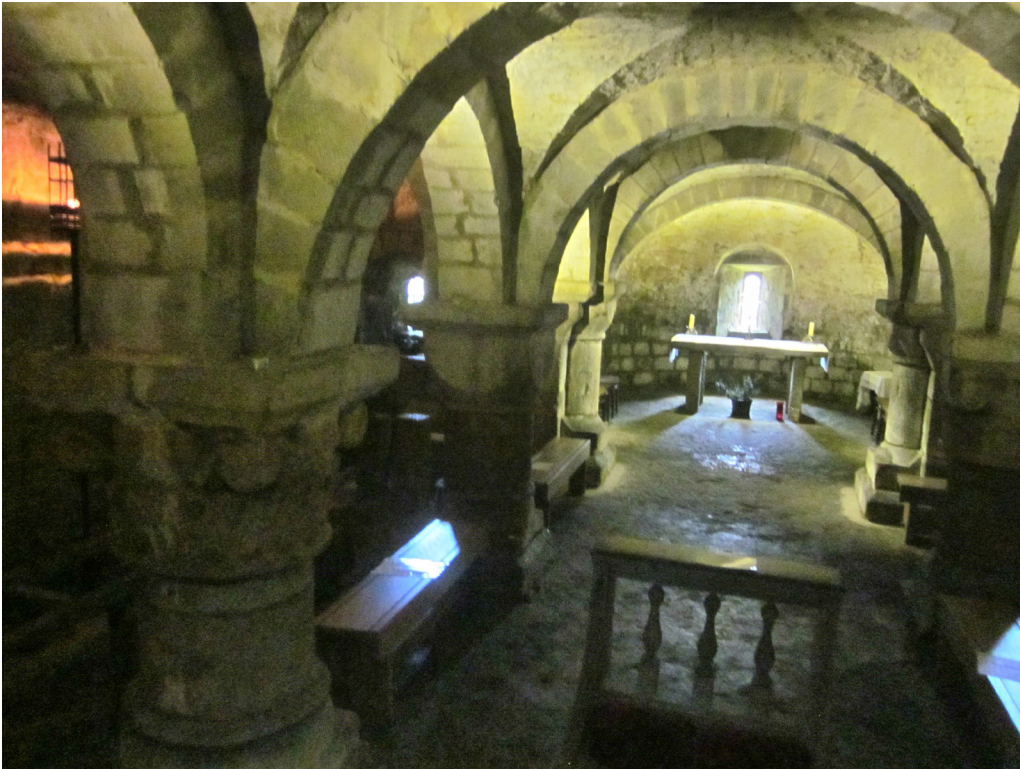
Figure 8.38. (Table 8.2). The crypt in Lastingham church, Yorkshire (SE 728 904) appears to show very limited modification since its original inception.

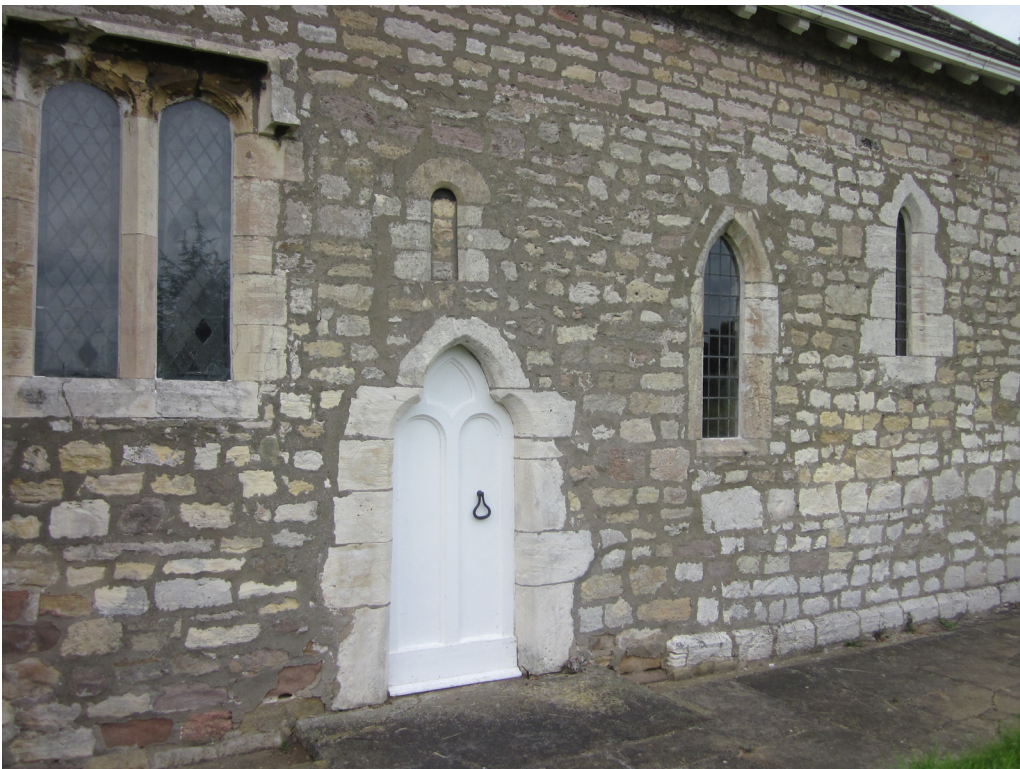
Figure 8.39. (Table 8.2). Newton Kyme church, Yorkshire (SE 466 449) displays three similar but unlike windows in the south wall of the chancel.

Laughton-en-le-Morthen	Yorkshire	SK 517 882	Chancel, south wall	Norman
Masham	Yorkshire	SE 236 806	Tower, windows second and third stages	Norman, part modified
Middleton-by-Pickering	Yorkshire	SE 782 854	Tower, lower windows south face	Anglo-Saxon modified
Newton Kyme <b>See Figure 8.39</b>	Yorkshire	SE 466 449	Semi-circular slit window south wall of chancel	Probably 12th C.

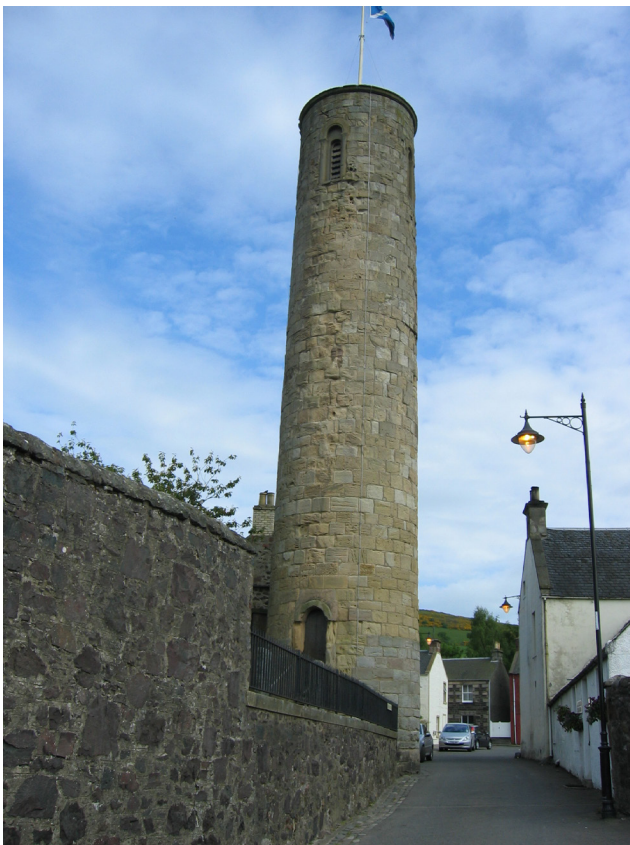
Figure 9.1. (Table 9.1). Abernethy round tower (NO 190 165) in Perth and Kinross, is today Scotland's only wholly free-standing tower. It is here viewed from the north.

Notes <sup>2</sup>	Other referrals to this church in this work
-	See Brooke (2000, 204)
The only free-standing church tower to remain in Scotland.	<b>See Figures 9.1, 9.2</b>
RCAHMS (1929) – ‘may be late 14th C.’	-
Church much repaired (Ferguson, 1890-1) ‘before the close of the 12th century’	See Brooke (2000, 41-42)

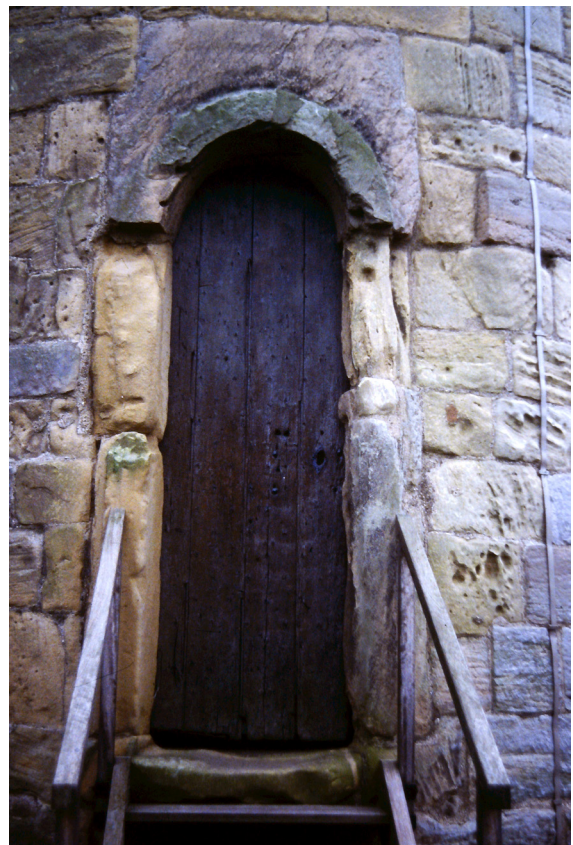
Figure 9.2. (Table 9.1). The stonework to the doorway of Abernethy round tower reveals a 'Patterned' style. A full description of the tower is given in Potter (2009a, 64-65).

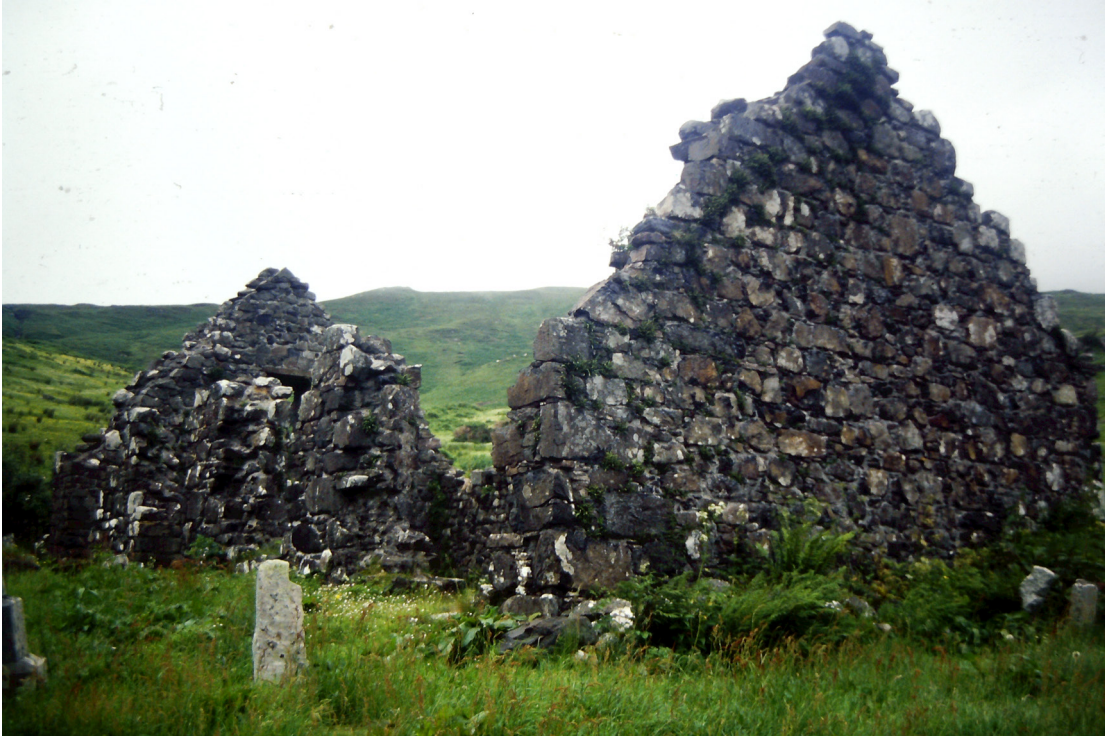
Figure 9.3. (Table 9.1). Borline ruined church, Loch Eynort, Skye (NG 375 260) as viewed from the south-east. The church is built of vesicular basalt.

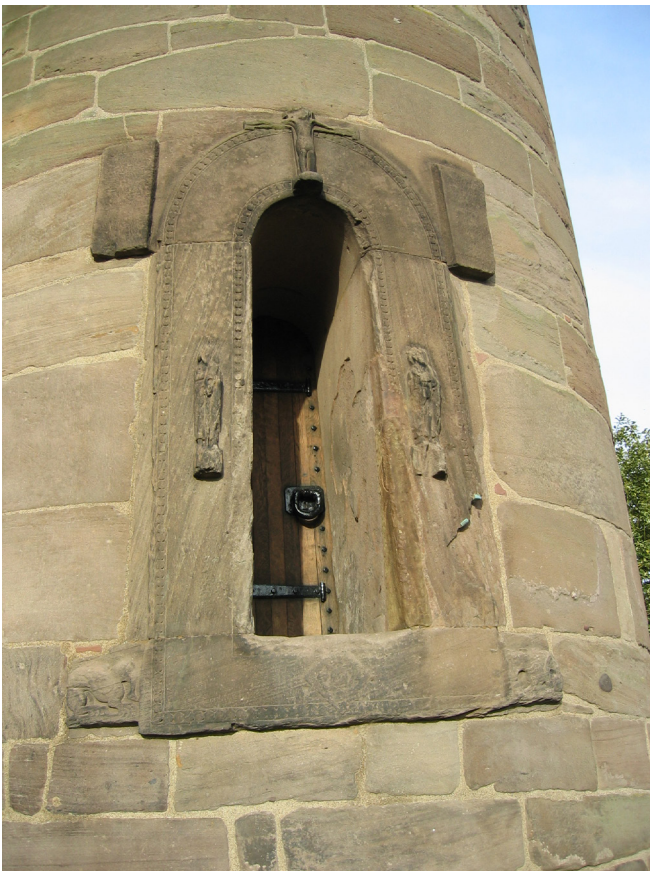
Figure 9.4. (Table 9.1). The doorway to Brechin Cathedral round tower (NO 596 601) possesses all the characteristics of being constructed in 'Patterned' style. The stones in the doorway are set BVFIA and exhibit cut backs.
