# Bar Locks and Early Church Security in the British Isles

John F. Potter

Access Archaeology

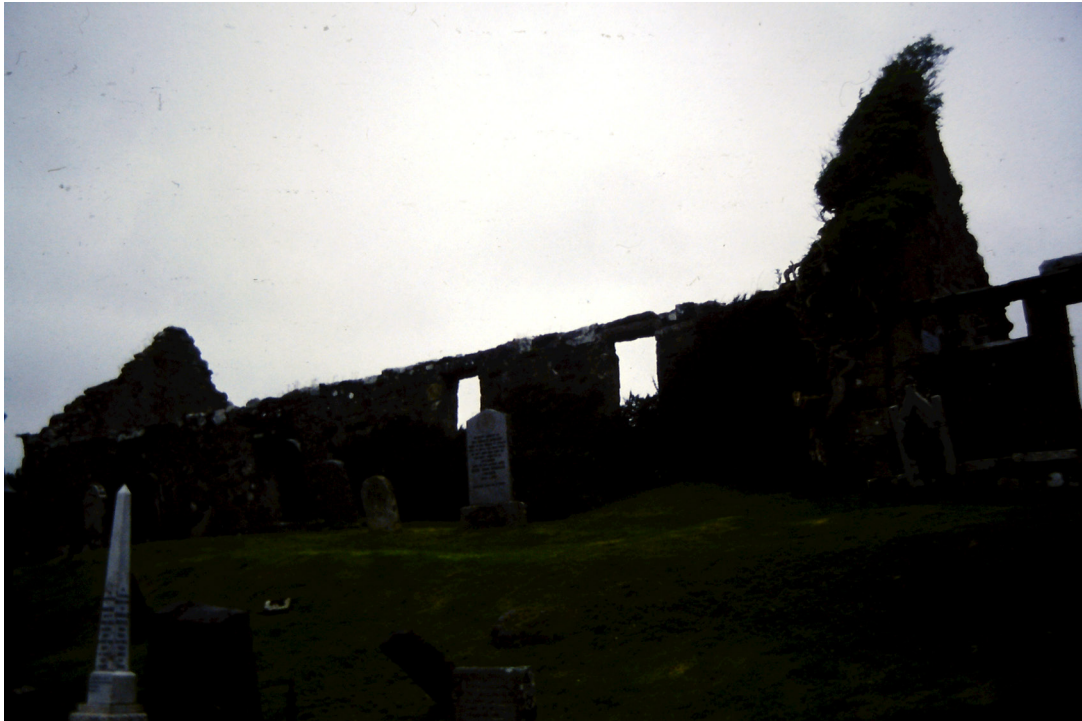
Figure 9.5. (Table 9.1). Cill Chriosd chapel, Strath Suardl, Skye (NG 617 207) viewed from the south-east. Although ruined, the north-east and south-east quoins both exhibit pre-Conquest, 'Patterned' construction.

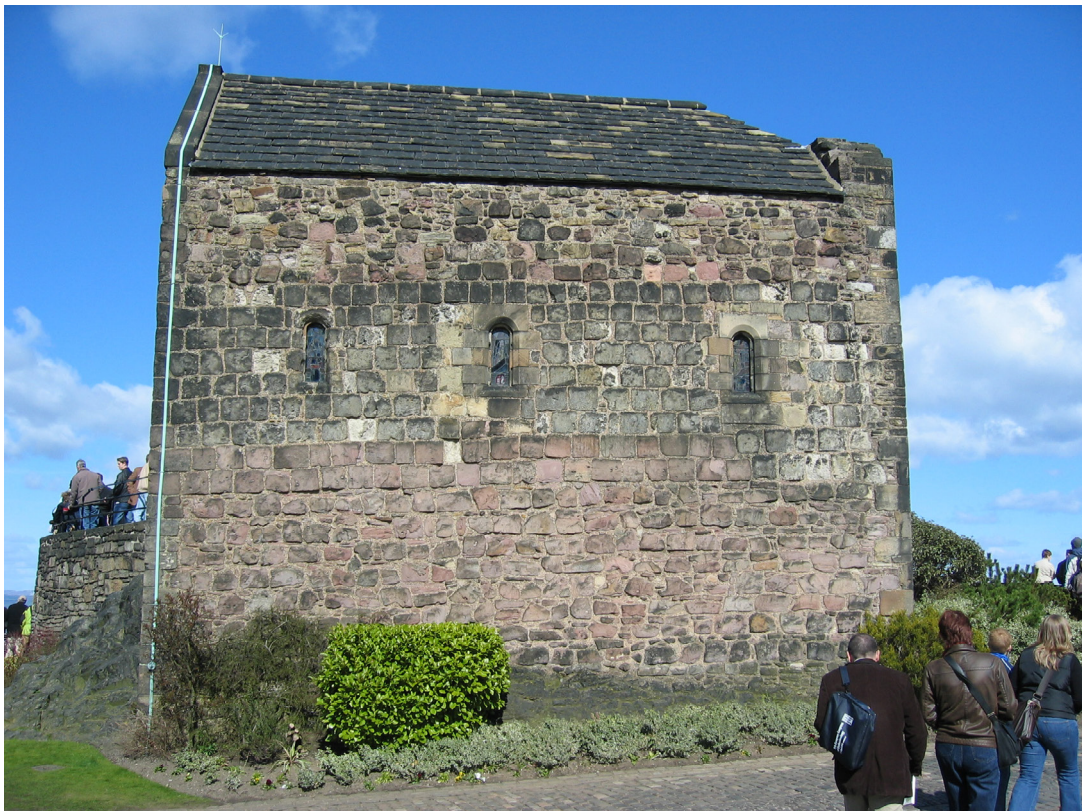
Figure 9.6. (Table 9.1). St Margaret's chapel, Edinburgh Castle (NT 253 735) has been described in detail Potter (2008b, 205-222). Various periods and styles of building are displayed in the south face shown here.

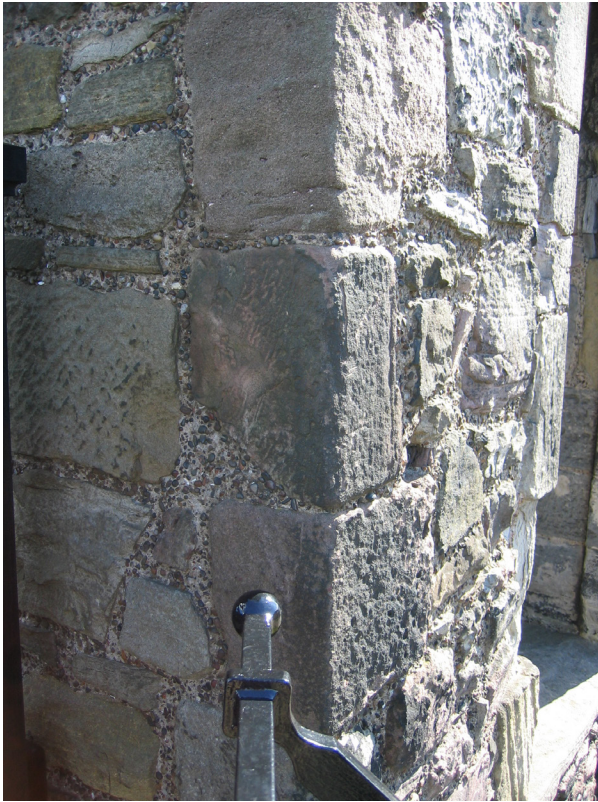
Figure 9.7. (Table 9.1). The north-west quoin of St Margaret's chapel, where the stones are set to 'Patterned' style.

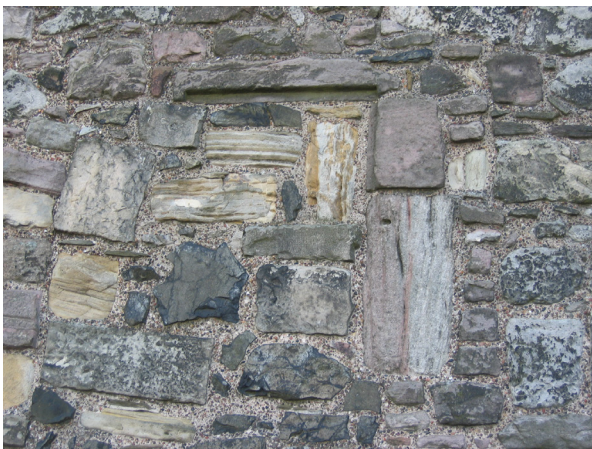
Figure 9.8. (Table 9.1). The outline of an earlier infilled window still shows some Anglo-Saxon ('Patterned') characteristics in the north wall of St Margaret's chapel, Edinburgh Castle.

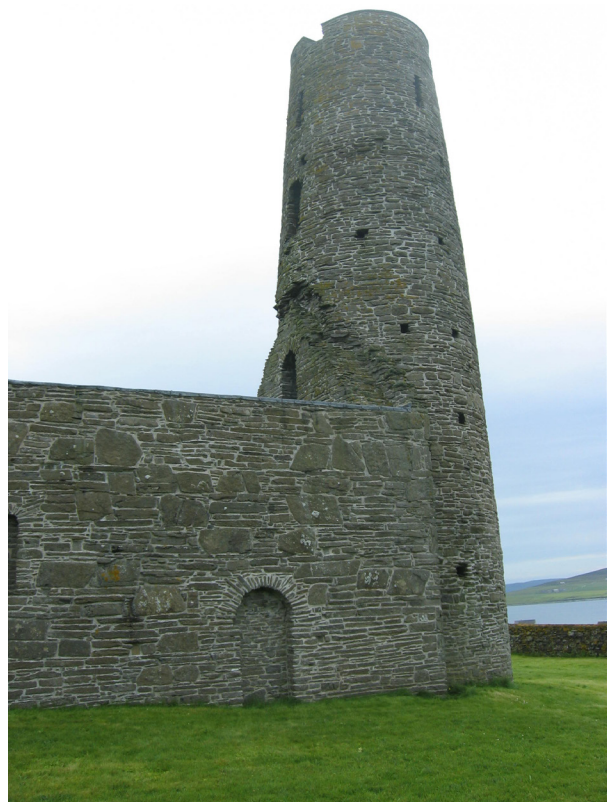
Figure 9.9. (Table 9.1). The ruined Egilsay church, Orkney (HY 466 304), seen here from the north to show the tower and north nave door. The church was probably built early in the 12th C. and Patterned features are not apparent.

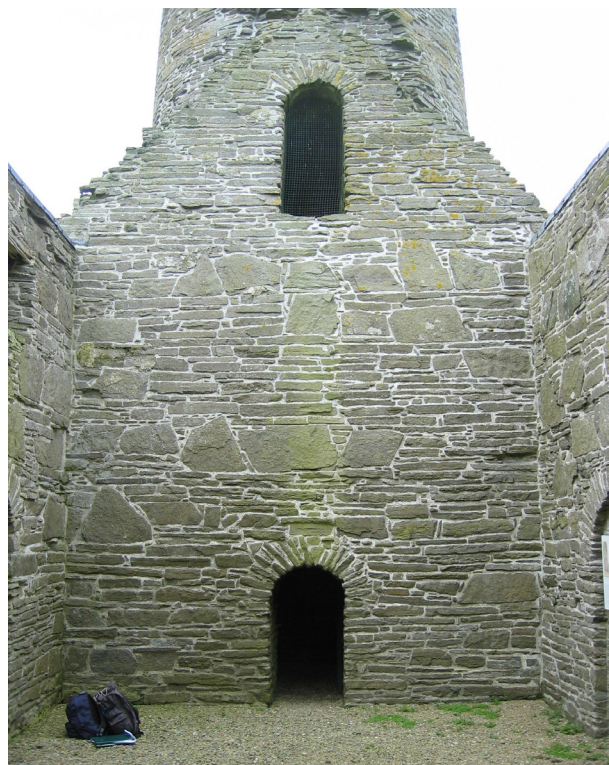
Figure 9.10. (Table 9.1). In this view the interior of the west end of Egilsay church is visible; this shows the nave door to the tower and a second doorway above.

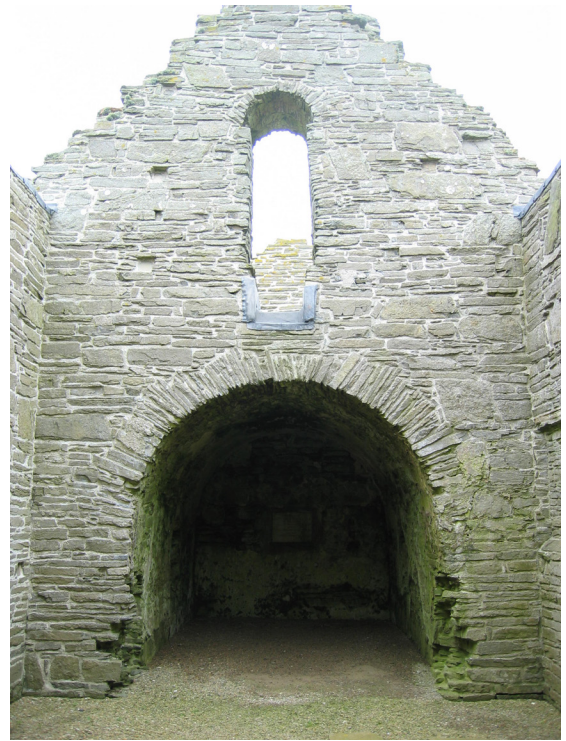
Figure 9.11. (Table 9.1). In the opposite direction to Figure 9.10, Egilsay church chancel's early single-splayed windows to north and south are now blocked and above the chancel a further room existed.

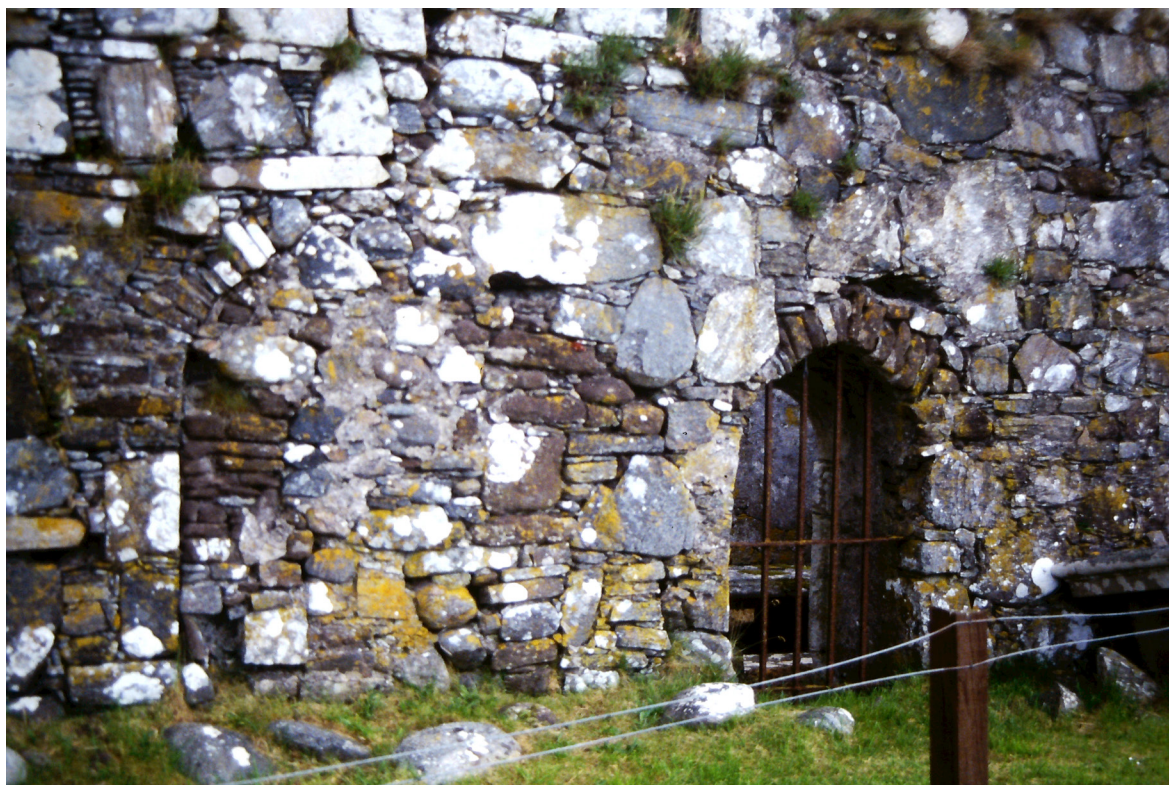
Figure 9.14. (Table 9.1). A closer view of the south nave wall of the Eye church to show what is probably a 13th C. doorway and to its left a taller blocked doorway which preserves some 'Patterned' characteristics.

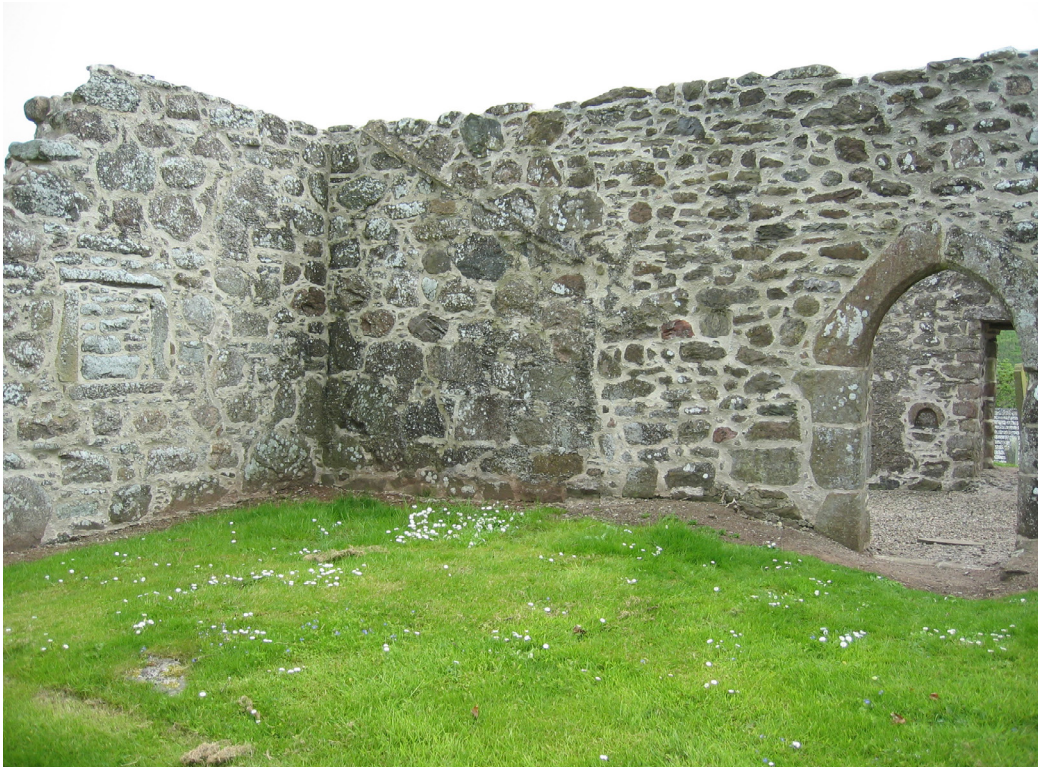
Figure 9.15. (Table 9.1). A view of the inside of the south east quoin, of St Ciaran, Fetteresso ruined church (NO 854 857), which retains areas of Anglo-Saxon (Patterned) workmanship.

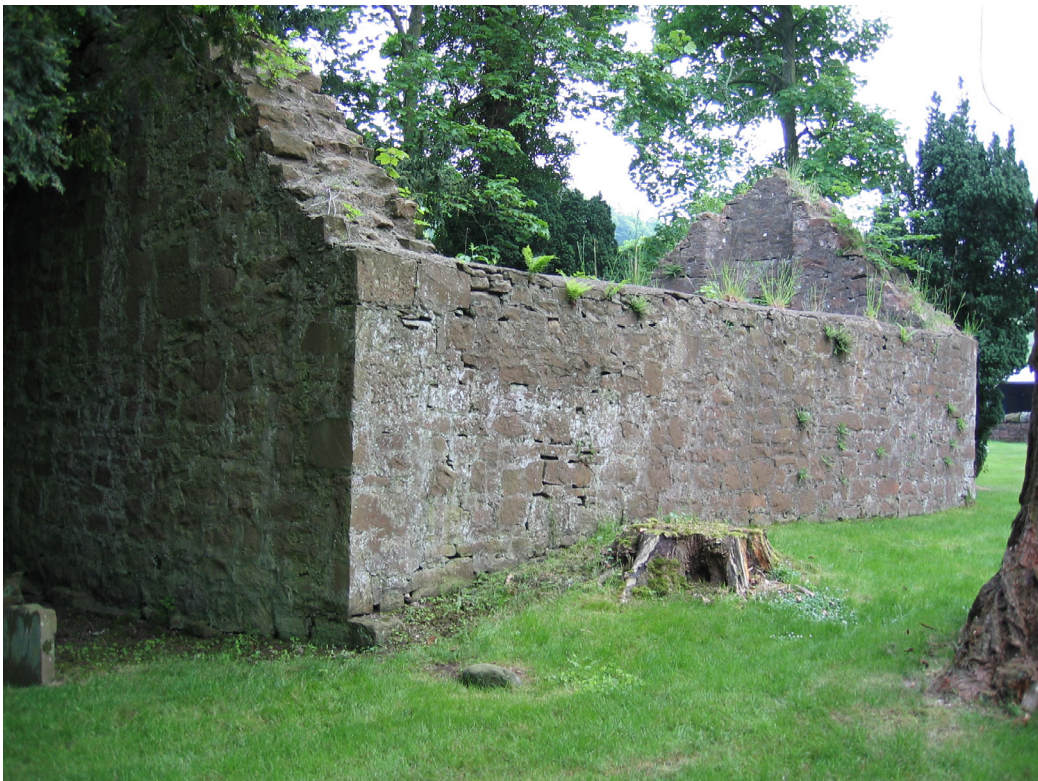
Figure 9.16. (Table 9.1). Although only preserving its principal features, Glenearn church (NO 107 164) here shows the north-east quoin to best advantage.

-	<b>See Figure 9.15</b>
-	<b>See Figures 9.16, 9.17</b>
9th C. church once ‘on site’	<b>See Figures 9.18, 9.19</b>
Church orientation atypical	<b>See Figures 9.20, 9.21</b>
The High Cross, illustrated as better known	<b>See Figure 9.22</b>
RCAHMS (1933) ‘consecrated 1243’	<b>See Figure 9.23</b>
Church abandoned mid-17th C.	See Brooke (2000, 16-17)
RCAHMS (1920) ‘probably early 16th C.’	See Brooke (2000, 335). <b>See Figures 9.24, 9.25</b>
Ferguson (1890-1) ‘church use ceased 1718’	See Brooke (2000, 37-38). <b>See Figure 9.26</b>

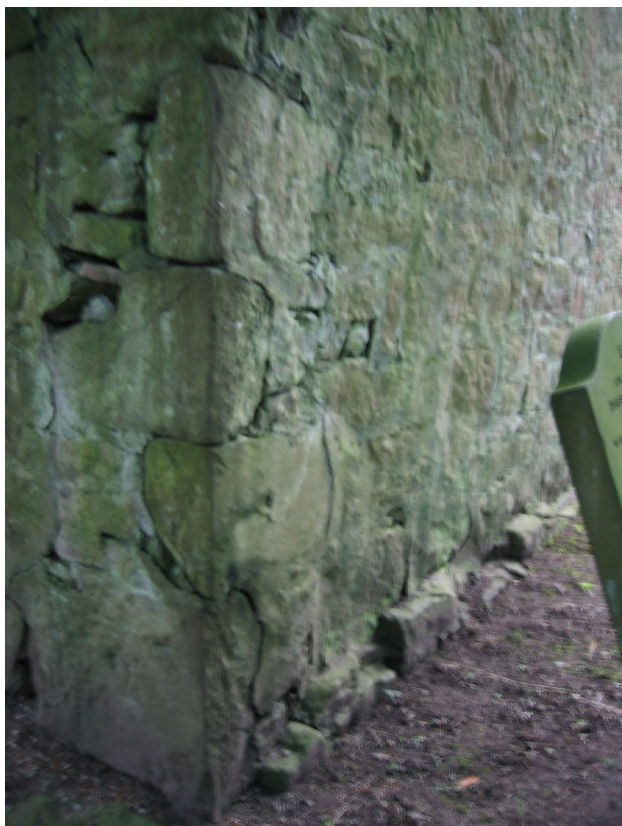
Figure 9.17. (Table 9.1). In this view the south-east quoin of Glenearn church clearly displays the 'Patterned' features of its stonework.

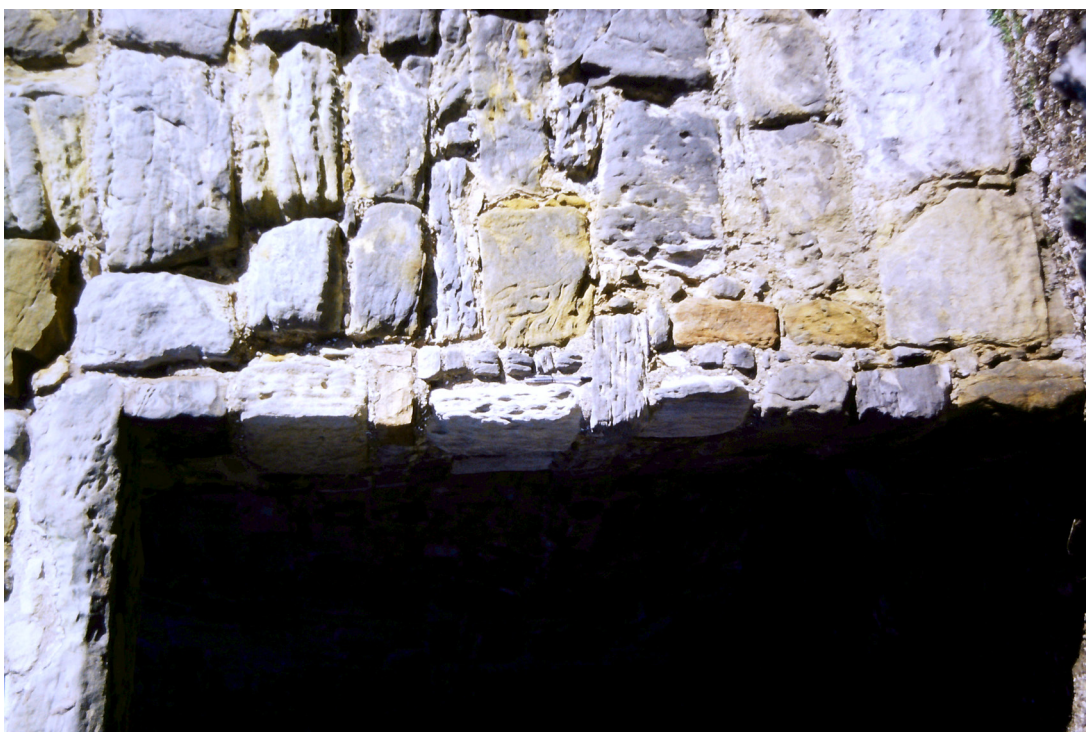
Figure 9.19. (Table 9.1). The north face of the east jamb of the north door to the nave of Gullane church has its stonework set mainly to 'Patterned' style.

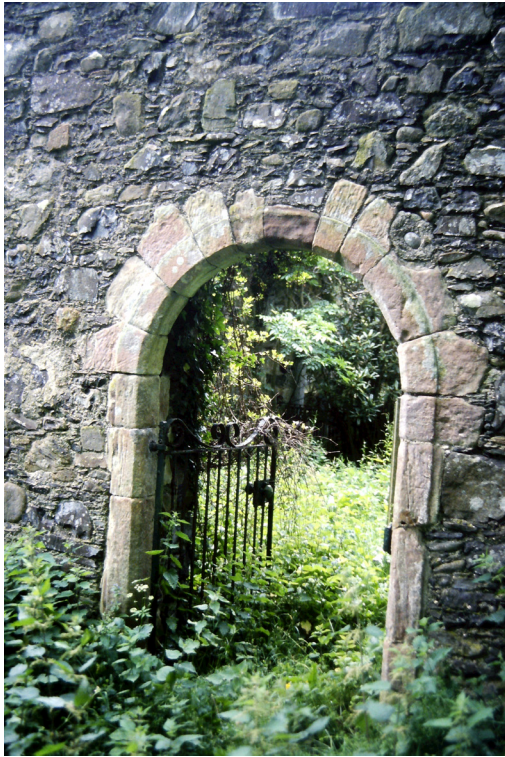
*Figure 9.21*

Figure 9.21. (Table 9.1). This doorway to Inch church has well preserved late Anglo-Saxon ('Patterned') features. Note the cut back voussoirs that create the arch.

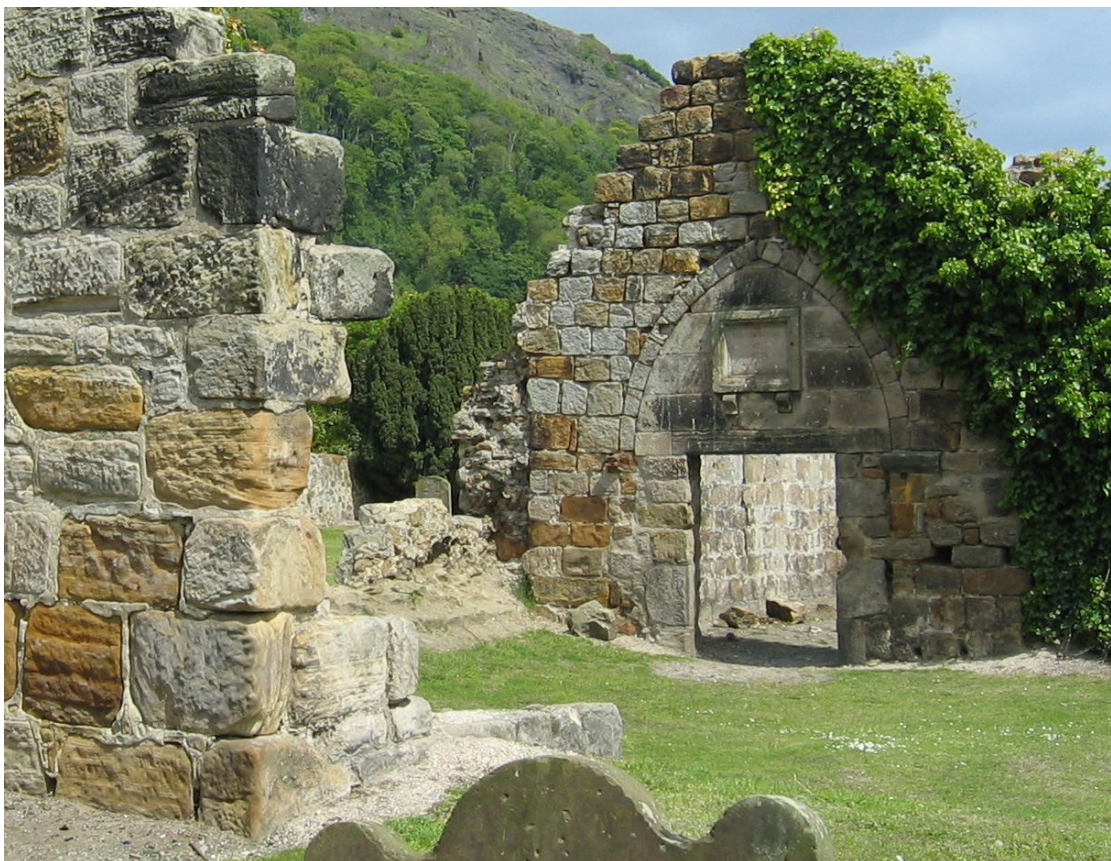
*Figure 9.23*

Figure 9.23. (Table 9.1). The ruined church of St Serf, Kirkton, Burntisland (NT 232 864) in its visibly closest south-west quoin displays a quoin structure representative of Anglo-Saxon style workmanship.

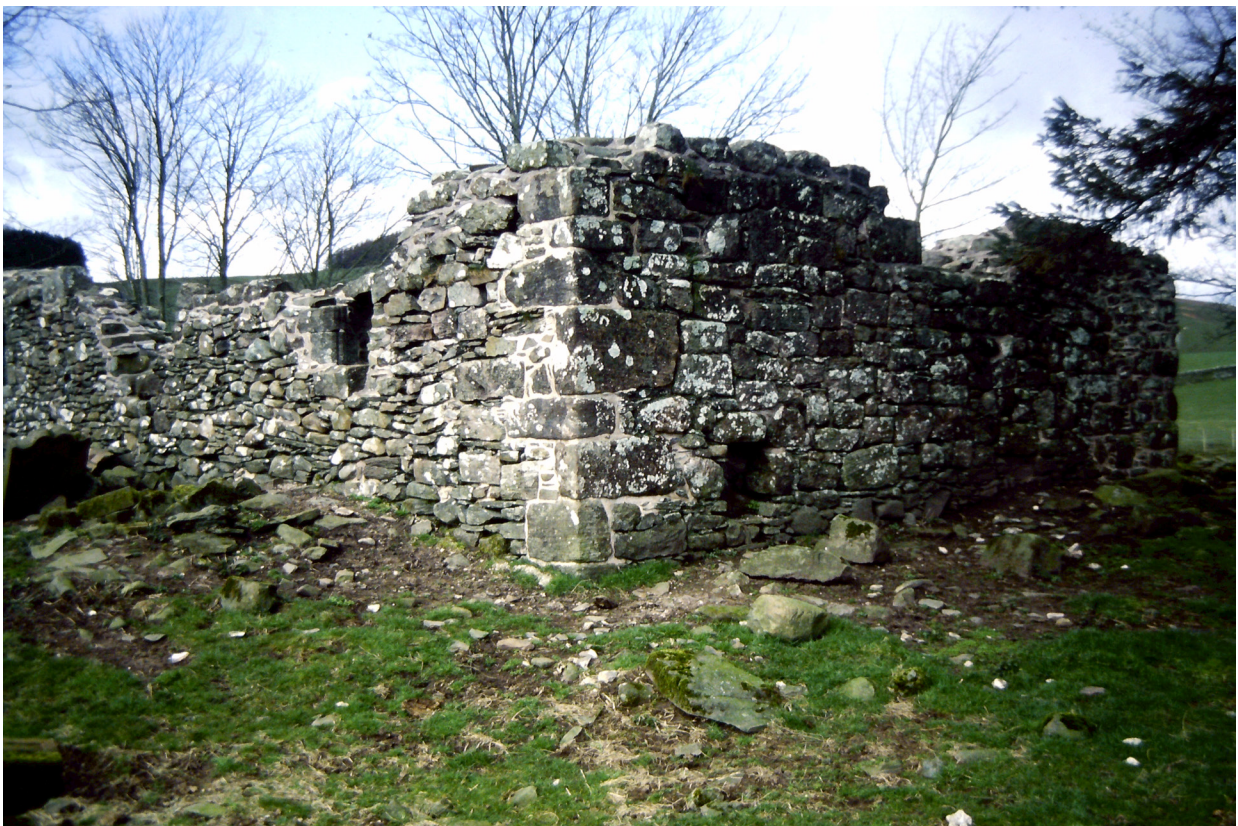
Figure 9.24. (Table 9.1). The ruined church of Little Dalton, in Dumfries (NY 090 747), in the Scottish West March, possesses a south-east quoin where the stonework is 'Patterned'.

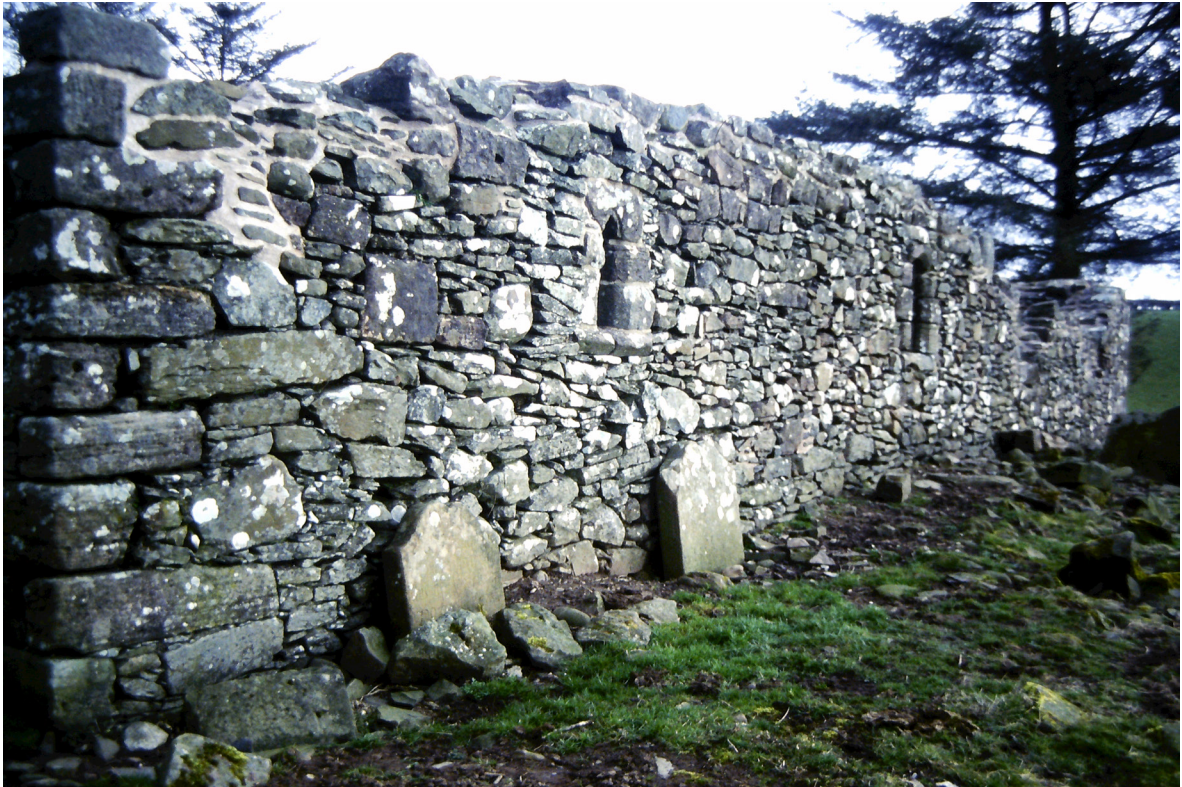
*Figure 9.25*

Figure 9.25. (Table 9.1). The south wall and south-west quoin of the same Little Dalton church is somewhat later in age; note the horizontally bedded rocks which are used to create the quoin.

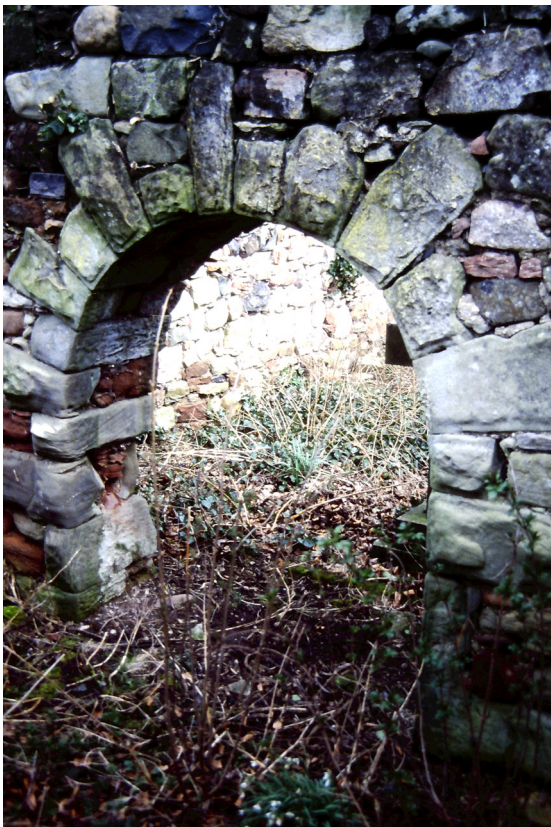
*Figure 9.26*

Figure 9.26. (Table 9.1). A further ruined church, that at Preston in Berwickshire and in the Scottish East March (NT 786 570), shows some evidence of early Anglo-Saxon building, as in a few stones in the south jamb of the later unusual chancel arch.

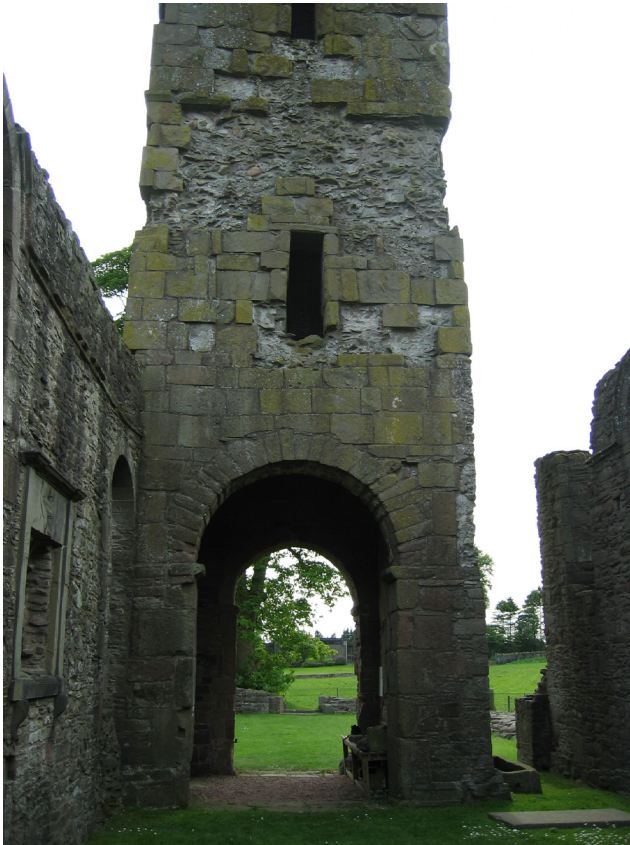
Figure 9.28. (Table 9.1). The east side of the tower arch of Restenneth church reveals a significant amount of building in Anglo-Saxon ('Patterned') style.

-	See Potter (2008). <b>See Figures 9.27, 9.28. 9.29, 9.30</b>
-	<b>See Figure 9.31</b>
-	<b>See Figure 9.32</b>
-	See Potter (2008). <b>See Figures 9.33, 9.34, 9.35, 9.36</b>

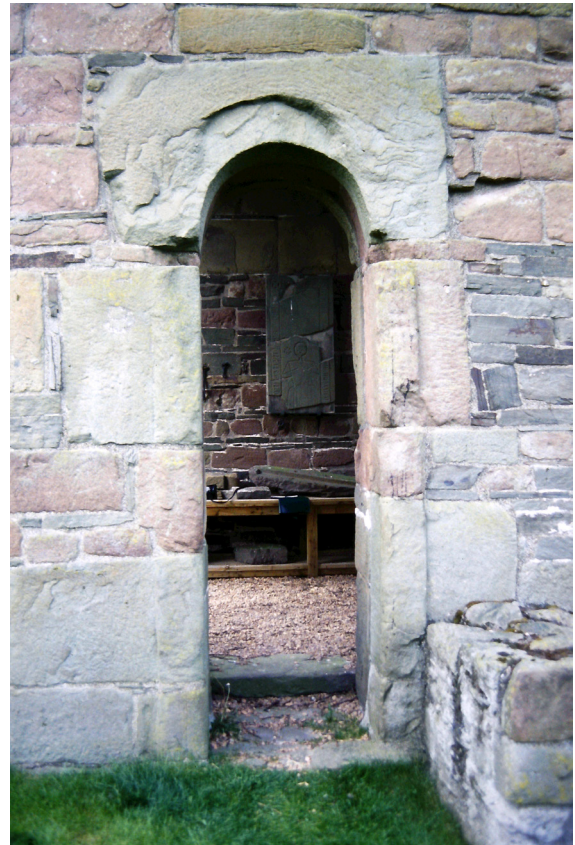
Figure 9.29. (Table 9.1). The south door of the tower at Restenneth is here viewed from the exterior. The cut back pilaster-strip (architrave) can be seen cut to the width of the third stone above the ground in the right jamb.

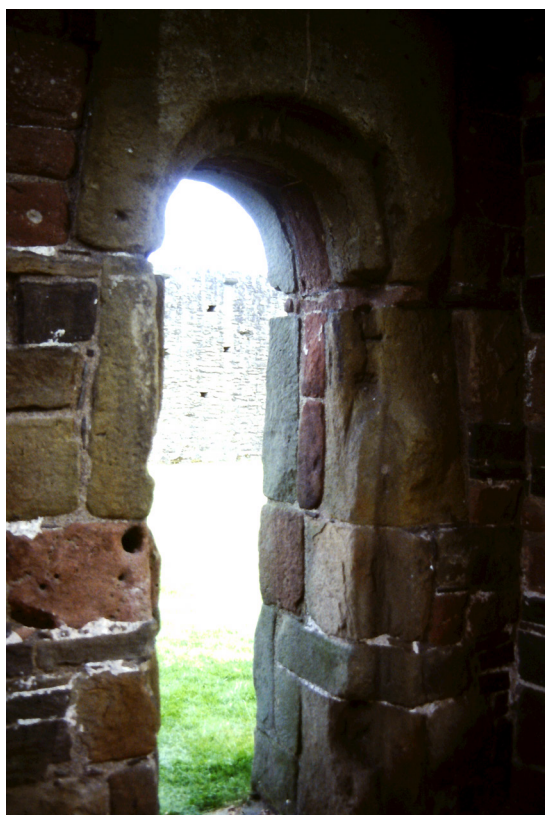
*Figure 9.30. (Table 9.1). The same tower south door at Restenneth viewed from the interior. The structure of this doorway is closely similar to that of the two Heysham churches in Lancashire.*

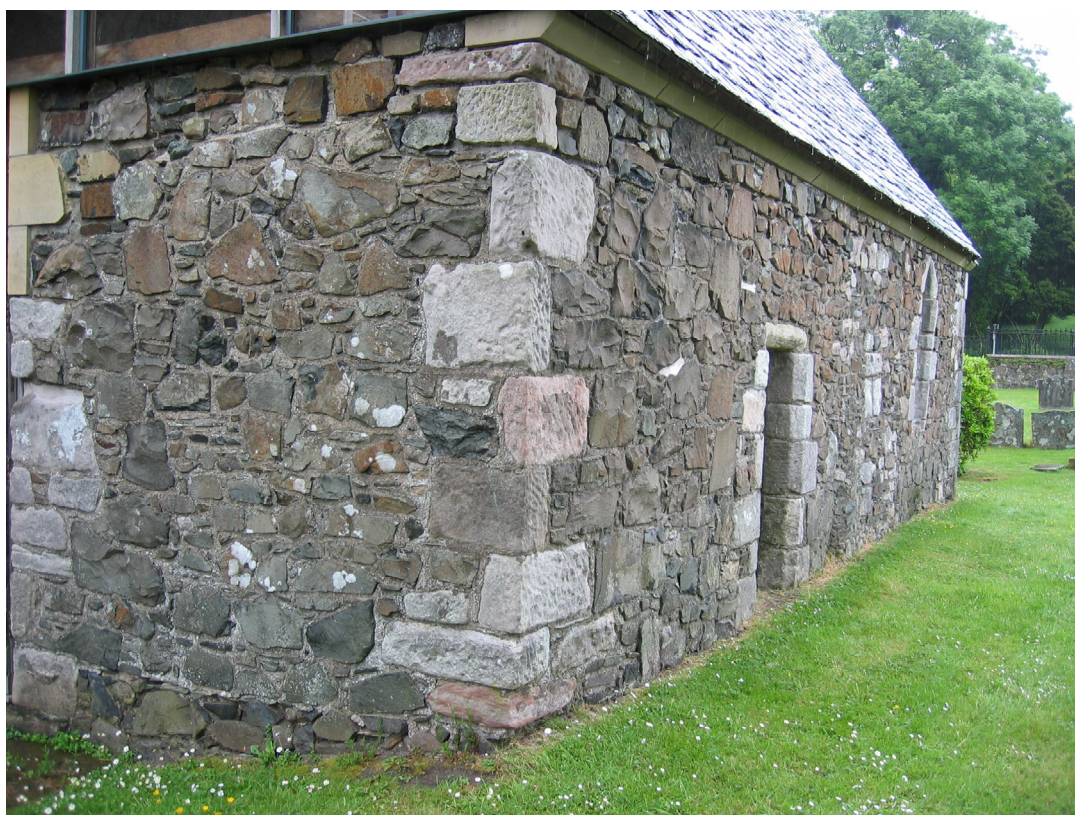
*Figure 9.31. (Table 9.1). The south-west quoin of St Mary, Rothesay, Bute (NS 085 636) remains partially built to 'Patterned' style.*

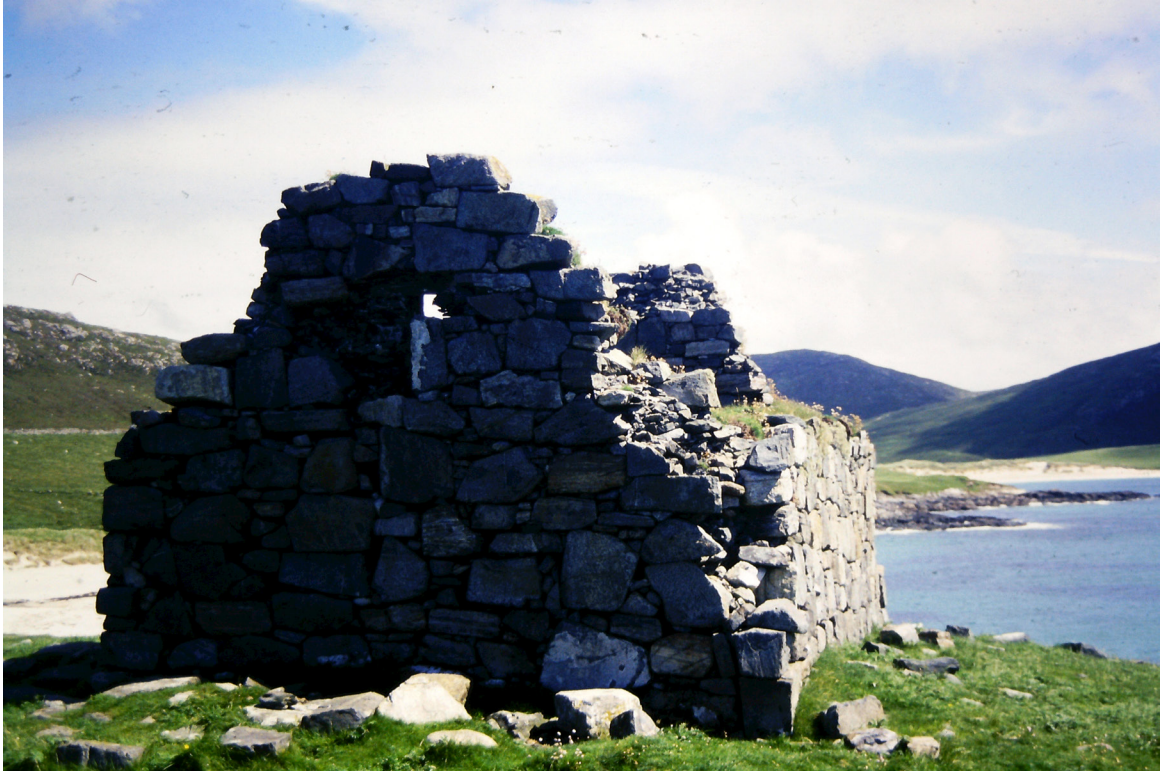
Figure 9.32. (Table 9.1). The ruin of Rudh' an Teampuill chapel, Harris (NF 970 913) in which the north-west and north-east quoins show evidence 'Patterned' style building.

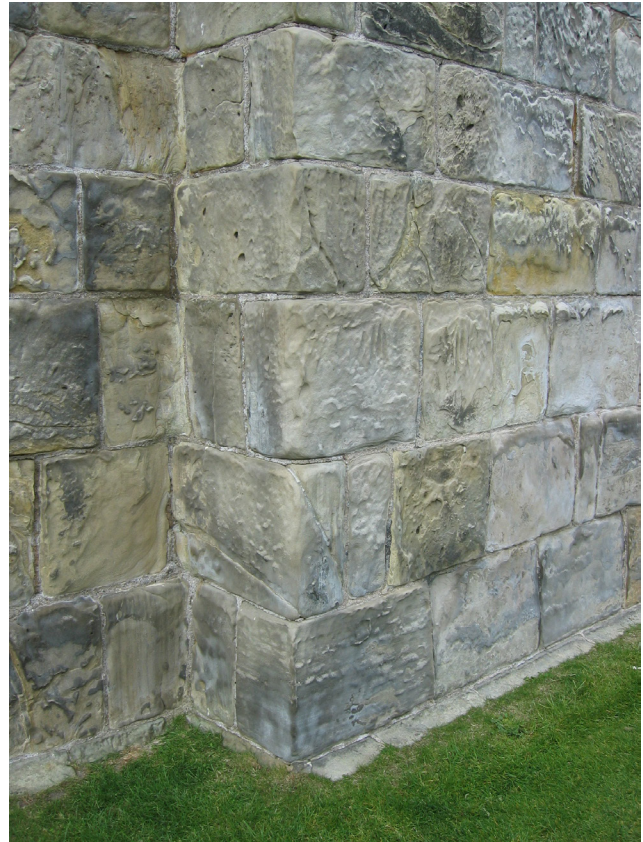
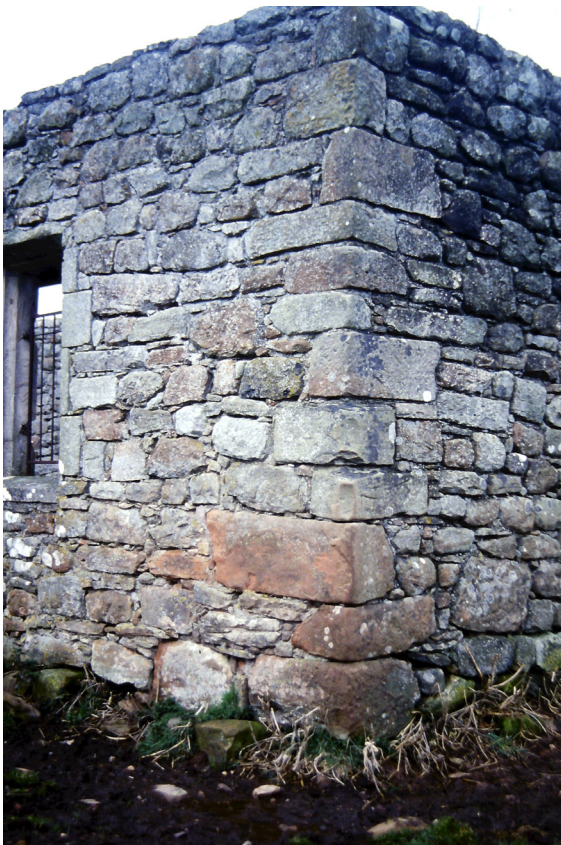
Figure 9.36. (Table 9.1). The detail of the plinth and stones 1 to 5 in the south-west chancel quoin of St Rule: above the plinth the stones in ascending order are set with their bedding orientated, BH, BVFL, BVFR, BVFL, BVFR, in Anglo-Saxon or 'Patterned' style.

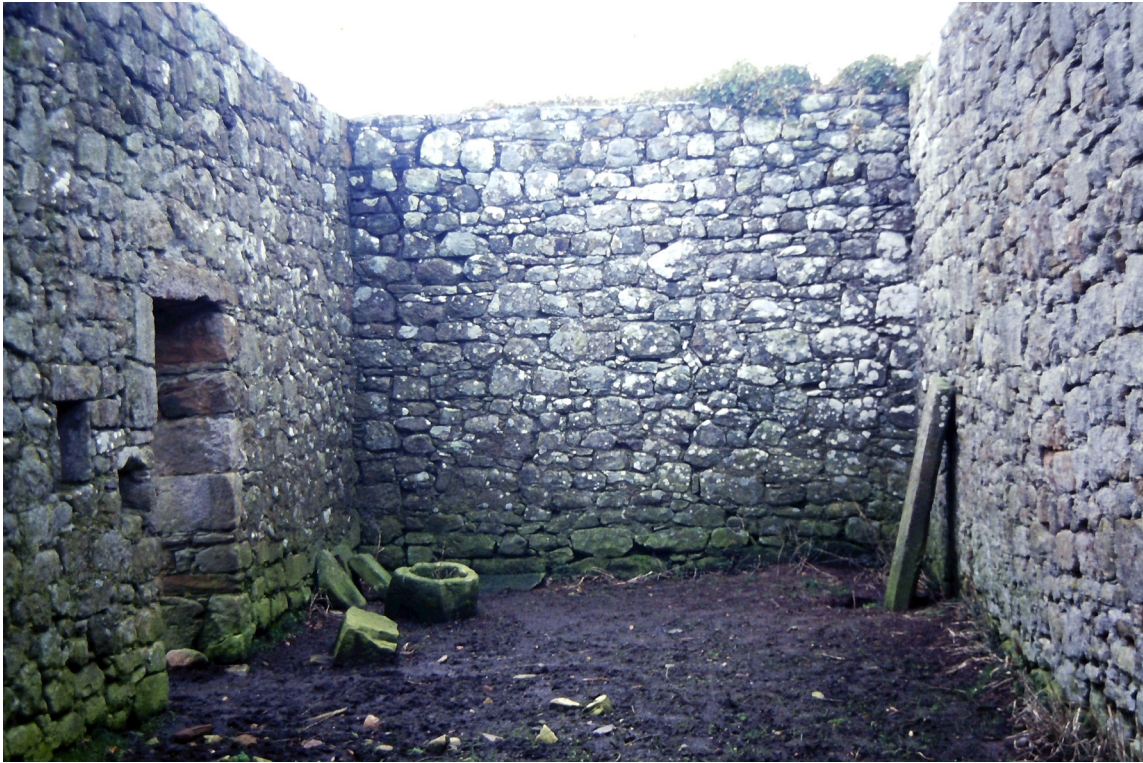
Figure 9.38. (Table 9.2). Access to the interior of Bassendean church is through the south door, as seen towards the west-south-west. Brooke observed 'there is evidence of a substantial draw-bar and lock-mortices to protect a door'. Regrettably, these were not observed by the present author.

<b>East March</b>
Auldcambus, Berwickshire (limited ruins, overall construction)
Bassendean, Berwickshire (ruin, overall construction). <b>See Figures 9.37, 9.38</b>
Chirnside, Berwickshire (much rebuilt, tower and documentary evidence)
Coldingham Priory, Berwickshire (documentary evidence)
Dryburgh Abbey, Berwickshire (perimeter wall, gun-loop, documentary evidence)
Dunglass, Lothian (overall construction, documentary evidence). <b>See Figure 9.39</b>
Ellemford, Berwickshire (limited ruins, restricted site)
Greenlaw, Berwickshire (much rebuilt, tower, documentary evidence)
Ladykirk, Berwickshire (tower, overall construction)
Swinton, Berwickshire (documentary evidence)
<b>Middle March</b>
Biggar, Lanarkshire (tower with shot holes in parapet).
Hermitage Castle Chapel, Roxburgh (ruin, construction details, earthworks, documentary)
Jedburgh Abbey, Roxburgh (archaeological excavations, documentary evidence). <b>See Figure 9.40</b>

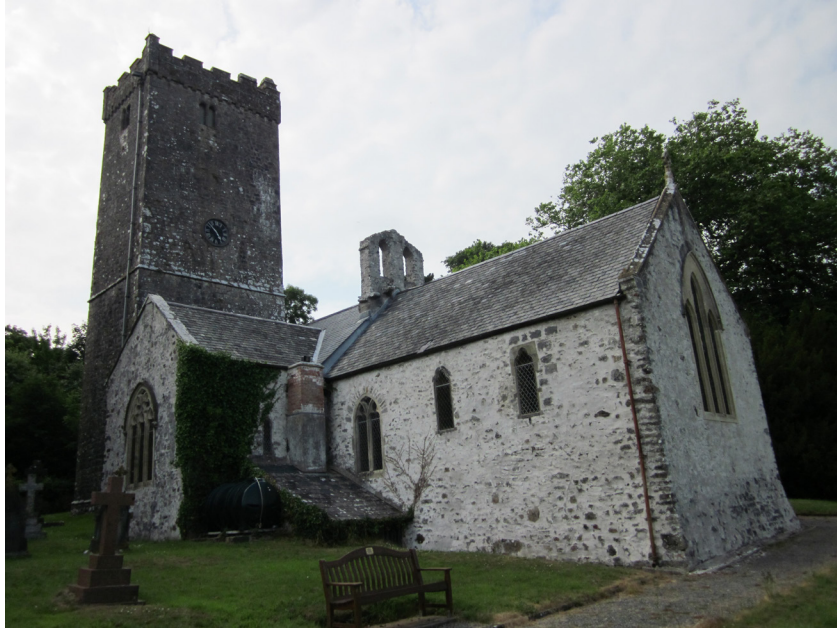
*Figure 10.3. The chancel of St Caradoc church, Lawrenny, Pembrokeshire (SN 016 068) had received an unsatisfactory coat of fairly recently applied lime plaster when this photograph was taken. On the east face of the tower the one time contact with a much higher nave roof line (above the clock) is just visible. Such a roof would have included the nave aisles in its cover. The aisles have been replaced by transepts where the aisle hagioscopes can now be used.*

Evidence of the facility of higher levels of communication on at least a second floor can be seen at churches such as St Caradoc, Lawrenny (SN 016 068) (see Figure 10.3), Llandyfaelog church (SN 414 119) (see Figure 10.4) and (as seen in Figure 10.5) St Illtwd, Llantwit Major (SS 966 687). Llandow church, in Glamorganshire (SS 943 734) (Figure 10.6) provides an example of a church in which the chancel arch was intentionally reduced in width. A small number of Welsh churches display double-storey porches (Figure 10.7) perhaps providing accommodation for an appointed priest.

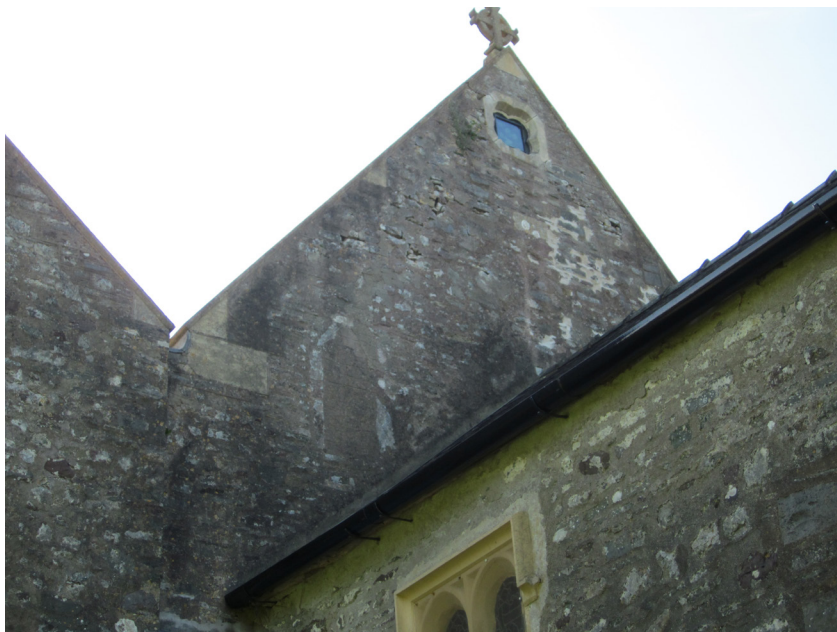
*Figure 10.4. The Carmarthenshire church of St Maelog, Llandyfaelog (SN 414 119) viewed from the south-east to show the east gable of the nave. The chancel has been rebuilt at a lower level than its predecessor. The outline of a doorway can be seen on the heavily rendered east nave wall. This doorway provided, for Wales, a facility for unusual high level communication between nave and chancel, a feature considered as assisting the defensibility of the church. The window in the nave gable appears to be above the earlier chancel roof line.*

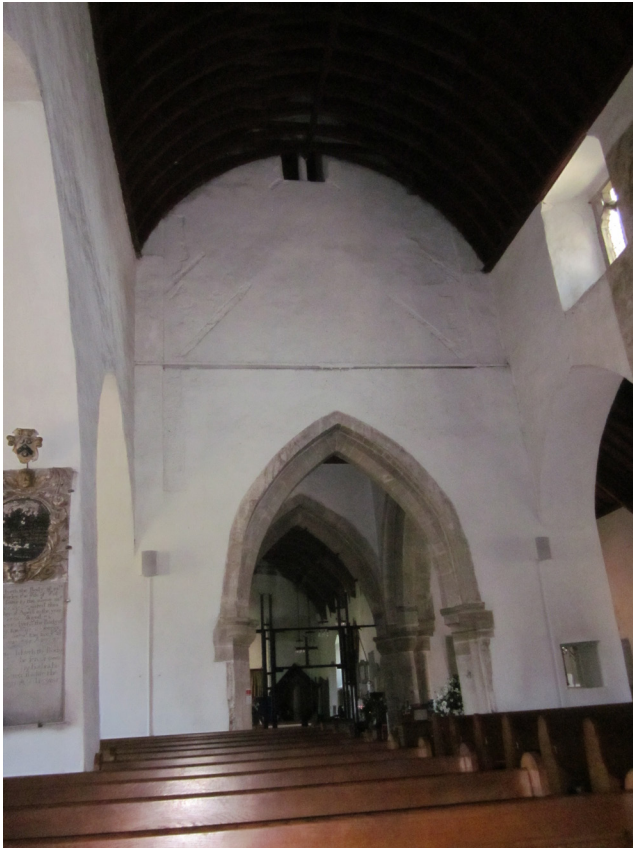
Figure 10.5. St Illtud church, Llantwit Major, in Glamorgan (SS 966 687) has Anglo-Saxon origins some of which are best shown in the stonework of the south chancel wall of the 'East Church' (Potter, 2013, 215-9). High early roof lines are visible inside the church on the east wall of the tower.

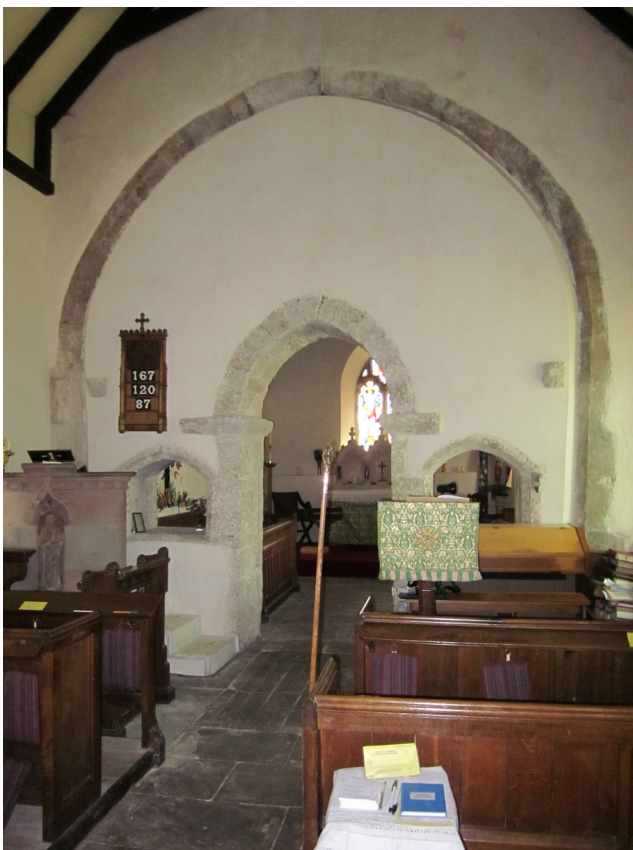
Figure 10.6. A characteristic of many churches regarded as showing defensible features is the occurrence of tower or chancel arches having been reduced in size. This is seen at Holy Trinity church, Llandow, Glamorganshire (SS 943 734), where the original Norman chancel arch (the age of which can be identified from the jamb stonework), which is seen here from the west, has been replaced by a smaller (probably 13th C.) arch.

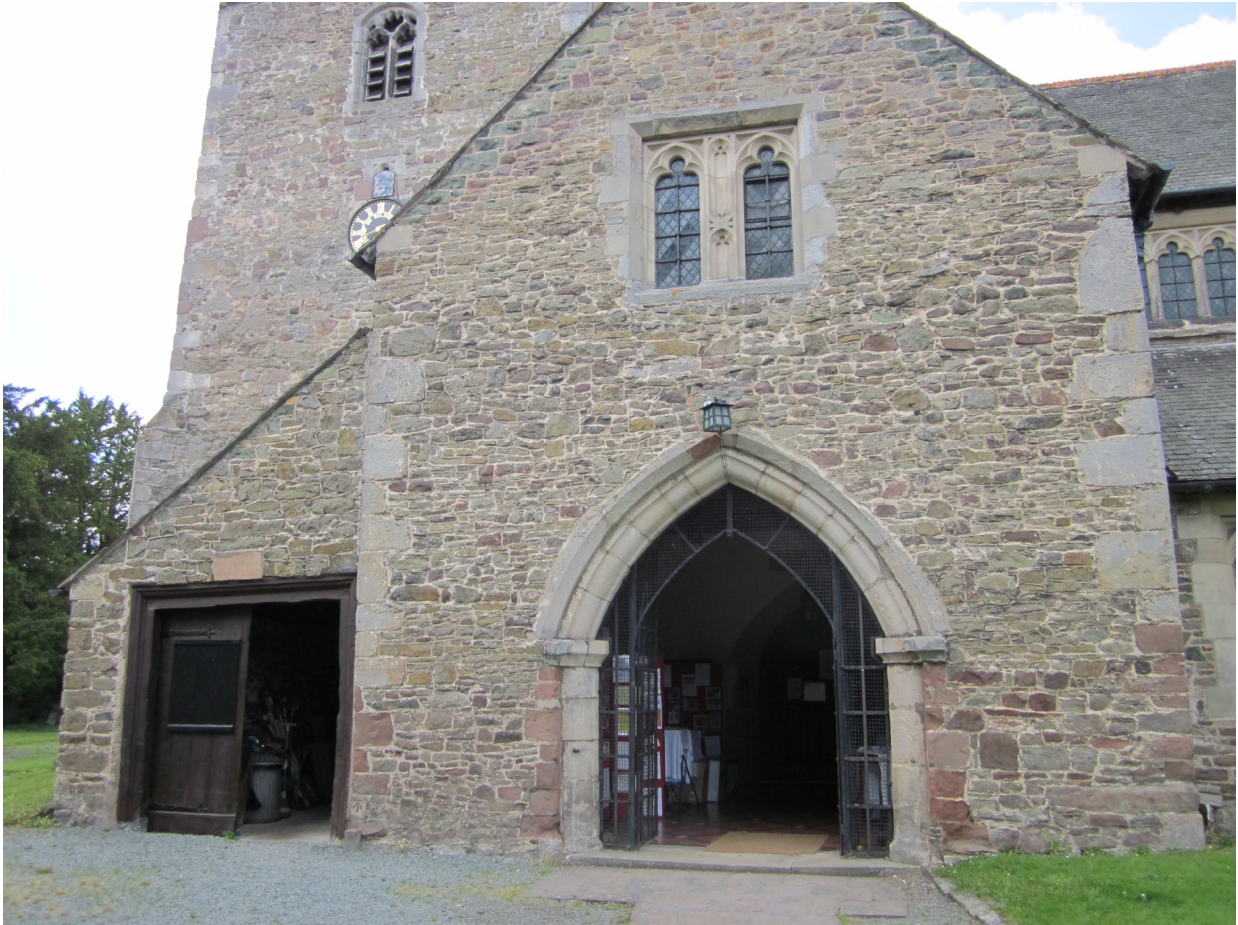
*Figure 10.7. St Aelhaiarn, Guilsfield, in Montgomeryshire (SJ 219 116) is one of only a few churches in Wales which has a two storey porch; this example was built prior to 1739. The second storey in some similar porches, and possibly in this instance, was used to provide accommodation for a priest in residence.*

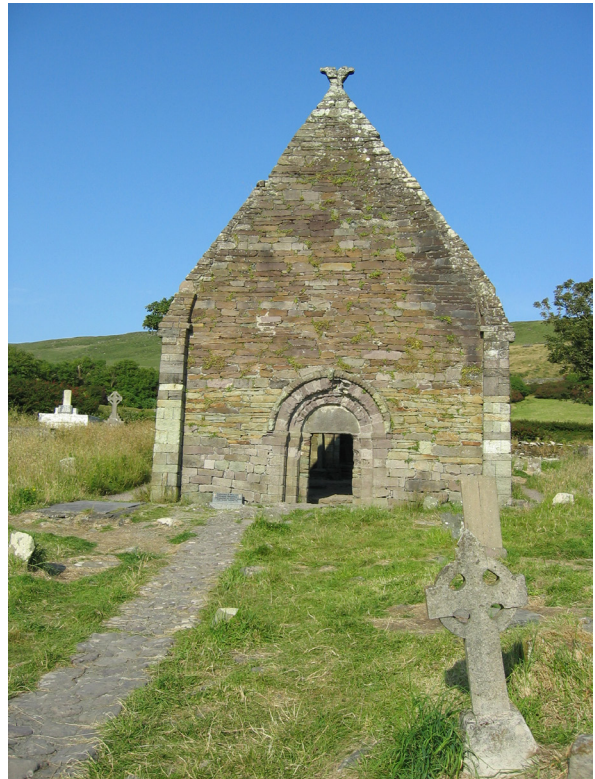
Figure 11.6. Kilmarkedar church, Dingle, Kerry (Q 403 062) is viewed here to display the west gable. The antae rise to roof height where they are 'capped' with slightly broader stones; they then continue a very short distance in line with the roof. The finials are, however, constructed on the top of the gable and are not associated with the antae. There are two, possibly three, building periods involved with the construction of the west gable wall, the earliest rising in height only to the top of the arch jambs.
