# Bar Locks and Early Church Security in the British Isles

John F. Potter

Access Archaeology

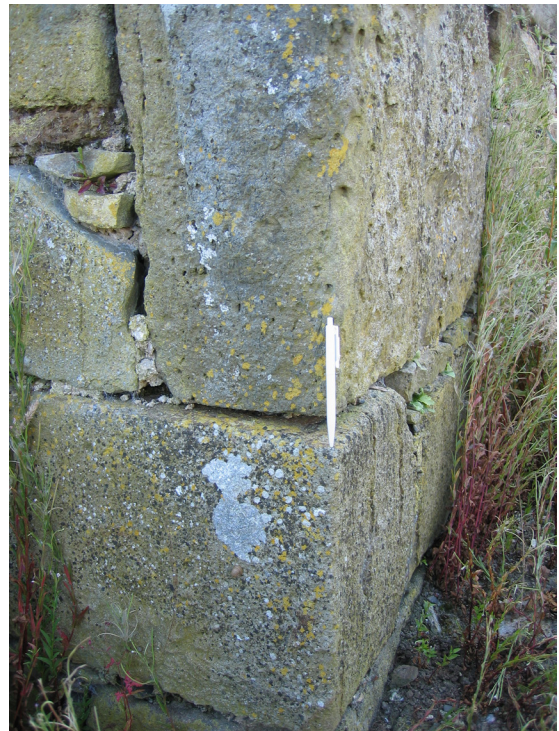
Figure 11.8 Detail of two stones in the north-east quoin of Rattoo church, Kerry (Q 878 336). The bedding in these calcareous sandstone blocks, which represented stones 2 and 3 in the quoin, is orientated BVFL, BVFR, as such in Patterned style. That Irish churches may preserve ornamented quoins tends to be overlooked. The church is not referred to in Ó Carragáin (2010). Rebuilding work subsequent to 2009 could mean that the stones may no longer be in the same position in the quoin.

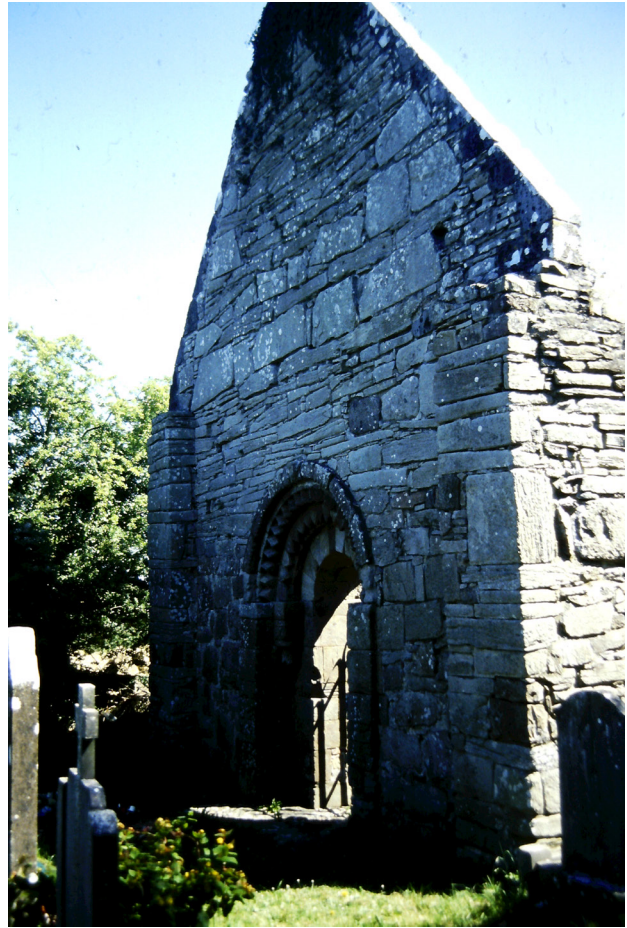
Figure 11.9. The west face of Clonkeen church (R 689 547) as viewed from the south-west. Although the lowest part of the west gable wall (and short stretches of the north and south walls) are considered to be of Patterned age, the *antae* have been entirely rebuilt (probably, in part, since the church fell into disuse in the mid-17th C.), with some of the stones being relatively modern. The stonework settings of the west doorway are Romanesque (possibly partly including re-used earlier stones).

- b) Manning (1998, 76), Ó Carragáin (2005a, 139) and others, have suggested that the amount which *antae* project beyond their respective gable walls (their depth) might reflect the date of origin of these structures. They proposed that those of earliest origin were the examples which projected the greatest. Ó Carragáin cited, for instance, the church at Clonkeen, County Limerick (R 689 547), where he stated, ‘...the pre-Romanesque *antae*...are 0.66m deep; those of its Romanesque extension are 0.30m deep’. Many of the *antae* examined by the present author have been extensively rebuilt, and Clonkeen provides no exception. All of the *antae* at Clonkeen have been rebuilt (Figure 11.9), with

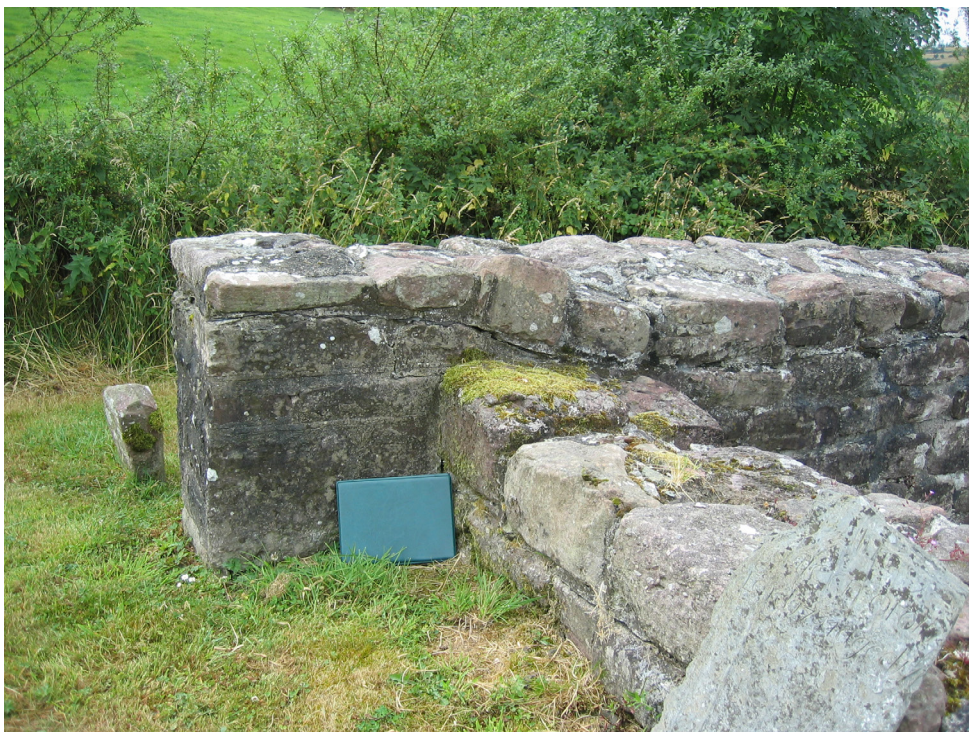
Figure 11.10. Labbamolaga small church, County Cork (R 764 176), classified by Ó Carragáin (2010, 66) as a shrine-chapel with antae, is viewed here to show the south-east anta (folder length, 315mm.).  
Note that the stones of which the anta is created are all laid with their bedding horizontal.

some of the rebuilding including stones dressed and inserted in recent centuries. Labbamolaga small church (Figures 11.10; 11.11) provides a typical example of the problems of rebuilt *antae* and the difficulties of trying to assess their date of construction from the differences in amounts the *antae* project from their associated gable walls. Nevertheless, the present author measured the projection length and the breadth of all *antae* observed and tabulated these figures together with their likely age of construction as determined from their stonework (see Potter, 2009c, 173, Table 6.1). In 2010, Ó Carragáin accepted levels of rebuilding in both churches.

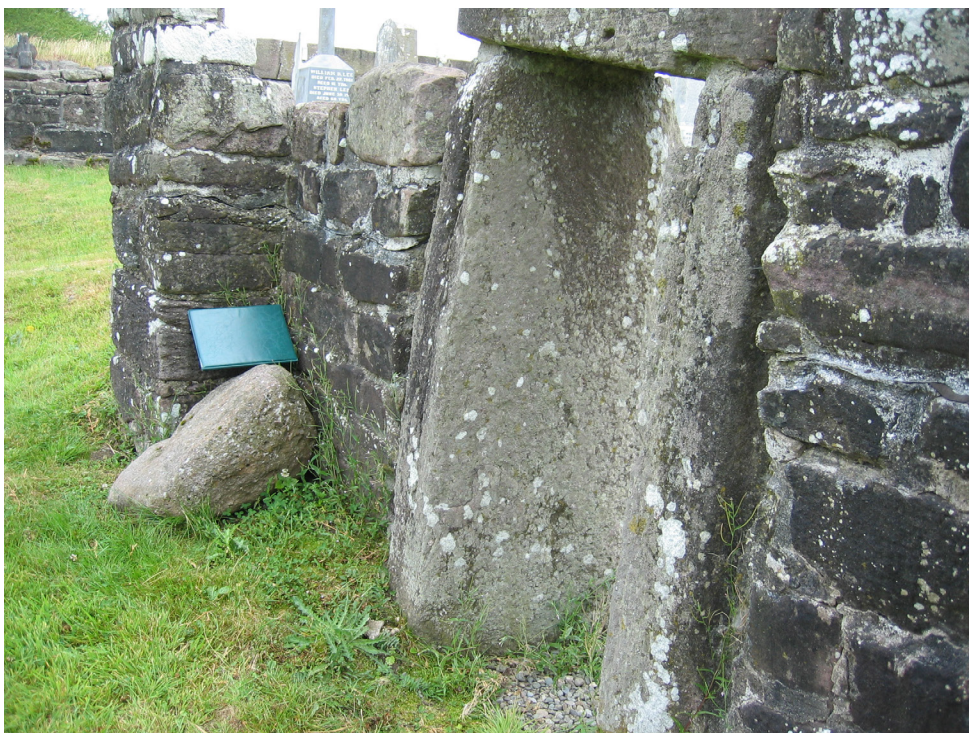
Figure 11.11. The same Labbamolaga church to show the shorter north-west anta and the west doorway which is set to Patterned style (vertically bedded jamb stones). The north-west anta is built in the same manner as that in the south-east with all stones set BH and both antae have been rebuilt.  
Ó Carragáin (2010) indicates that just the south-east has been rebuilt.

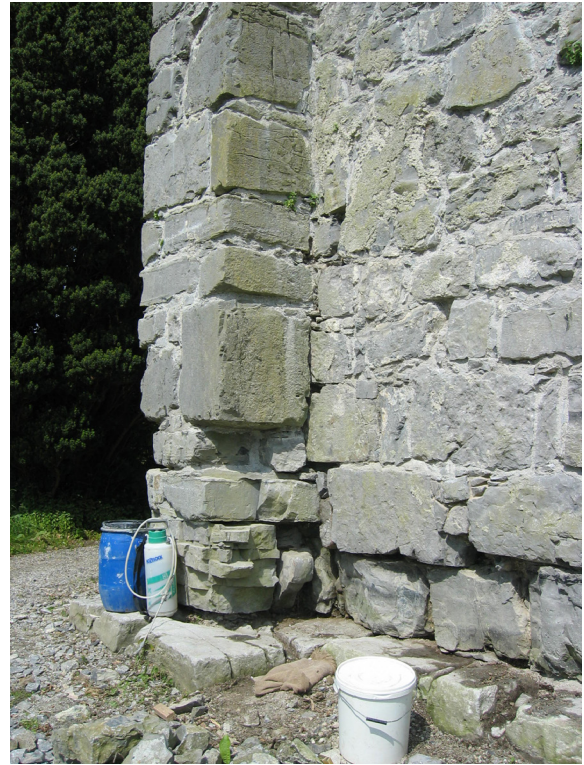
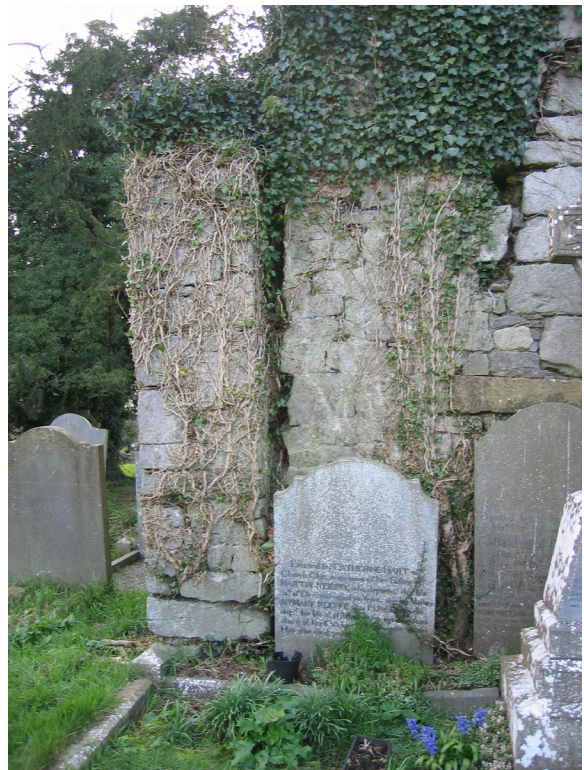
Figure 11.13. The south-east anta at Clara church, Kilkenny (S 578 564) is slightly displaced from the east gable wall. Bonding between the two walls when viewed from the east appears to be negligible, and of the two walls in this view the gable wall appears to be of a more recent date.

- d) An unusual aspect of *antae* construction is that, in many instances when the simple, single-celled church is closely examined, the gable walls appear to lack any proper stone bonding externally with their respective north and south walls (see Figure 11.13). One wall appears to abut directly upon the other. Exceptions tend to occur only where walls have been repaired. The external appearance is, therefore, of the north and south *antae* walls having been built first. One of the earliest detailed descriptions of a church with *antae* was provided by Biggar (1896) following a visit to St MacDara on the Atlantic island of the same name, off Galway. In this description Biggar noted that slight bonding did actually exist (as did the present author at other sites), with stones perhaps every three or four courses being inserted a small amount into the opposing wall (Figures 11.14). Initially, the present author suspected that what was an apparent lack of wall bonding was provided intentionally by the early Christian mason as an act of deception to frustrate any assailant, guiding that person to an area of the wall from which it would prove impossible to remove further stones (for internally, stones would remain interlocked). Such early

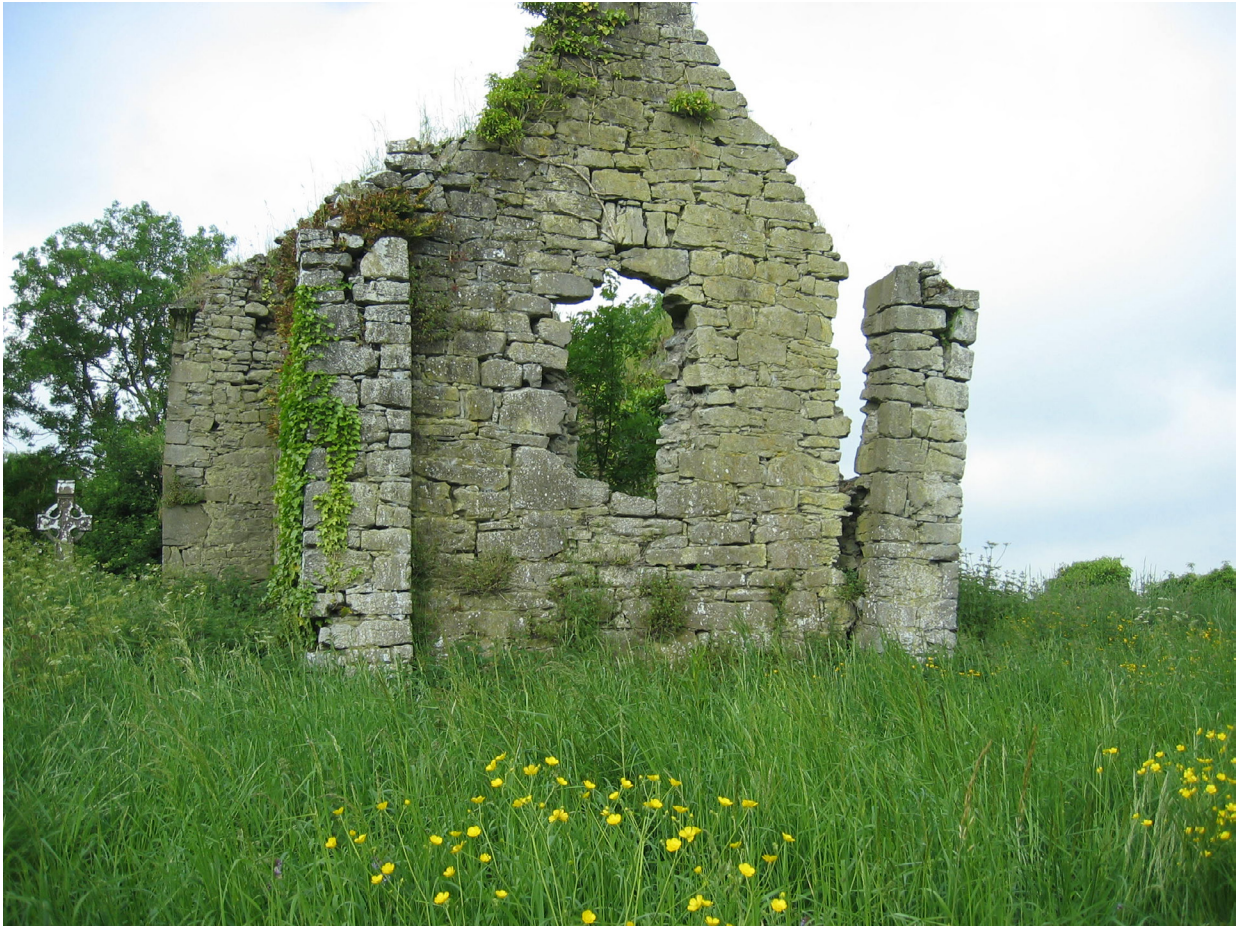
Figure 11.14. In the years leading up to 2009 the north-east anta at Sheastown church, Kilkenny (S 544 523) started to fall away from its adjoining east gable wall. The east end of the site is viewed in this photograph.

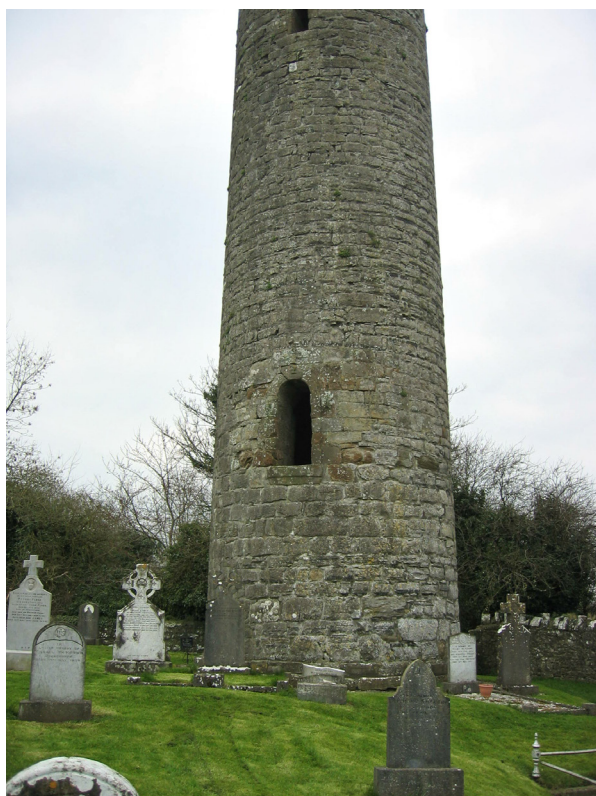
*Figure 11.16. The lower part of the tower at Donaghmore, South Tipperary (S 188 291) which is built of Carboniferous Limestone. Sufficient evidence is visible from the stonework to determine that the tower is of Romanesque age. Note the height of the doorway.*

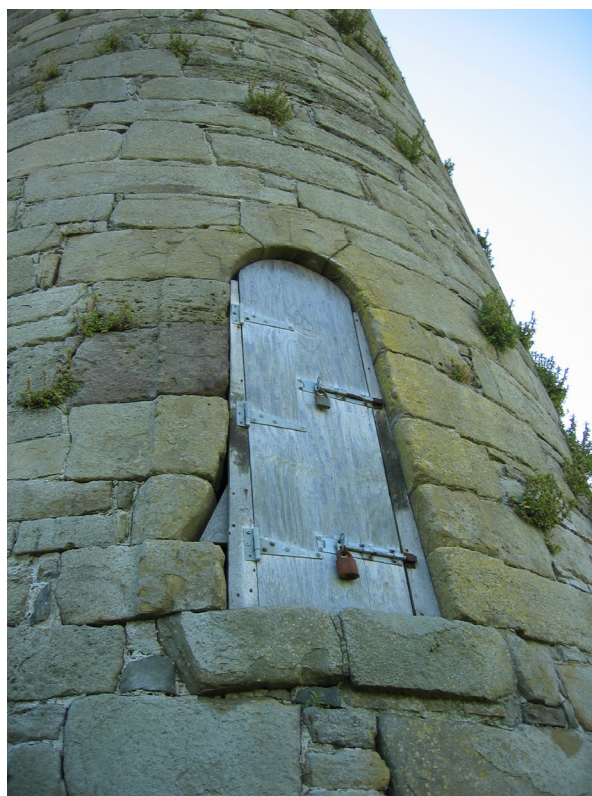
*Figure 11.17. The round headed doorway to Rattoo tower, Kerry (Q 878 336) is of interesting stonework and is probably of early Romanesque age. The door is relatively modern.*

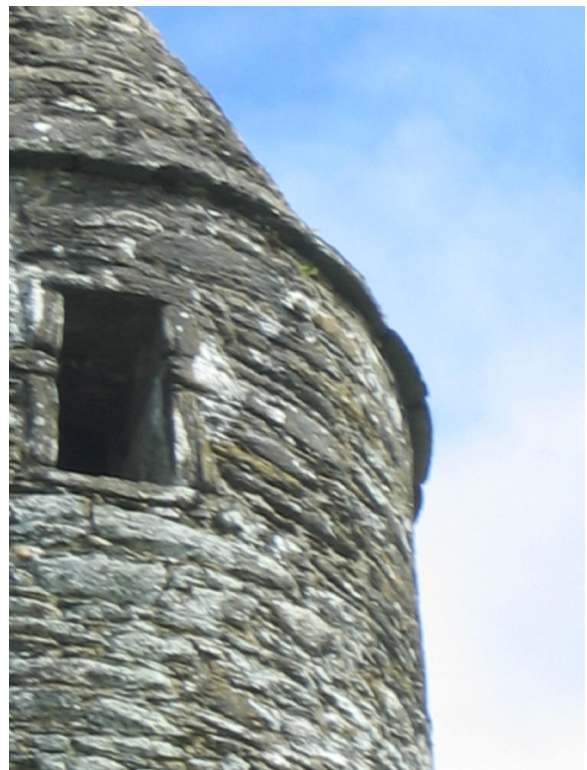
*Figure 11.19. The west window at the top of the Glendalough round tower is constructed of blocks of phyllite which are clearly set in Patterned style. The jambs, each of three stones, are placed in long and short setting and orientated BVFIA, BH, BVFIA.*

The author was extremely fortunate to visit the Glendalough site on an occasion when he was able to view (with binoculars) the tower's features in bright low setting sunlight (but regrettably the camera was hand held). Figures 11.18 to 11.21 reveal that the tower windows stonework was in the main created to the Patterned style. The doorway to Glendalough tower has been reconstructed in blocks of granite (Figure 11.22), and the lichen attracted to this rock type covers any possible lineation that might otherwise be visible on the granite surfaces.

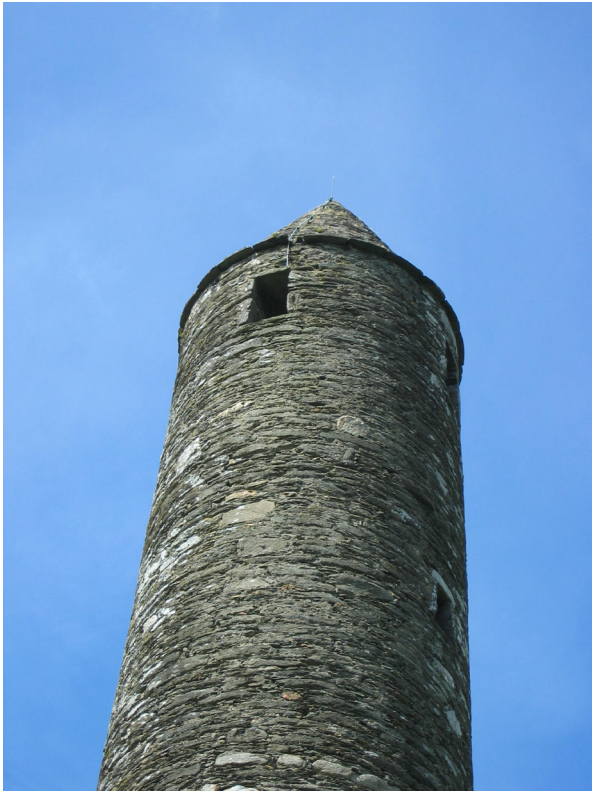
Figure 11.20. The south window at the top of the Glendalough round tower, is similar to the west window (Figure 11.19), but the right jamb appears to have three BH between the BVFIA stones.

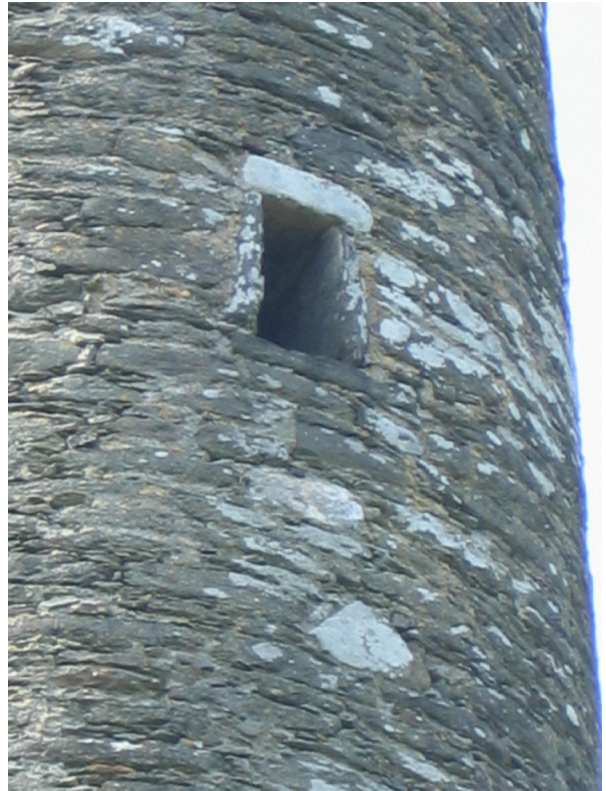
Figure 11.21. Such well illuminated windows in Irish round towers are so rare that one further window from the Glendalough display is shown in this figure. The east window on the level below those at the top of the tower (Figures 11.19 and 11.20) is captured in this photograph. It shows the jambs are in this instance constructed of single large BVFIA stones.

The lintel stone attracting the lichen may be of granite.

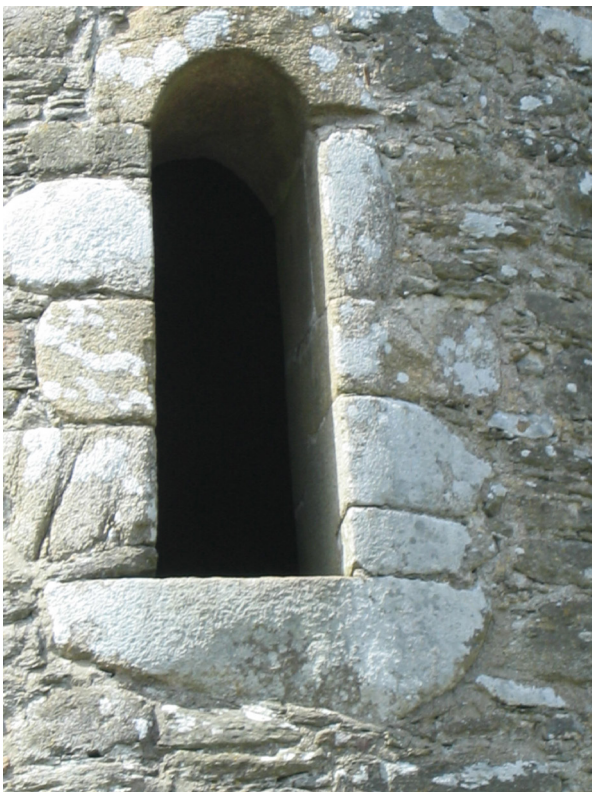
Figure 11.22. The doorway to the Glendalough round tower is largely reconstructed of granite (upon which lichen grows readily). Any lineation in the granite stones is, therefore, impossible to determine.

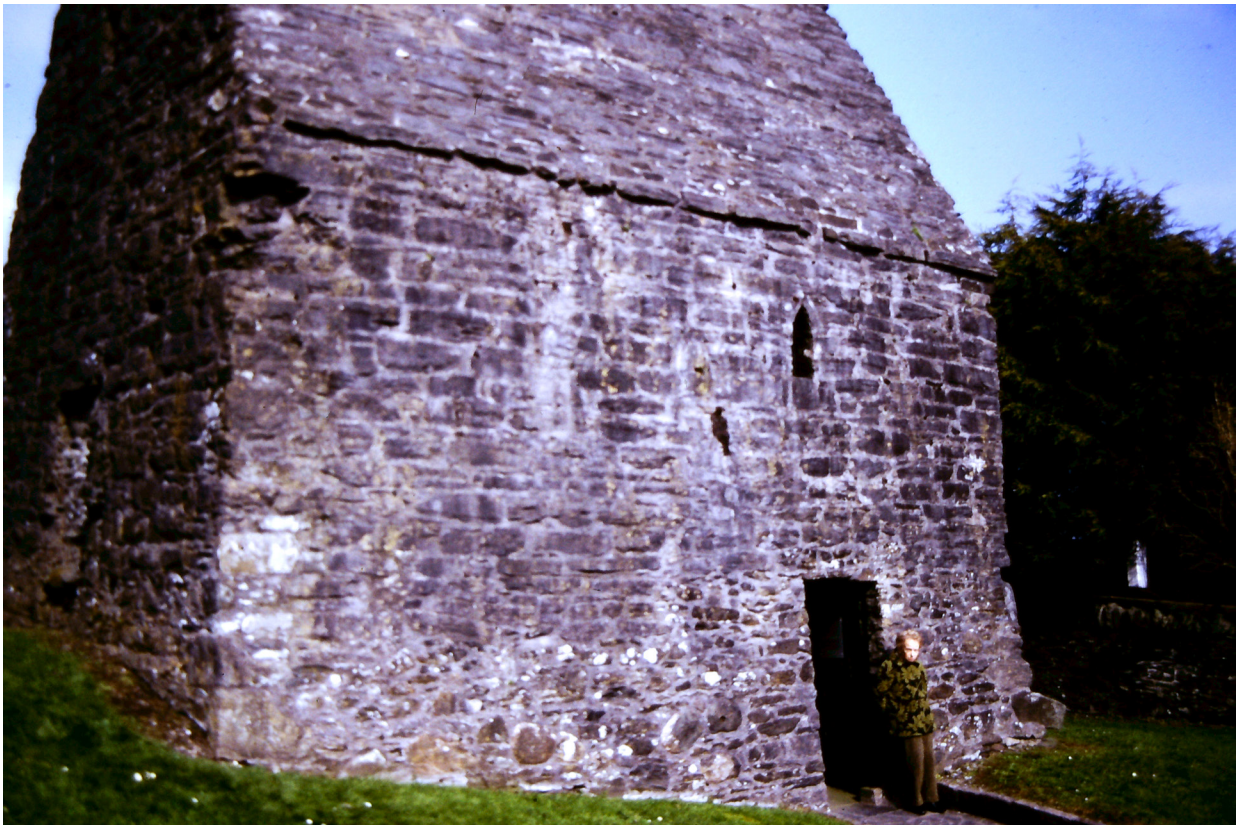
Figure 11.23. St Columcille's house, Kells, Meath (N 740 758) is viewed here from the south-west. A wall fabric change near the base of the south wall can be distinguished. The south doorway is reasonably modern and now provides the access to the building.

A small number of Irish churches have been classified by Ó Carragáin (2010) as double-vaulted. These churches contain a relatively inaccessible chamber on their upper floor, reached only by ladder, which must certainly have provided an element of security, although Ó Carragáin does not suggest this for being a reason for their structure. Perhaps the most famous of these is variously named as St Columba's or St Columcille's house, and is evident at Kells, Meath (N 740 758); see Figures 11.23 to 11.25. A further example (Figure 11.26) may be seen at St Kevin's house, Glendalough (T 123 967).

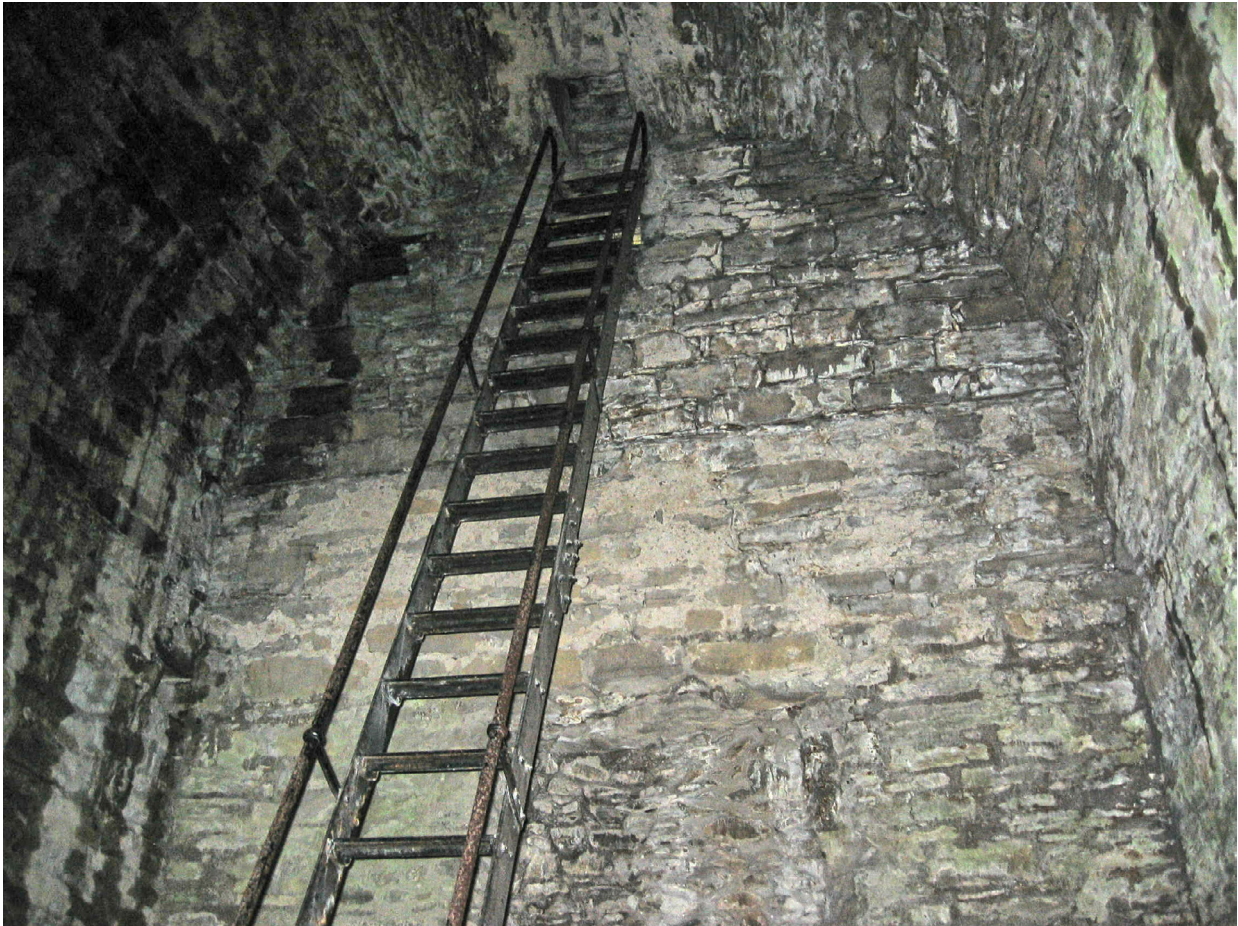
*Figure 11.24. Inside St Columcille's house, Kells, the interior of the west wall displays a fabric change at gable level, indicating rebuilding at the time of construction of the vault and the roof, now accessed by ladder.*

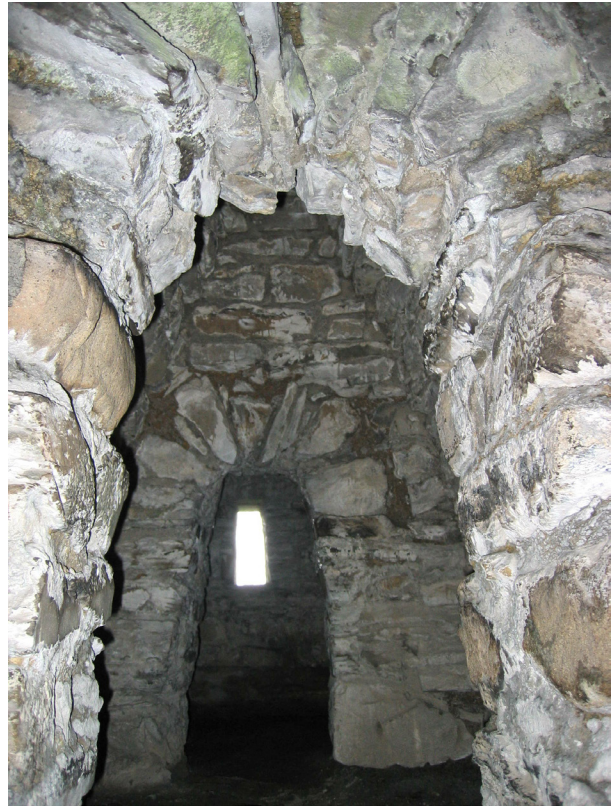
Figure 11.25. The 'propping arches' which are built into the interior of the roof of St Columcille's house, Kells.

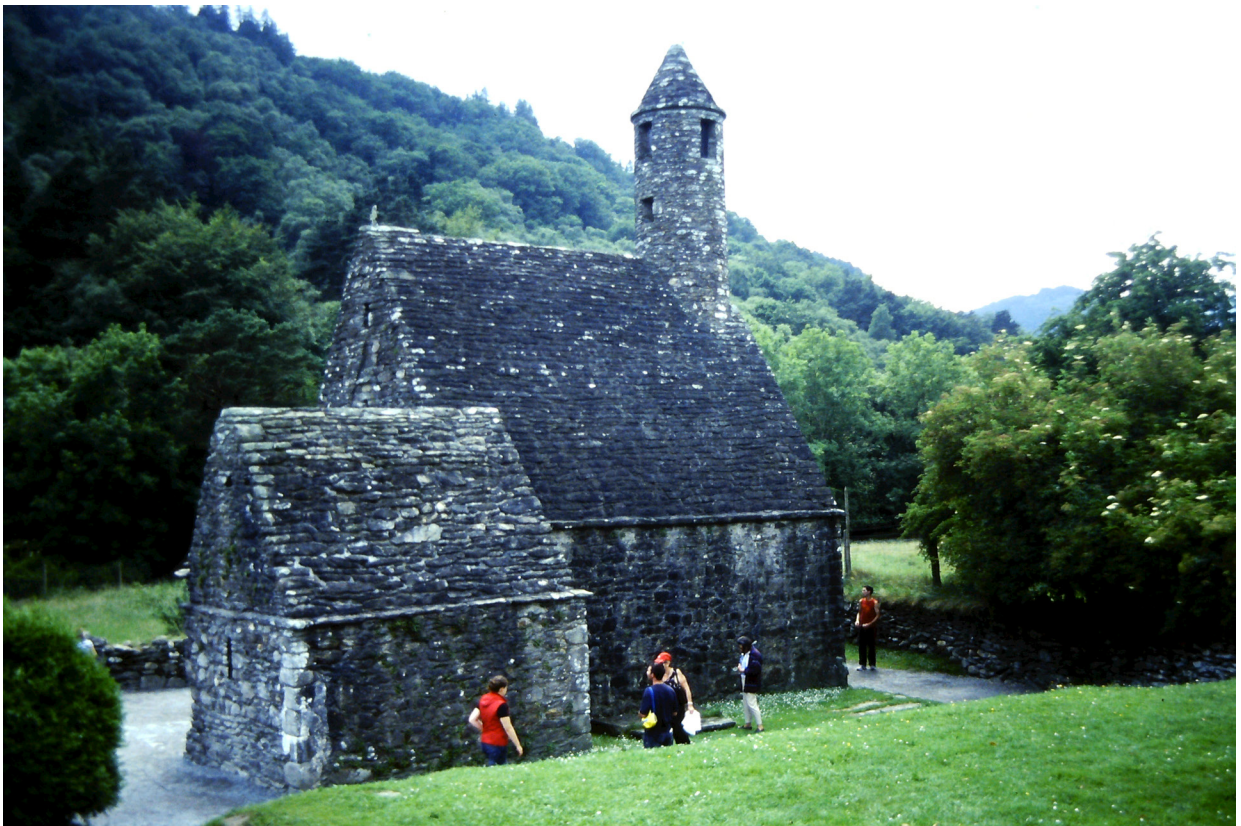
Figure 11.26. Viewed from the north-east, St Kevin's house, Glendalough, Wicklow (T 123 967). Evidence of an upper floor can be observed externally by the small windows which can be seen at the appropriate level when walking round the site.

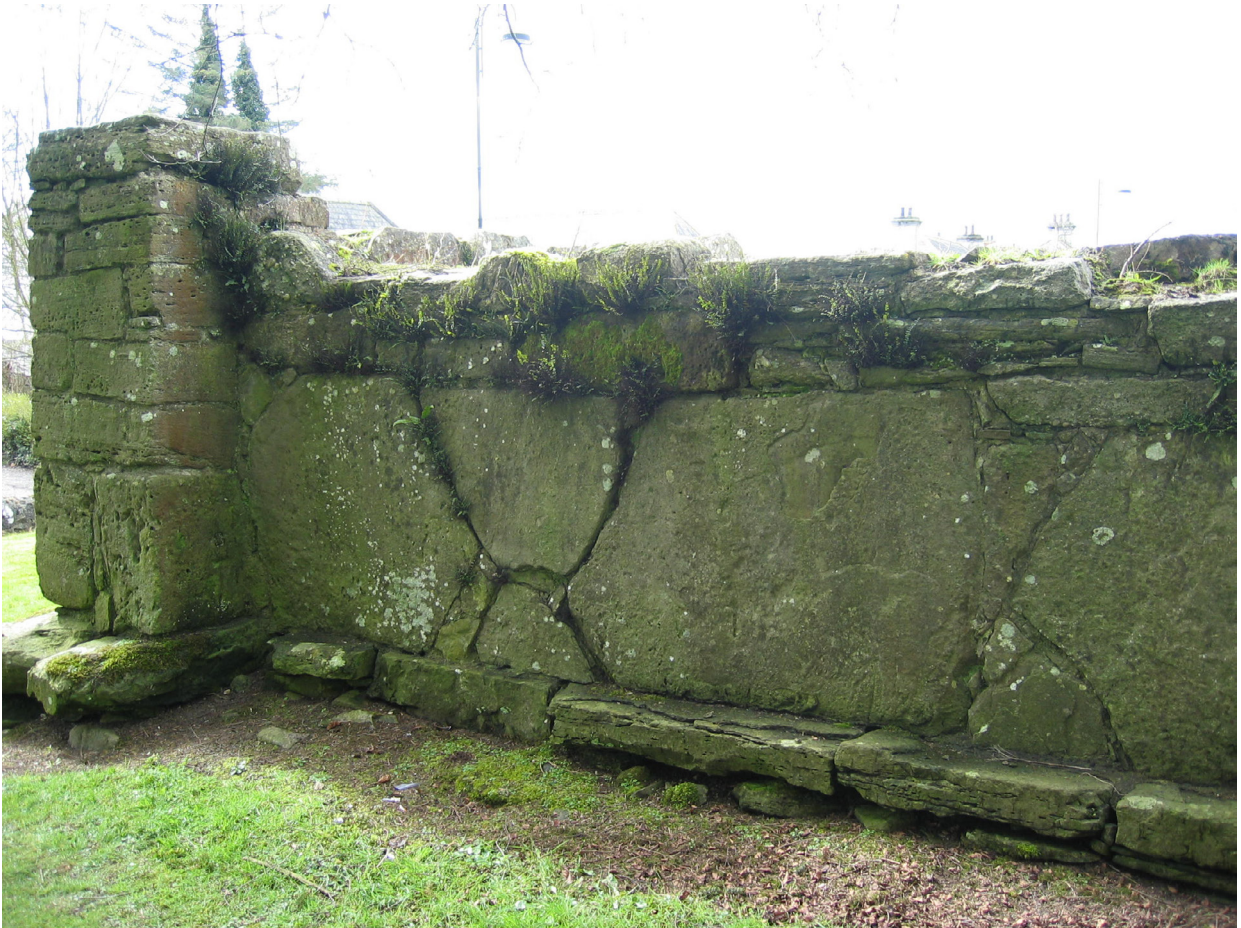
*Figure 11.27. The east wall of St Mel, Ardagh, Longford (N 204 686) showing the megalithic blocks of face-bedded Lower Carboniferous calcareous sandstone. The wall has been capped more recently with limestone.*

The frequency with which both megalithic and face-bedded stonework is used in churches in parts of Ireland (Figure 11.27 5.30) has for some suggested that their use, particularly with reference to megalithic stones, might be related to methods of increasing church security. This is not, however, the case. Rather, the common occurrence of these features in Ireland relates to the underlying geology and the readily available widespread presence of rocks such as calcareous sandstones from within the Carboniferous Limestone sequence (such as Unit 64; which can be broken more readily into more megalithic proportions).
